Assessment on coral reef and seagrass meadows within the 10km radius from the proposed groynes site in Keelavaippar coast, Gulf of Mannar

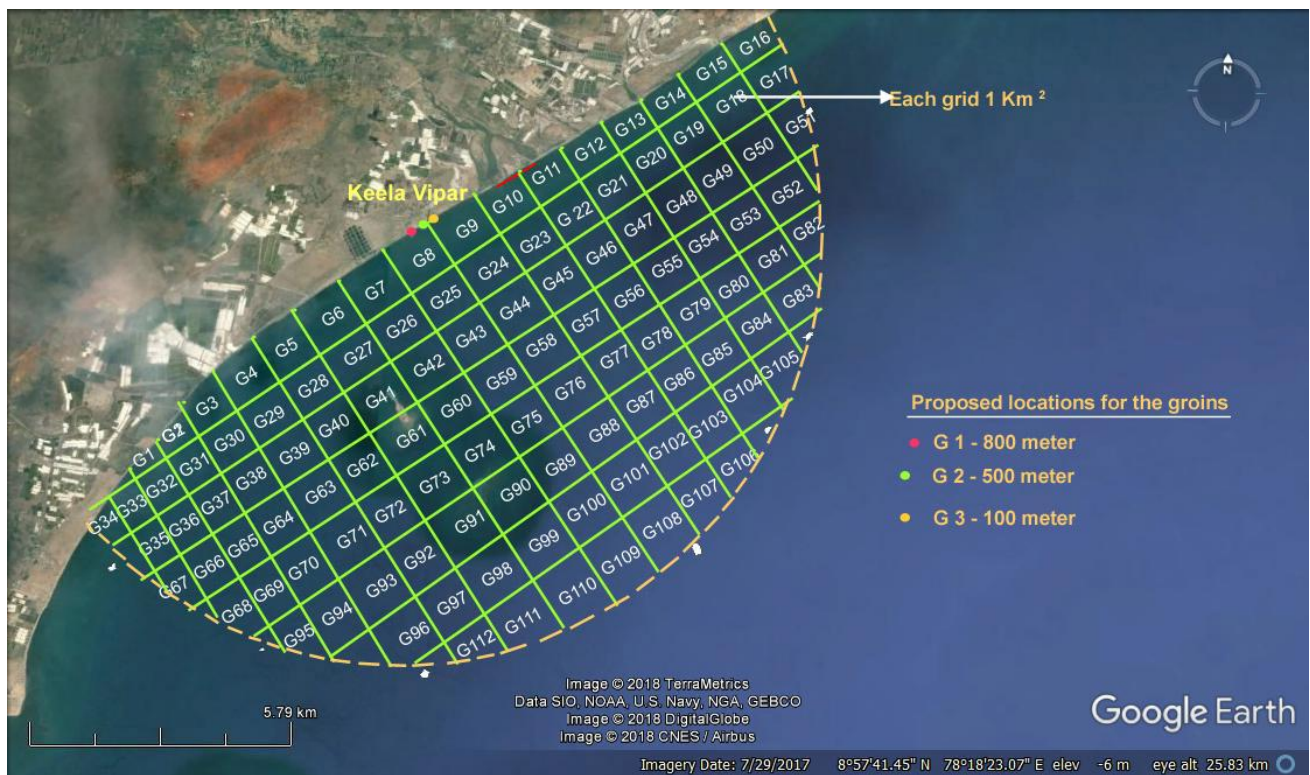
Fig. 1: Map showing the monitoring location in Keelavaipar Coast

The study area is divided into eight zones (Zone 1 to Zone 8) depending on horizontal distance from the shoreline (Fig. 1). Zones are further divided into equal spaced grids (G) of approximately 1 sq km each and totally 116 numbers of grids formed with in the 10 km radius. Zone 1 is located nearer to the groynes point which consist of G1 to G16; Zone 2 (G17 to G34); Zone 3 (G35 to G51) ; Zone 4 (G52 to G67) ; Zone 5 (G68 to G82) ; Zone 6 (G83 to G95) ; Zone 7 (G96 to G105) ; Zone 8 (G106 to G116), which was away from the groynes.

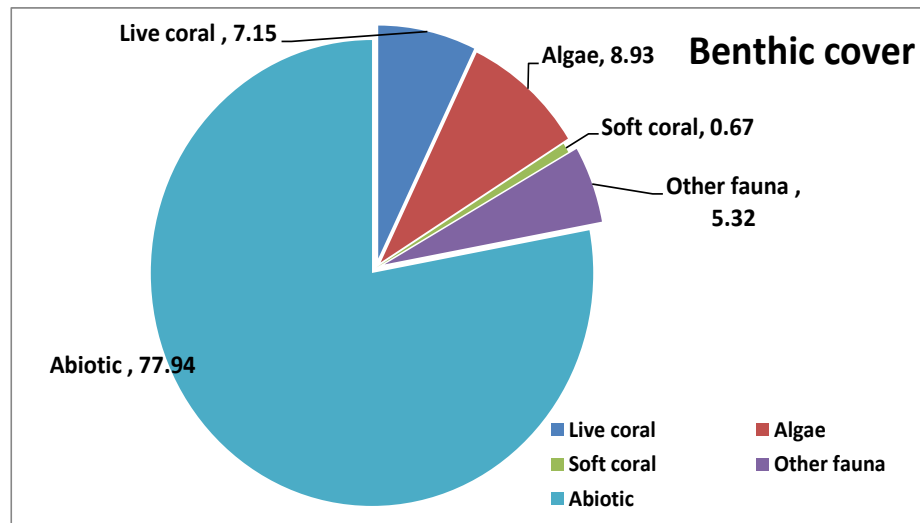
Fig. 5. Mean % cover of benthic community structures in Zone-1

Inshore patchy coral reef habitats were found in this zone. Mean live coral was 7.15% and among the benthic community, abiotic (sand and rubbles) factor occupied maximum with a mean of 77.94% (Fig. 5 & Table 2). The highest coral cover was observed in G 4 with 11.14% followed by 6.08% at G 7 respectively. A total of 4 hard coral species were observed and *Turninaria mesentrina* and *Porites lutea* were the most commonly observed coral species. Similarly low density of coral recruits was recorded with a mean value of 1.92 m⁻² and density ranged between 1.52 and 2.24 m⁻² in the observed grids (Table 3). Few coral health issues were observed in this zone and among the Coral health issue types, Macroalgae competition, Worm infestation and Sponge competition were observed with the mean prevalence of 1.02% (Table 3).

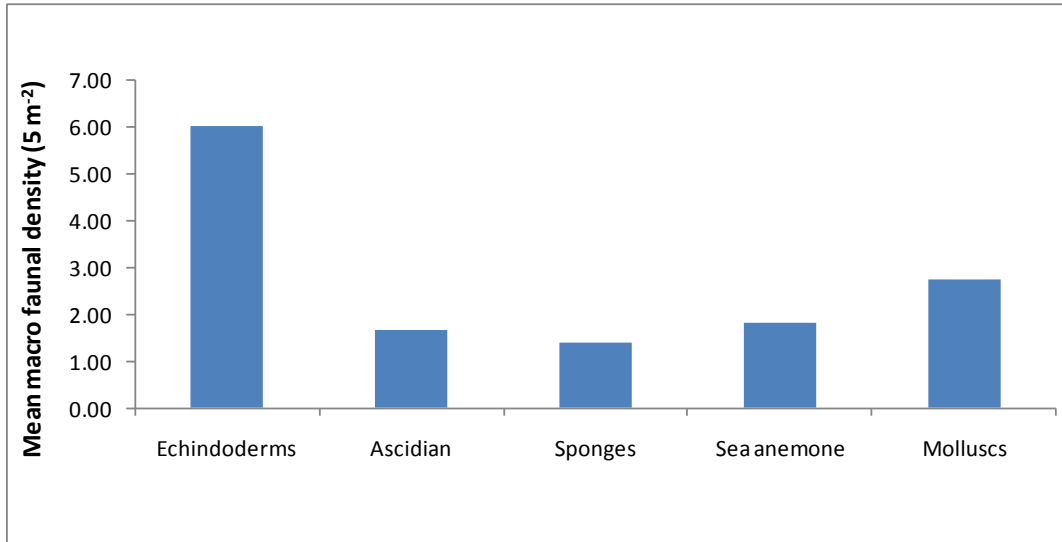
Fig.12. Mean macro faunal group density in Zone-2

Five major macro faunal groups were observed in this zone. Mean density was 13.60 5m^2 and density ranged between 1.93 and 17.71 5m^2 (Fig. 12 & Table 10). Among the macro faunal community, Echinoderms were dominant with 23.09 5m^2 followed by Molluscs with 1.52 5m^2 . In the observed grids, greater density was seen in G 29 with 23.09 5m^2 followed by G 28 with 20.33 5m^2 (Fig. 13).

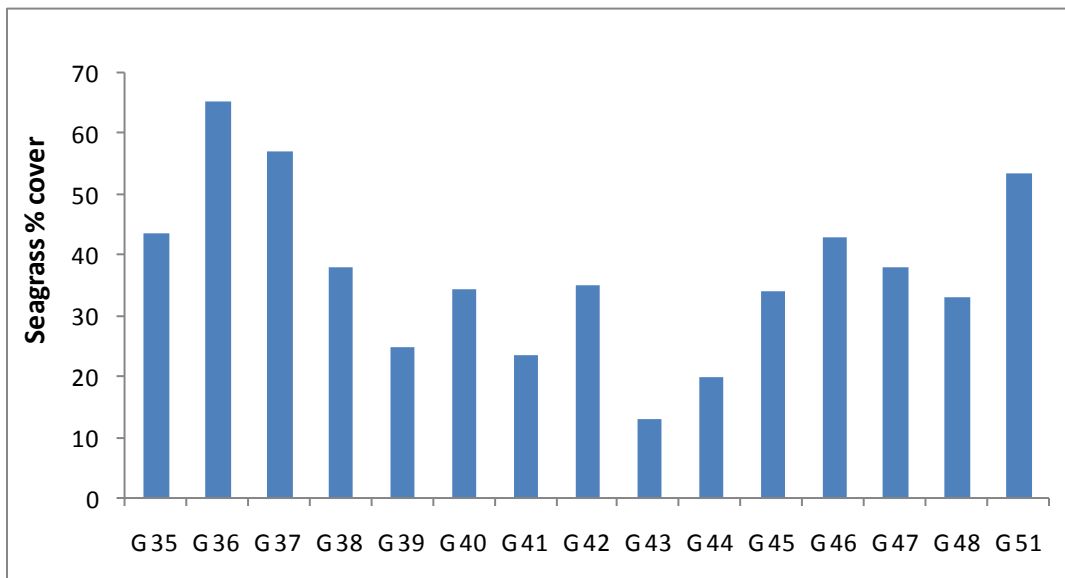
Fig.14. Seagrass percentage covers in Zone-3

In zone-3, patch and dense seagrass meadows were found and mean percentage cover was 37.22%. The maximum cover was observed in G 36 with 65.49 % followed by G 37 with 57.13 respectively (Fig. 14). A total of six seagrass species were recorded, among them, *Thalassia hemprichii* and *Cymodocea serrulata* were the dominant species.

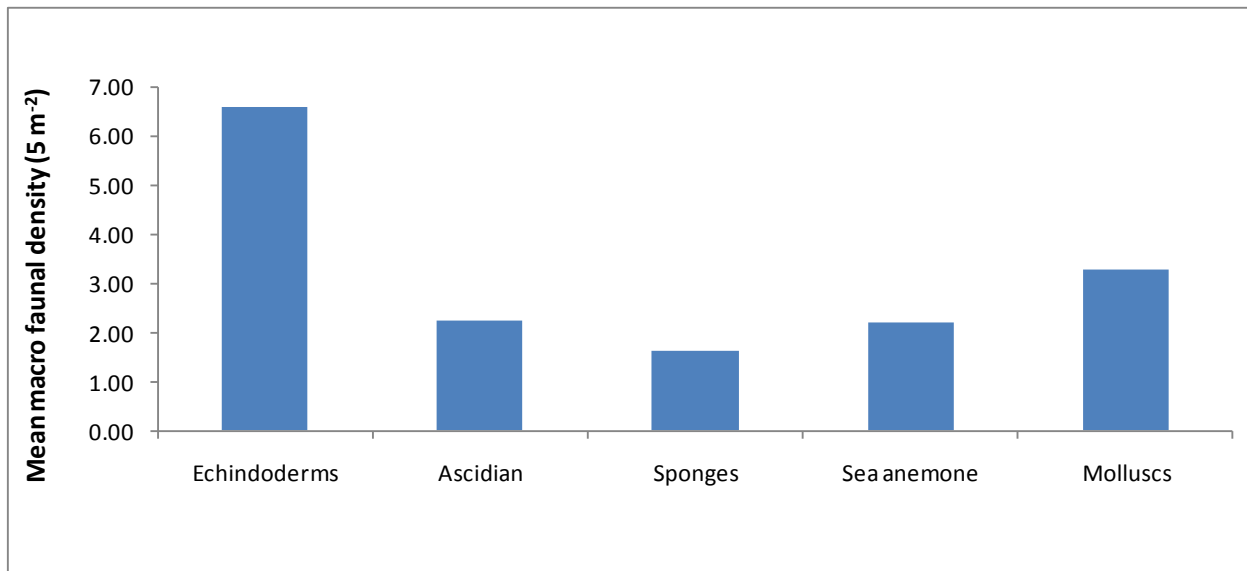
Fig.18. Mean macro faunal group density in Zone 3

Five major macro faunal groups were observed in this zone. Mean density was 15.88 5m² and density ranged between 7.29 and 23.2 5m² (Fig. 18 & Table 16). Among the macro faunal community, Echinoderms were dominant with 6.57 m² followed by Molluscs with 3.28 5m². In the grids, greater density is observed in G 36 with 23.2 followed by G 51 with 21.78 5m² respectively (Fig. 19).

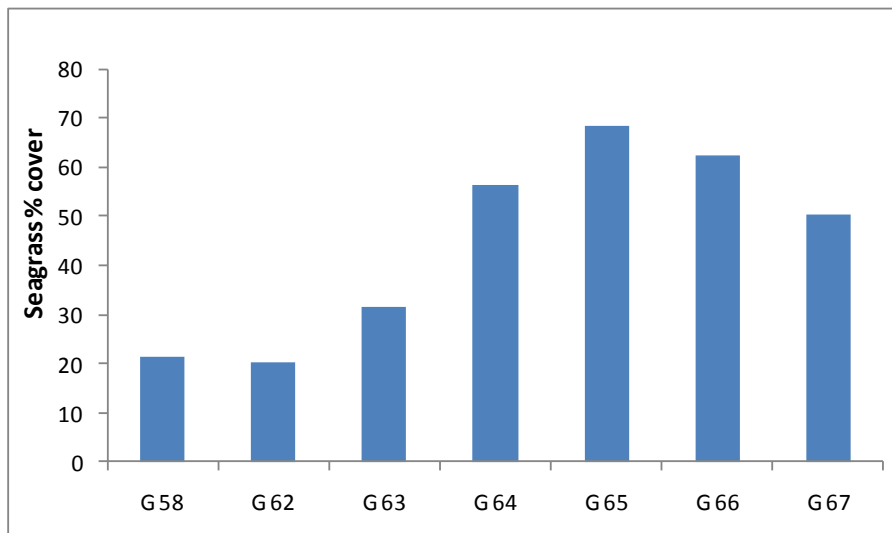
Fig.20. Seagrass percentage covers in Zone-4

In zone-4 also dense and sparse seagrass meadows were found with a mean percentage cover of 44.30%. The maximum cover was observed in G 65 with 68.32% followed by G 66 with 62.32% respectively (Fig. 20). A total of seven seagrass species were recorded, among them, *Cymodocea serrulata* and *Thalassia hemprichii* were the dominant species.

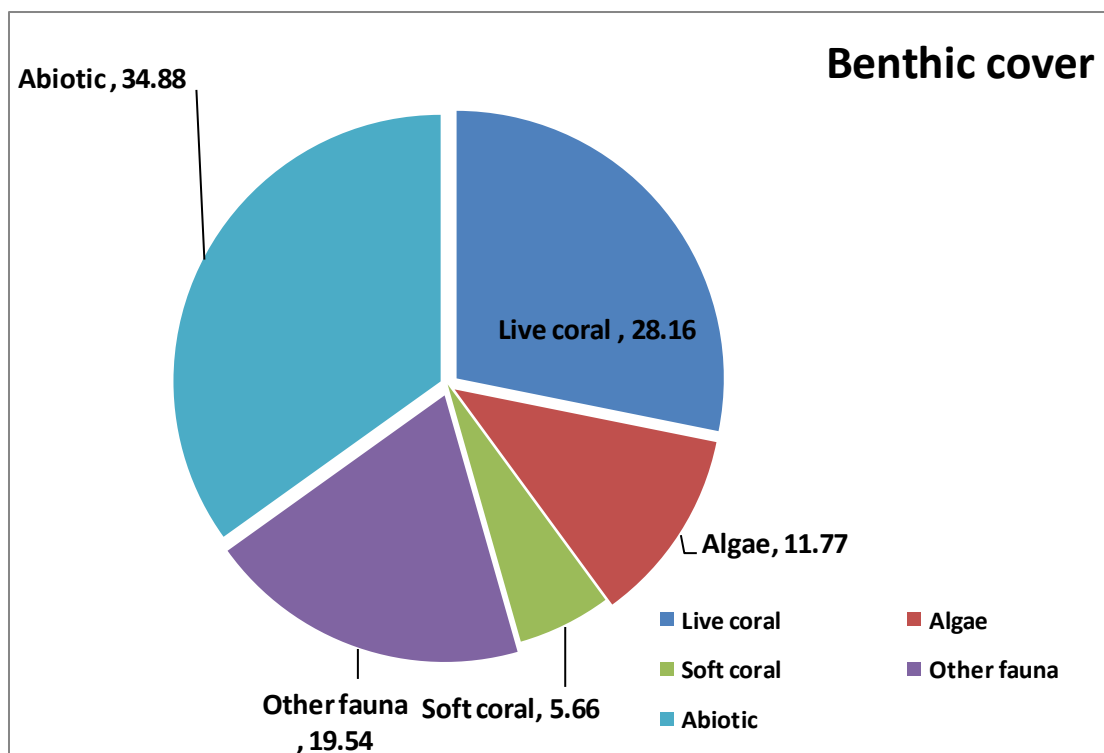
Fig.23. Mean % cover of benthic community structures in Zone 4

Dense and patch coral reef sites were observed. Mean live coral was 28.16% and among the benthic community, abiotic (sand and rubbles) factor occupied maximum with a mean of 34.88% (Fig. 23 & Table 20). The highest coral cover was observed in G 61 with 46.38% followed by 33.62% at G 60 respectively. A total of 15 hard coral species were observed *Acropora intermedia*, *A. formosa*, *A. cyhtherea*, *Montiopora digitata*, *Turbinaria peltata*, *Platgyra lamellina*, *Favia favus* and *Porites lutea* were the most commonly observed coral species. Similarly low density of coral recruits was recorded with a mean value of 3.85 m⁻² and density ranged between 1.86 and 6.02 m⁻² in the observed grids (Table 21). Few coral health issues were observed in this zone and among the coral health issue types, Macroalgae competition, Sponge Competition, Invetibrate Gall, White syndrome, Growth Anomaly, Focal Bleaching, Worm infestation and Fish predation were observed with the mean prevalence of 6.60% (Table 21).

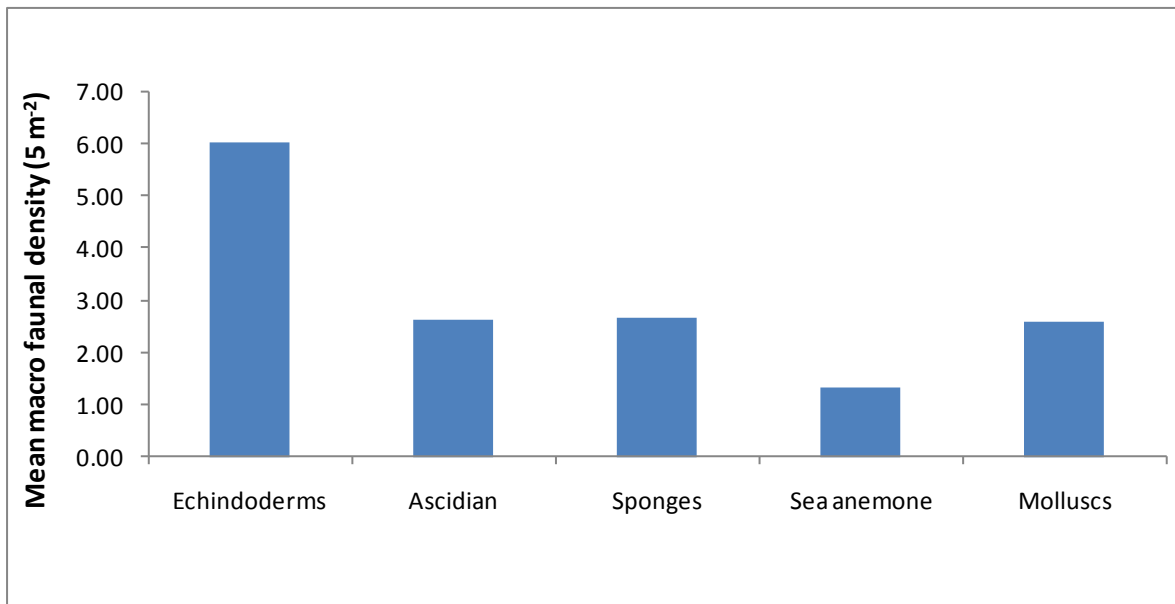
Fig.24. Mean macro faunal group density in Zone 4

Five major macro faunal groups were observed in this zone. Mean density was 15.28 $5m^2$ and density ranged between 0.53 and 30.99 $5m^2$ (Fig. 24 & Table 22). Among the macro faunal community, Echinoderms were dominant with 6.04 $5m^2$ followed by Ascidian with 2.64 $5m^2$. Greater density was observed in G 65 with 30.99 followed by G 61 with 27.74 $5m^2$ respectively (Fig. 25).

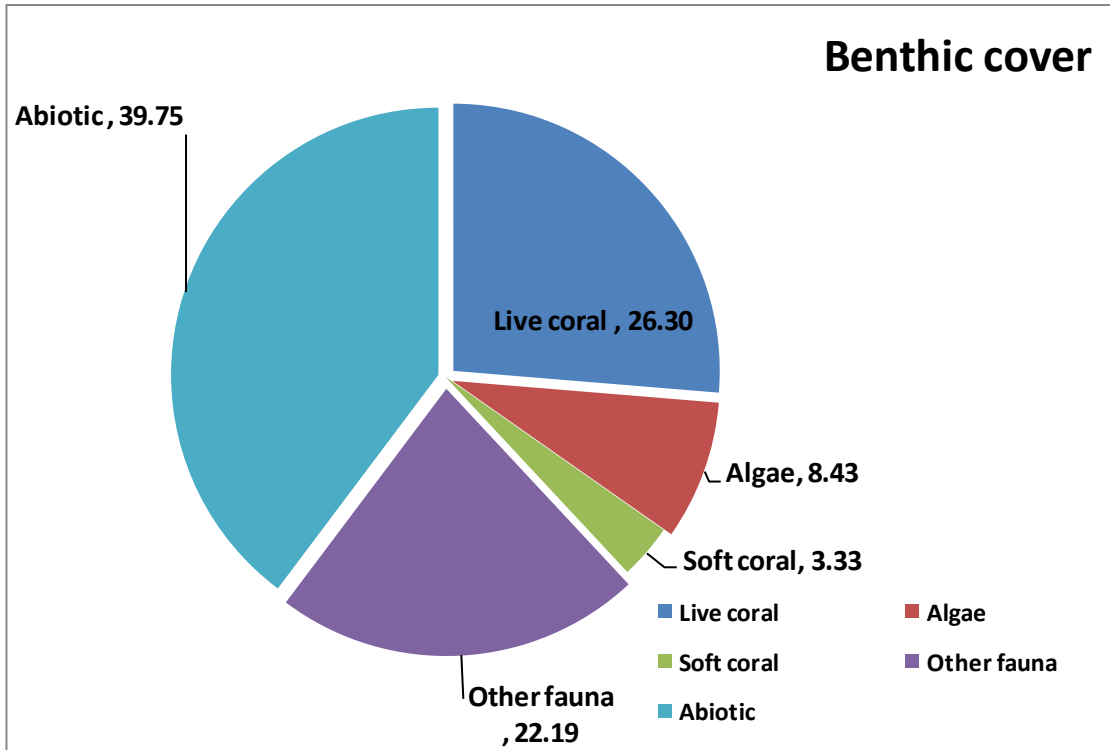
Fig.29. Mean % cover of benthic community structures in Zone-5

The mean live coral cover of this zone was 26.3% and coral habitat was seen as few minor and dense patches. Among the benthic community, abiotic (sand and rubbles) factor occupied maximum with a mean of 39.75% (Fig. 29 & Table 26). The highest coral cover was observed in G 74 with 36.92% followed by 31.59% at G 73 respectively. A total of 11 hard coral species were observed, among them *Acropora cytherea*, *Turbinaria peltata* and *Porites solida* was the commonly observed coral species. Similarly fair amount of coral recruit density was recorded with a mean value of 2.9 m⁻² and density ranged between 1.02 and 4.63 m⁻² in the observed grids (Table 27). Few coral health issues were observed in this zone and among the coral health issue types, Macroalgae competition, Sponge Competition, Invertebrate Gall, White syndrome, Growth Anomaly, Focal Bleaching, Worm infestation and Fish predation were observed with the mean prevalence of 6.58% (Table 27).

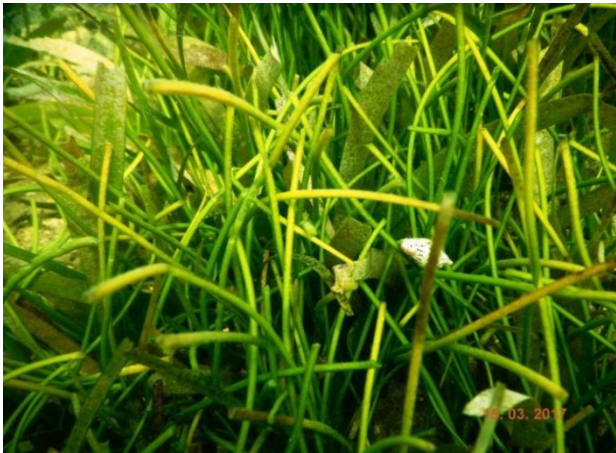
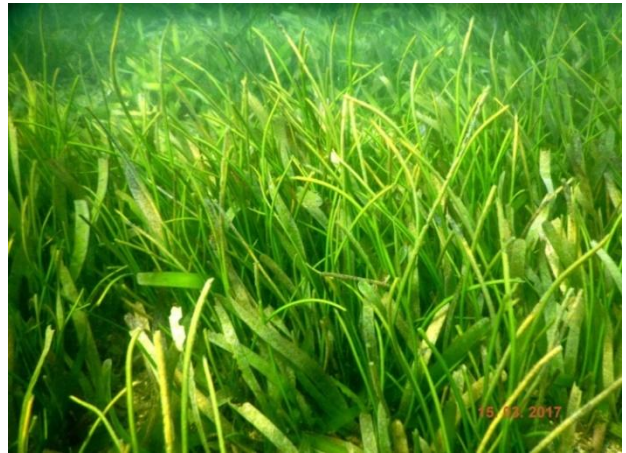
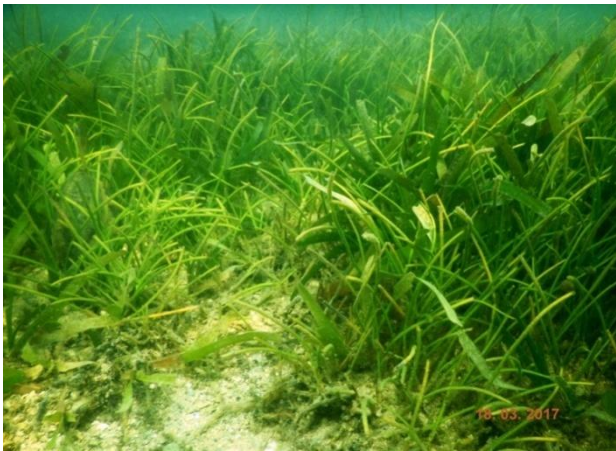
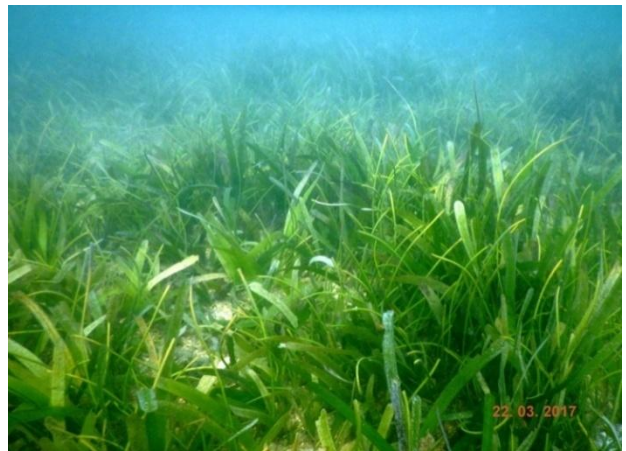
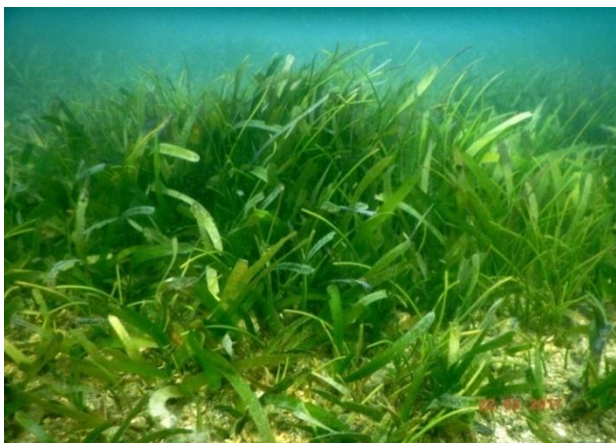
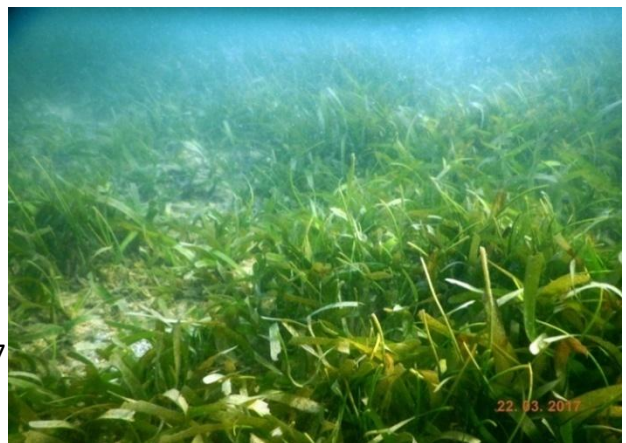
Plate 2

Dense seagrass area located about 7.6 Km from project site

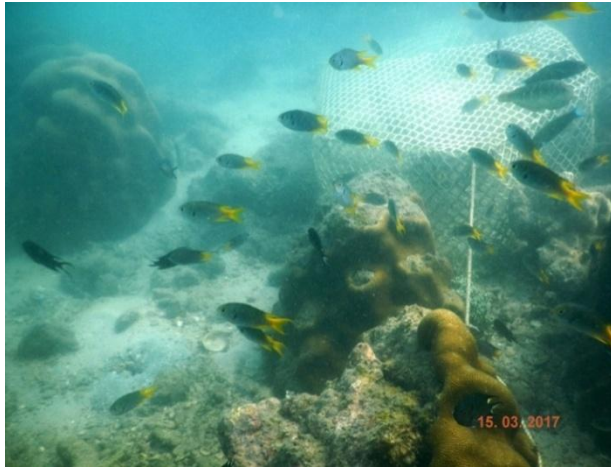
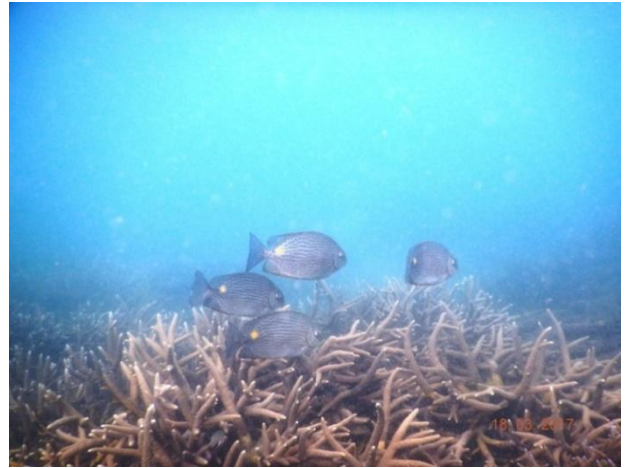
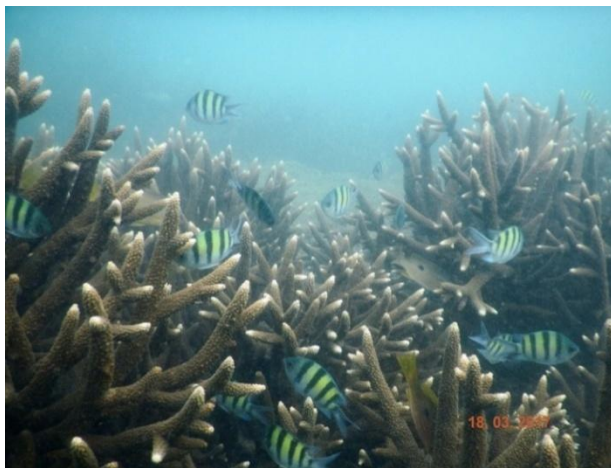
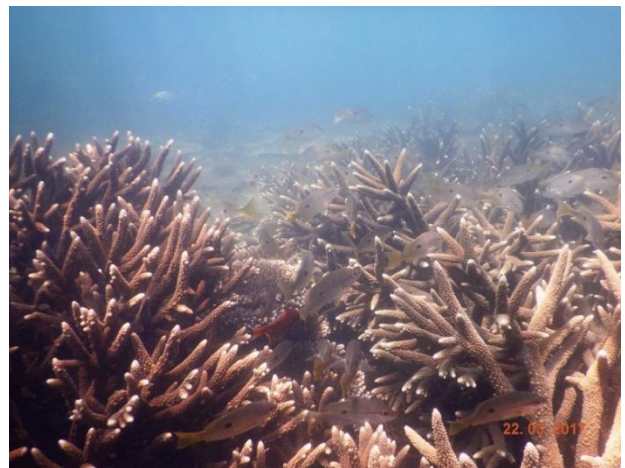
Plate 3
Observed fishes in the coral area

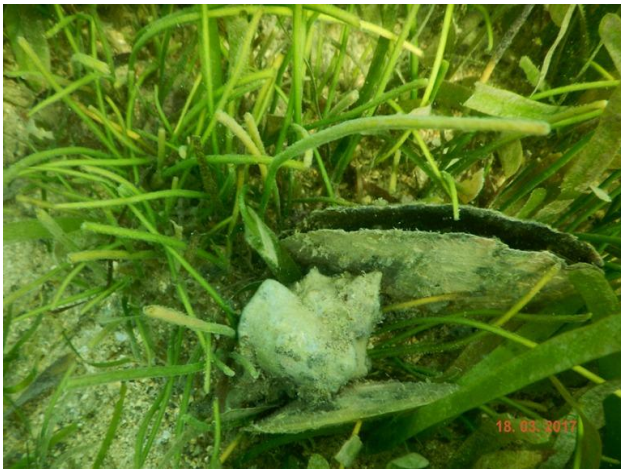
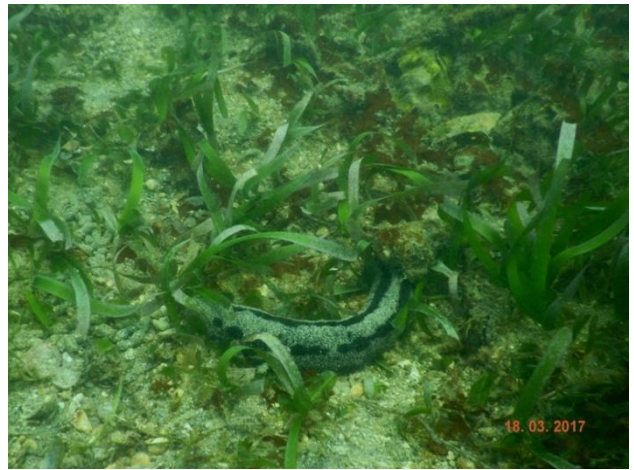
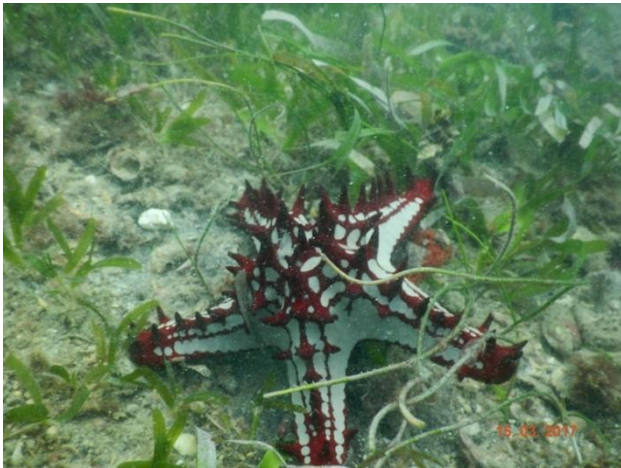
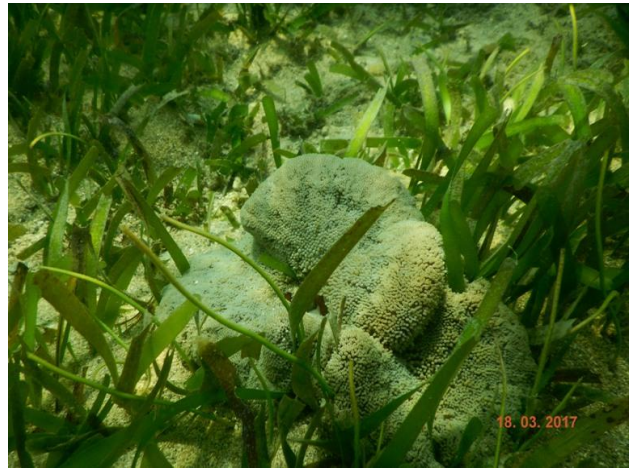
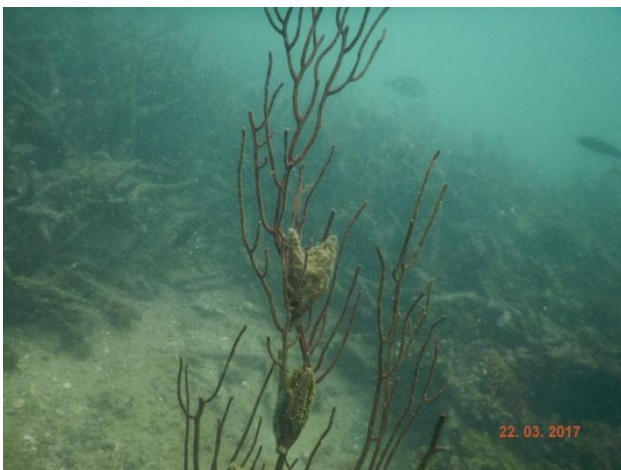
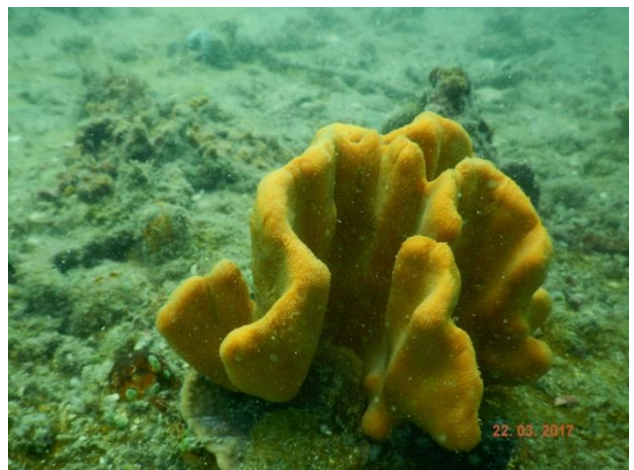
Plate 4

Observed macro faunal community in the dense seagrass and coral area

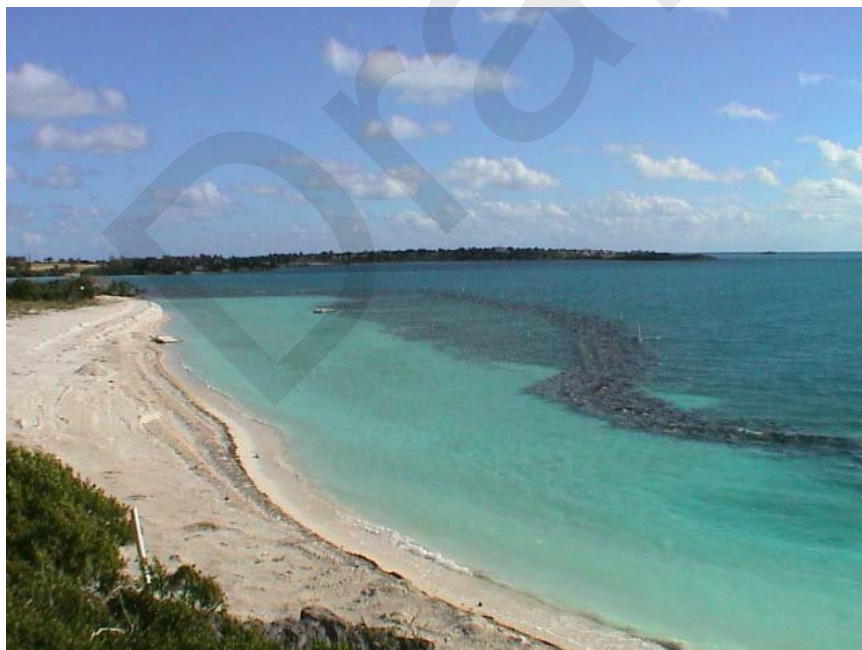
Fig.1.9. A view showing the submerged reef as a coastal protection measure

wave breaking process, to the required level that maintains the dynamic balance on the shoreline as shown in **Fig.1.8**. The Narrowneck Artificial Reef is located on the Gold Coast of Queensland, Australia (Jackson, 2004), approximately 2km north of Surfers Paradise implemented by Gold Coast City Council (GCCC). The design dimensions are 400m long (cross-shore), 175m wide (longshore), with the base of the reef positioned approximately 150m offshore (B/S ratio = 1.16). A view of the submerged reef as a coastal protection measure is shown in **Fig. 1.9**.

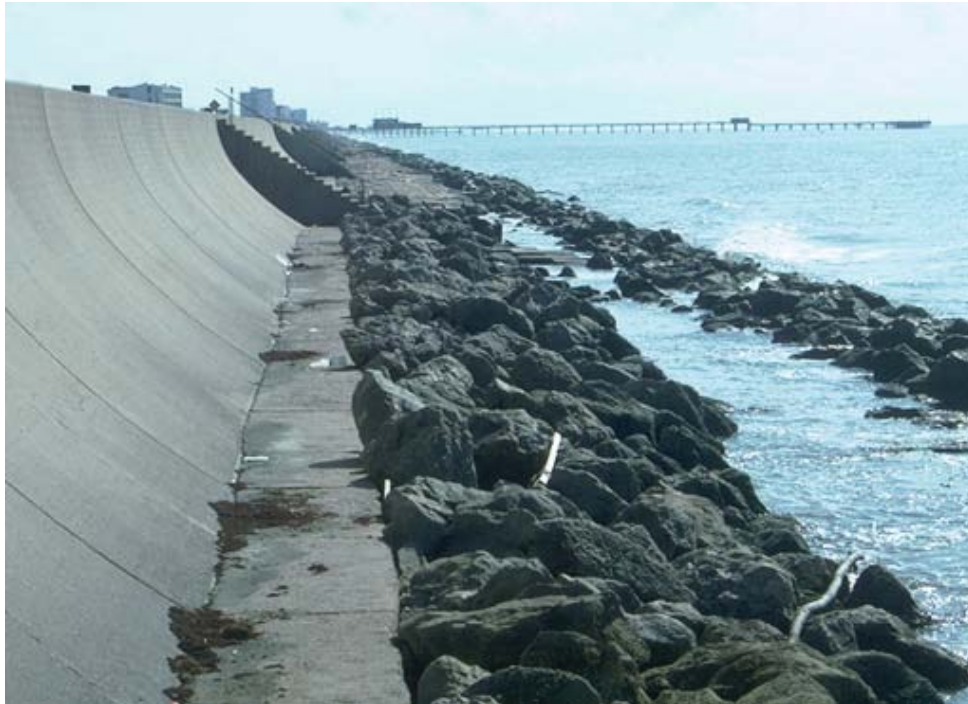
Fig. 1.12 View of a typical concrete seawall

Seawalls and Bulkheads are structures placed parallel or nearly parallel to the shoreline to separate the land from water area. The primary purpose of a bulkhead is to retain or prevent sliding of the land, with a secondary purpose of affording protection to the back shore against damage by wave action. The most common and widespread coastal engineering tool for the protection of shoreline is the seawall as a hard measure. Varieties of seawalls / dikes constructed world- wide is shown in **Fig.1.10**. A typical concrete seawall cross-section is shown in **Fig.1.11**. A view of an existing concrete seawall is shown in **photo 1**. **Seawall protection is for all practical purposes an irreversible act because the beach in front of it is often removed.** A masonry/concrete seawall as shown in **Fig.1.12**, although very stable is expensive and difficult for implementation over long stretches of the coast affected by erosion. A seawall would not be more effective on coasts that experience predominant littoral drift, like the east coast of India. For example, the seawall along north of Chennai, Visakhapatnam and Paradeep ports have been suffering damages continuously. A strong toe for seawall is very essential as in the case of the seawall for a particular stretch, north of Chennai harbour shown in **Fig.1.13**. The section has withstood the effects of the tsunami 2004 and is still intact. In locations, where, large size natural rocks is scanty, gabions (wire net filled with stones of smaller size) as shown in **Fig.1.14** can be adopted. At locations of abundance of sand (near river mouths which may be dredged and Geo-bags or Geo-tubes can be adopted for seawalls or groins as can be seen in **Figs. 1.15a** (Island of Sylt) **and 1.15b** (Protecting the digha beach, west Bengal designed by IITM).

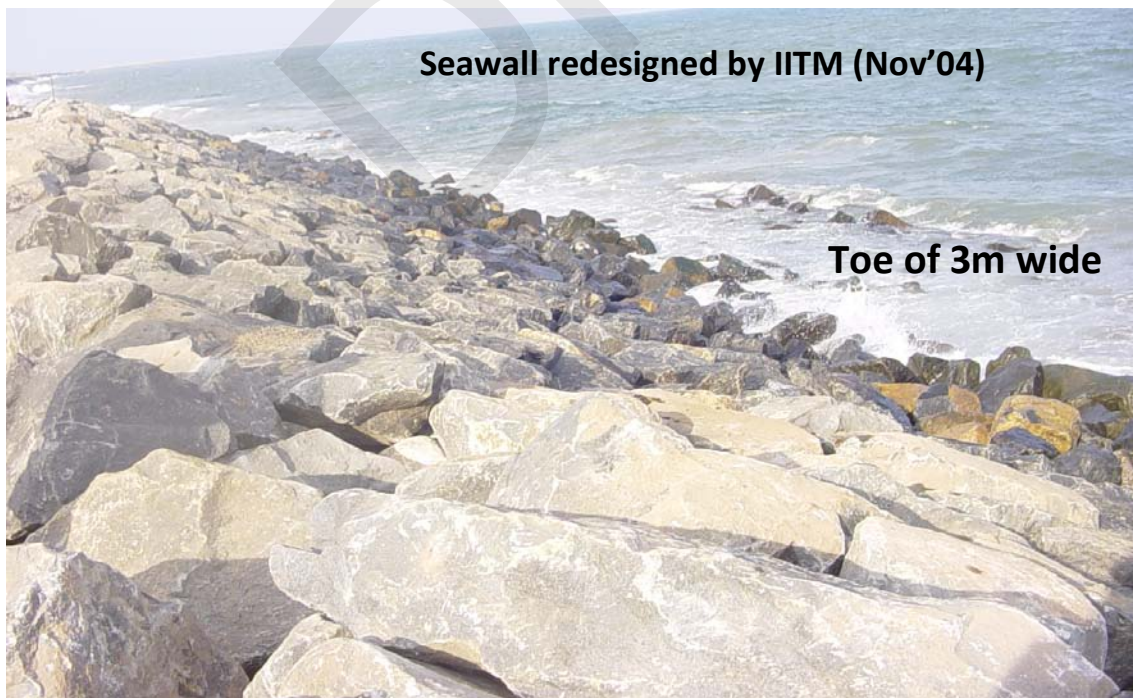
Fig.1.13. Seawall with toe protection north of Ernavur

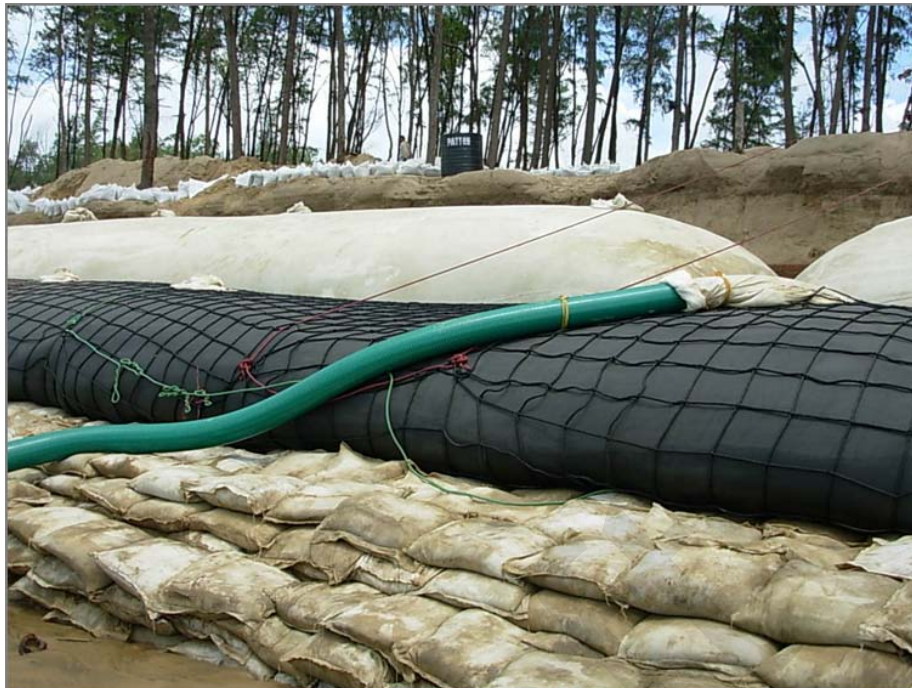
Fig.1.15b Use of Geo-tubes to protect Digha beach, West Bengal (IITM)

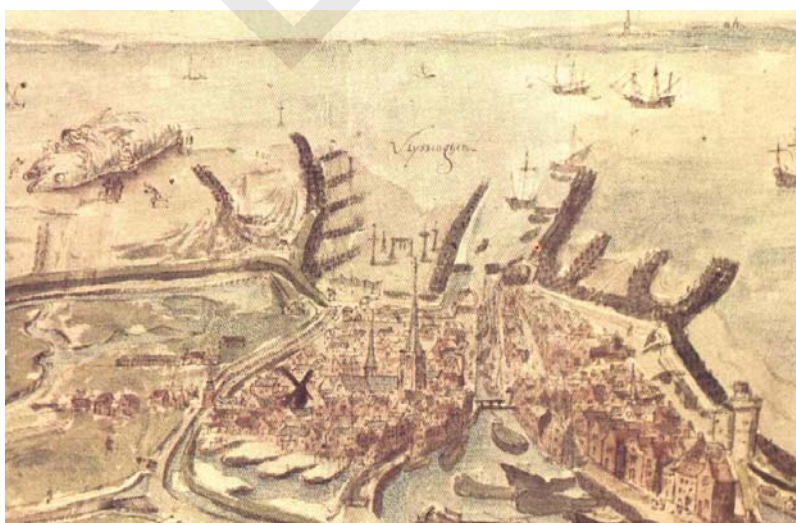
Fig.1.19b. Oldest groins (1503),Vvissingen, Netherlands

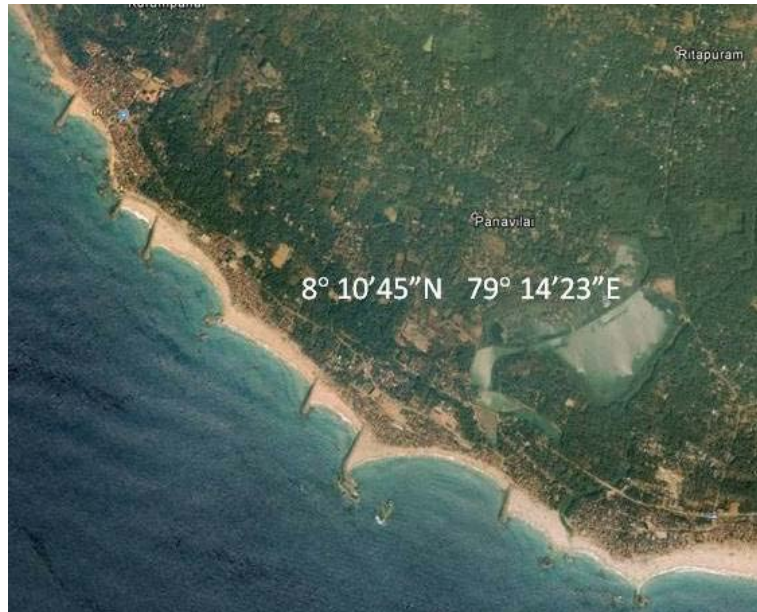
Fig.1.20. Groins field protecting the West coast of Tamilnadu

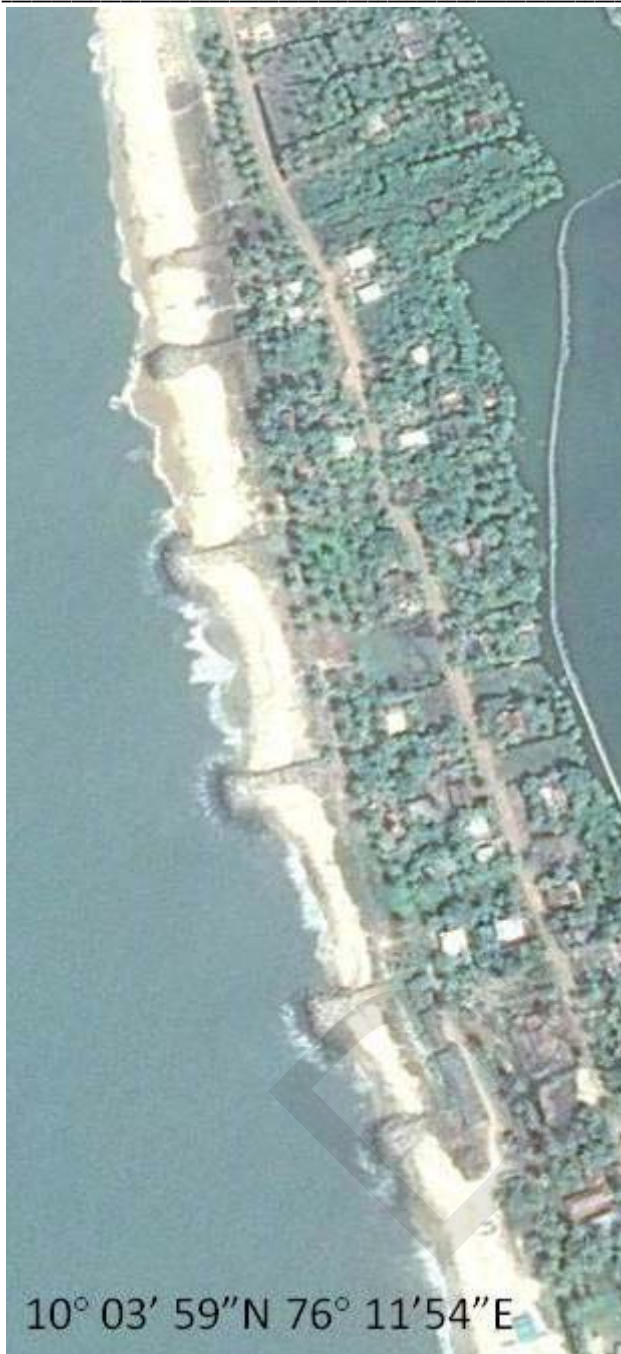
Fig.1.21. T-Gorin field protecting the coast of Narayanambalam, Kerala

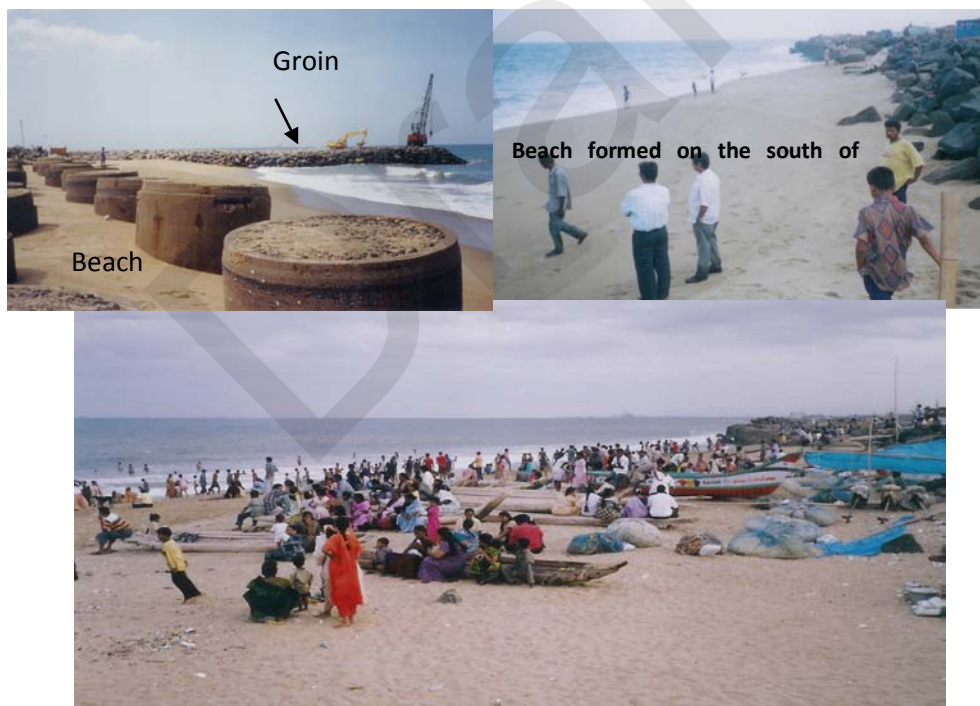
Fig.1.23. Effect of Groin field in winning the beach (Royapuram, Chennai)

Another way of using groins is to build a series of small groins (groin field) at shorter intervals along the affected coast. This will tend to stabilize the entire coast by keeping the sand trapped between them. Typical shoreline changes due to a single groin and that due to a groin field are projected in **Figs.1.17 and 1.18** respectively. The groin field has to be carefully designed and implemented. The effects of a groin field are clearly brought out through **Fig.1.19a**. Too small will produce offshore loss due to rip currents or seaward currents. Correct spacing will allow filling and overspill and too great a spacing will produce poor retention and scour. The oldest groin in the world in Vissingen, The Netherlands is shown in **Fig.1.19b**. The effect of the groin field as a protection measure protecting the west coast of Tamilnadu (Kurumbunai, Vanyakudi villages, etc) designed by IITM is projected in **Fig.1.20**, while, that of a T-groin field protecting the shoreline of Narayanambalam, Kerala designed by IITM is shown in **Fig.1.21**. Sometimes unplanned groin works may still be an effective protection measure as in the case of the coast of Cyprus depicted in **Fig.1.22** Groin fields as a protection measure for Royapuram, Chennai and Kanyakumari district designed by IITM that have proven to be successful are shown in **Figs.1.23 and 1.24** respectively.

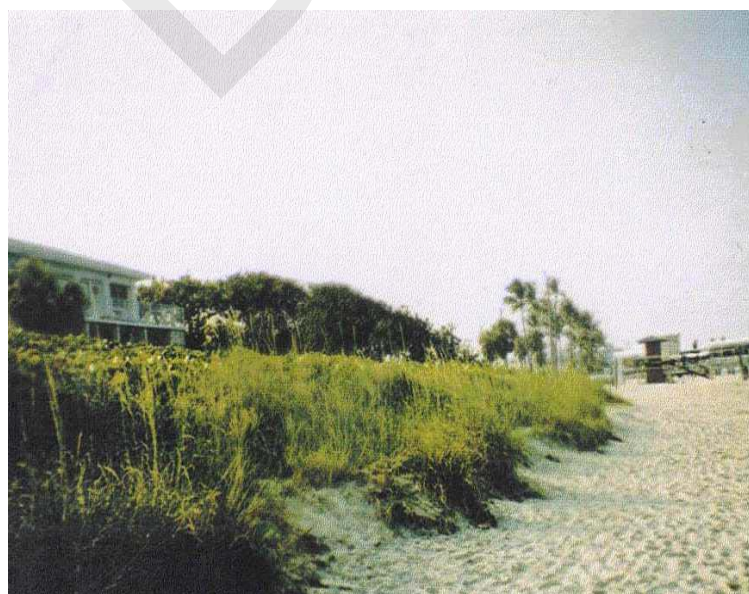
Fig. 1.29. Plantations serving as coastal protection

some extent. **Vegetation** as a protection can both reduce loads and increase strength. Vegetation has a relatively large resistance to waves and currents, thus reducing the loads. Roots can increase the strength by protecting the grains on a micro scale or by reinforcing them. **Fig. 1.27** shows strength of vegetation with wave load. The outside plants are “front soldiers” and have to withstand a higher load than the inside plants. At the front, due to the high velocities, scour can also occur if the roots are not able to retain the soil. The effect can be that the outside plants are damaged or disappear. As long as the number of soldiers is large enough, the battle can still be won. Vegetation also influences the resistance against sliding. The roots clearly armour the soil, see **Fig.1.28** from CIRIA, 1992. Typical stretch of the coast protected by plantation is shown in **Fig. 1.29**.

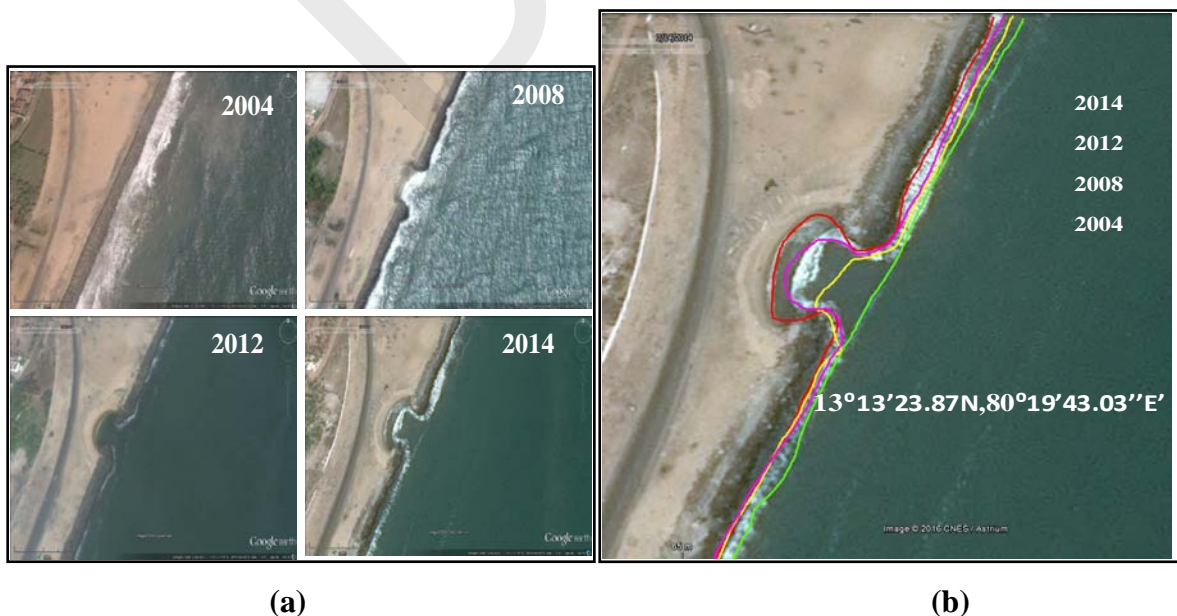
The satellite imageries from 2004-2012 in an interval of 4 years are shown in **Fig.1.31a**. The seawall from north and from south terminating near ($13^{\circ}13'23.87''N, 80^{\circ}19'43.03''E$) shows the initiation of erosion in between them in 2008, which is observed to penetrate landward with a continuous increase over the period. The super position of the shoreline (**Fig. 1.31b**) indicates that the stretch of beach of about 30m eroded over a length of about 25 m.

Fig. 1.31a and 1.31b Shoreline behaviour near the termination of seawalls

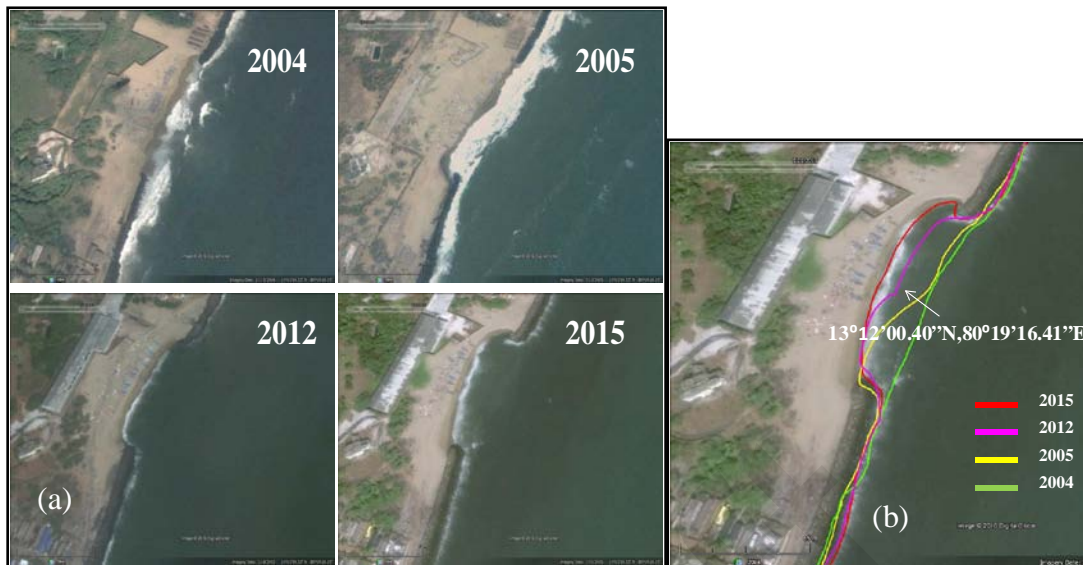
Similar kind of scenario is observed at ($13^{\circ}20'00.40''\text{N}$, $80^{\circ}19'16.41''\text{E}$) as shown in **Fig. 1.32a**. The superposition of the shoreline shown in **Fig. 1.32b** demonstrates a loss of beach of about 35m over a length of 125m.

Fig 1. 32a and b. Shoreline behaviour near the termination of seawalls

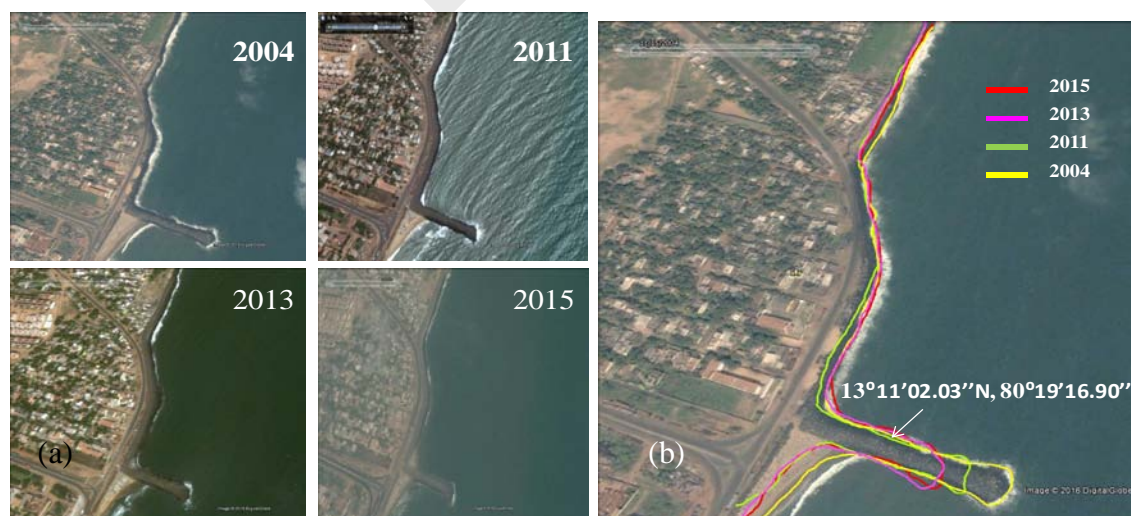
Fig. 1. 33a and 1. 33b. Behaviour of shoreline due to groin field off Chennai coast

The groin field constructed north of Chennai harbor solved 5 decade problem of perennial erosion. It has been a general feeling that groins are expected to shift the zone of erosion further down drift side which is not the case if planned properly as can be seen in **Fig.1. 33a**. The superposition of shorelines (**Fig. 1.33b**) show that such problem does not arrives if a carefully designed seawall is constructed along the down drift of the last groin of the groin field. This indicates clearly irrespective of type of protection measure that is planned for, a stable coastline can be achieved if effects are put in an effective design, analysis, construction and follow up.

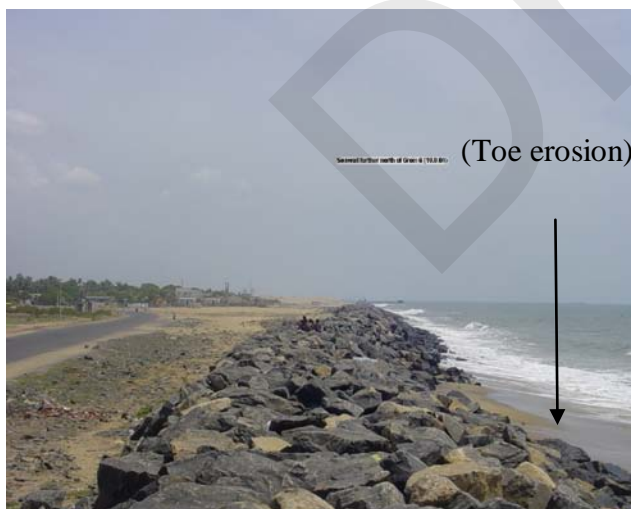
Fig.1.34. Seawall beyond ernavur experiencing toe erosion

A rubble mound seawall that is widely adopted along the coast will eventually have to be rehabilitated in constant intervals with bigger size stones as can be seen in **Fig.1.34**. In the event rehabilitation is not carried out, the cumulative damage can be even upto the disappearance of the seawall and the penetration of the shoreline into the landward side.

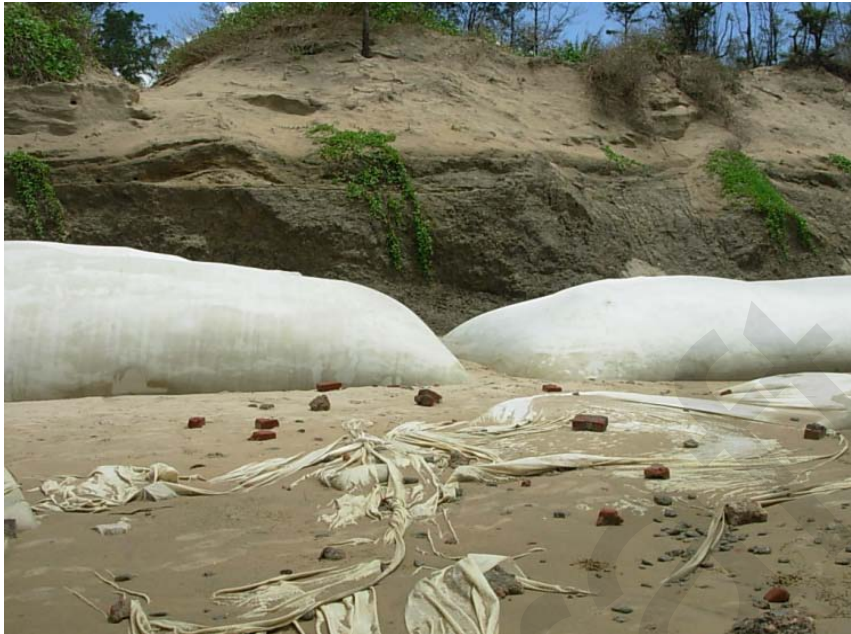
many successful projects dealing with application of geo-synthetic products in marine environment. The laying of geo-tubes with a gap in between them, can result in strong run-down of flow in event of monsoon, resulting in scour and unequal settlement of the tubes, finally leading to its failure. Vandalism by piercing the geo-tubes would be a irreversible act as the sand will escape, in which case repair work becomes impossible.

Fig.1.35a Gaps between geo-tubes- vulnerable for scour/erosion
