Assessment on coral reef and seagrass meadows within the 10km radius from the proposed groynes site in Keelavaippar coast, Gulf of Mannar

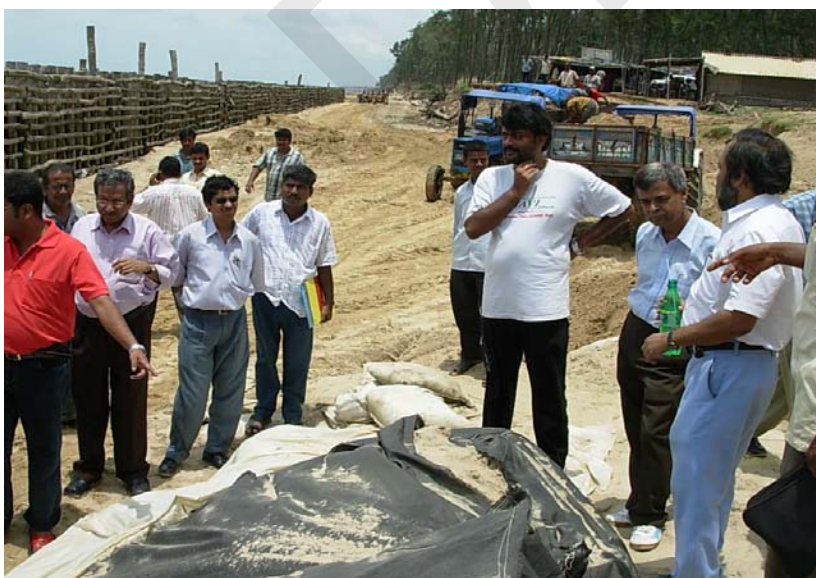
Fig.1.35bvandalism-punch ring of geo-tubes

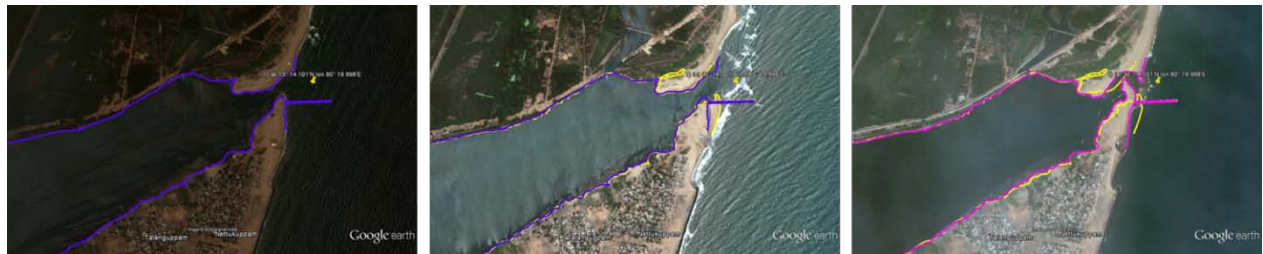
It is inferred that the mouth is open during the non-monsoon period and as the monsoon approaches the siltation increases and chokes the mouth. This scenario has enhanced due to the construction of Ennore port and also polluted due to discharge from thermal plants.

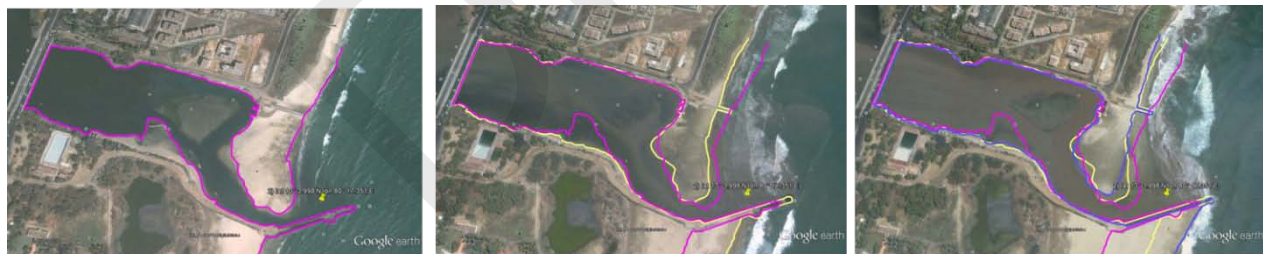
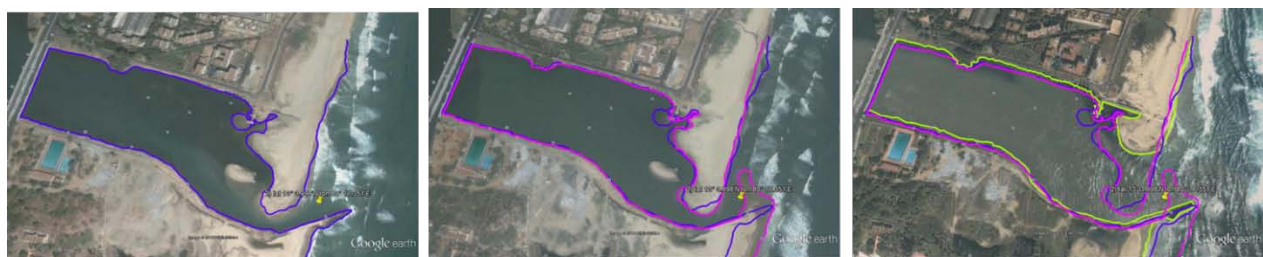
This estuary is situated south of Chennai harbour. Once upon a time it was a breeding ground for migratory birds. But due to low inflow and construction of harbour it has been choked and it has also become a drainage carrier. Two training walls were constructed both on northern and southern side of the river mouth. From the **Fig. 5.4** it is inferred that though siltation is considerably reduced near the mouth still the problem exist. An in-depth study is need of the hour.

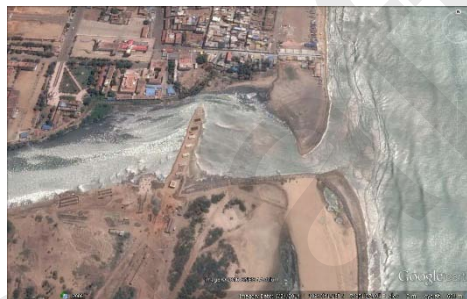
Fig.5.6 Typical view of inlet at Vellar River mouth

This lies in Nagapattinam district and the famous Velankanni shrine is situated by the side of river mouth. A typical view of the inlet is shown in the **Fig. 5.6**.

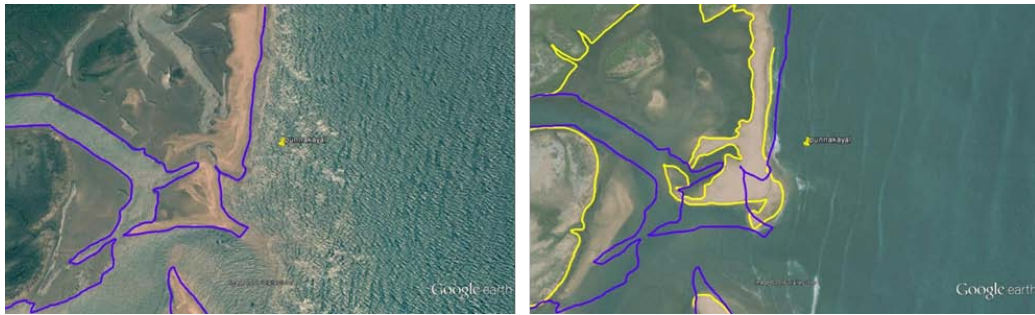
Fig. 5.7(a) Effects of seasonal variations on inlet dynamics at Northern Inlet of Punnakayal River

This is the estuary of Tamaraparani situated along Bay of Bengal near Thiruchendur. Typical images representing the seasonal variations on inlets at Punnakayal is shown in **Fig. 5.7(a) and (b)**. This river has two inlet connected to the Bay of Bengal as shown in the earlier figure. The closure of the mouth deprives the fisherman performing their fishing operation. This area is referred for study to Institute of Hydraulics and Hydrology, Poondi by the Fisheries Department. Training this inlet would be a challenge as the mouths are not stationary and keep oscillating.

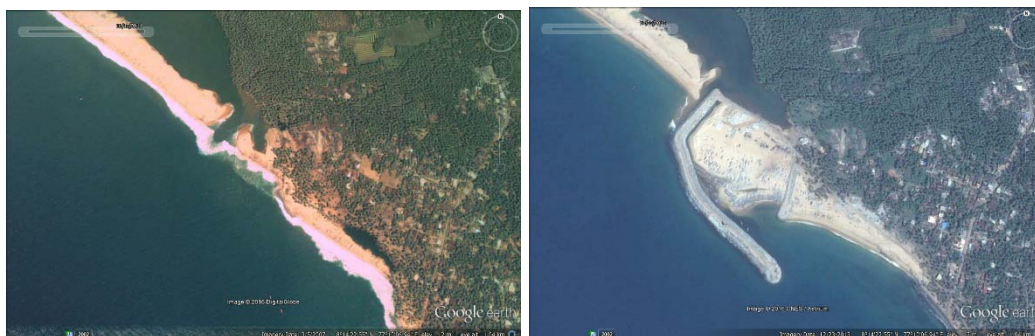
Fig.5.8. Thengapattinam before and after construction of fishing harbour

This is situated along west coast of Arabian Sea and the river Pazhayar of Kodayar system meets Arabian Sea. Typical images representing the seasonal variations on inlet dynamics at Punnakayal river mouth is shown in **Fig. 5.8**. A fishing harbor at the mouth constructed by the Tamilnadu fisheries department has resulted in the closure of the mouth due to the misalignment of the longer breakwater, which is opened towards the east and the sediment transport which happens to be westerly has found its way into the mouth, thereby closing it. This proves beyond doubt that the direction of the littoral drift is extremely important in the planning of harbors, training walls or for that matter any type of shore connected structure.

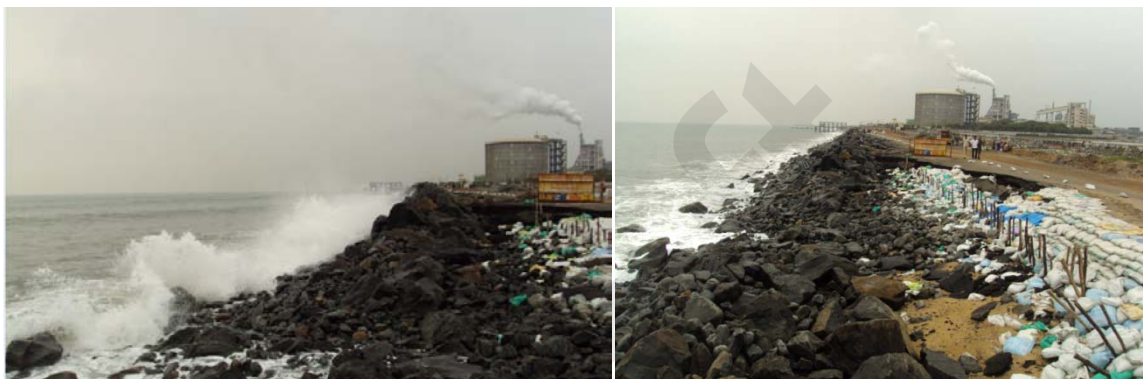
Fig. 7.4 (a) Cyclonic waves lashing the coast

Fig. 7.4(b) Erosion of seawall due to cyclonic waves

It was reported by Chennai Port trust that a severe cyclone occurred on 12.11.1984 which generated significant wave height of 6.0 m with a maximum wave height of 9.10 m. In the year 2010 cyclone naming JAL has crossed Chennai coast in October 2010. The net effect of cyclones on the coast is erosion and flooding. The details of damages on coastal stretch is shown below In **Figs. 7.4a** and **b**.

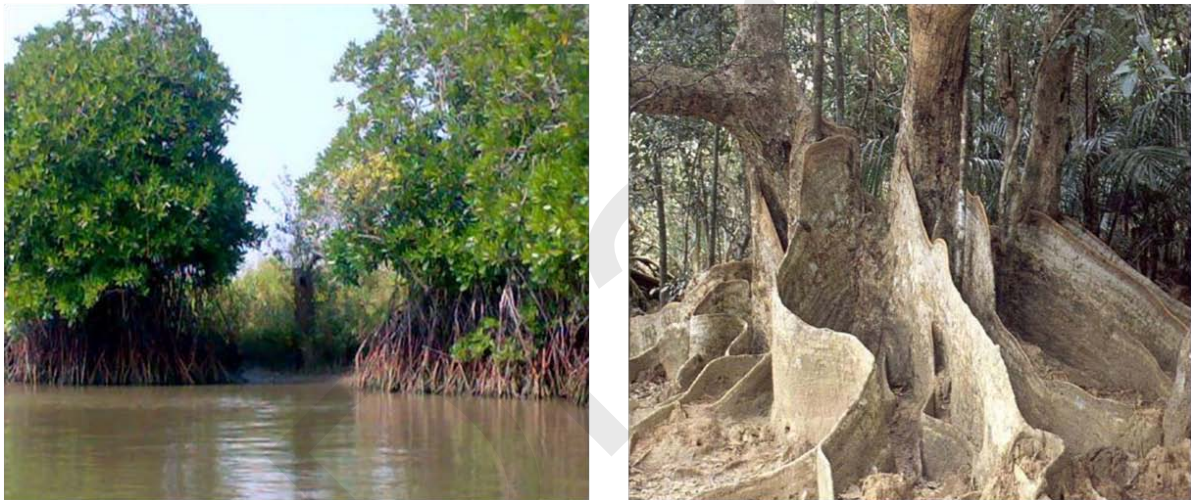
Figure 8.3 Typical view of mangroves along with their root system

- Network system of roots traps the sediments - stability of the shore, as shown in **Figs. 8.3 and 8.4**
- Nutrient and metal sinks
- Breeding and nursery grounds
- Source of wood, poles, firewood, charcoal, honey, medicines, fodder, etc

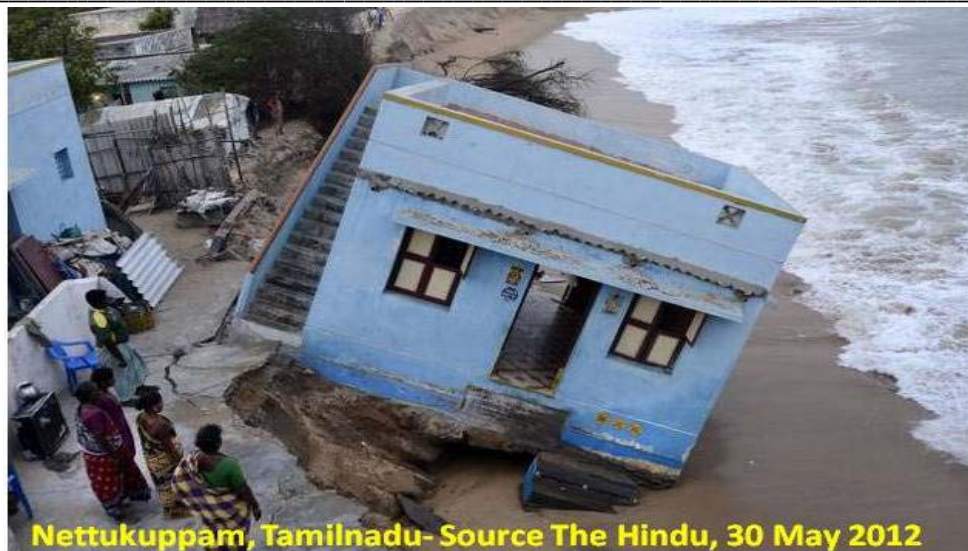
Fig.10.1c Erosion in Nettukuppam in 2012.

The stretch of the coast of Nettukuppam is shown in **Fig.10.1a**. A clear view of the northern region of Nettukuppam that is continued as a seawall on the sea front is shown in **Fig.10.1b**. The conventional seawall to be given due to densely populated region. The conventional seawall with a crest elevation of +5.2m is recommended to avoid storm-surge overtopping when the surge occurrence coincides with high tide, the overtopping and erosion leading the damage to the seawall could be high. Erosion in Nettukuppam is shown in **Fig.10.1c**.

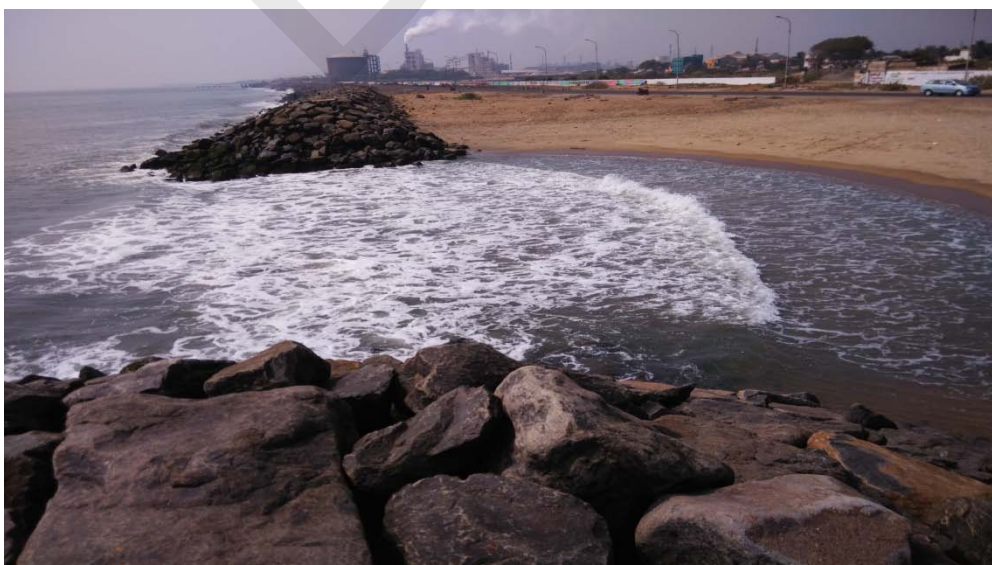
Fig.10.2 Mouth region of Tharankuppam

The stretch of the coast off Tharankuppam is shown in **Fig.10.2**. The gap between two seawall ends has resulted in erosion, the details of which has been discussed earlier. A perfect road is also available up to this beach, which may be quite suitable for the development of a fish landing centre and also prevent further coastal erosion. The gap between the tips of the seawalls can be utilised for developing the stretch into small fish landing centre by providing a pair of training walls.

Solution suggested: *A pair of groins designed through detailed scientific studies with existing bathymetry and shoreline morphology could be the solution.*

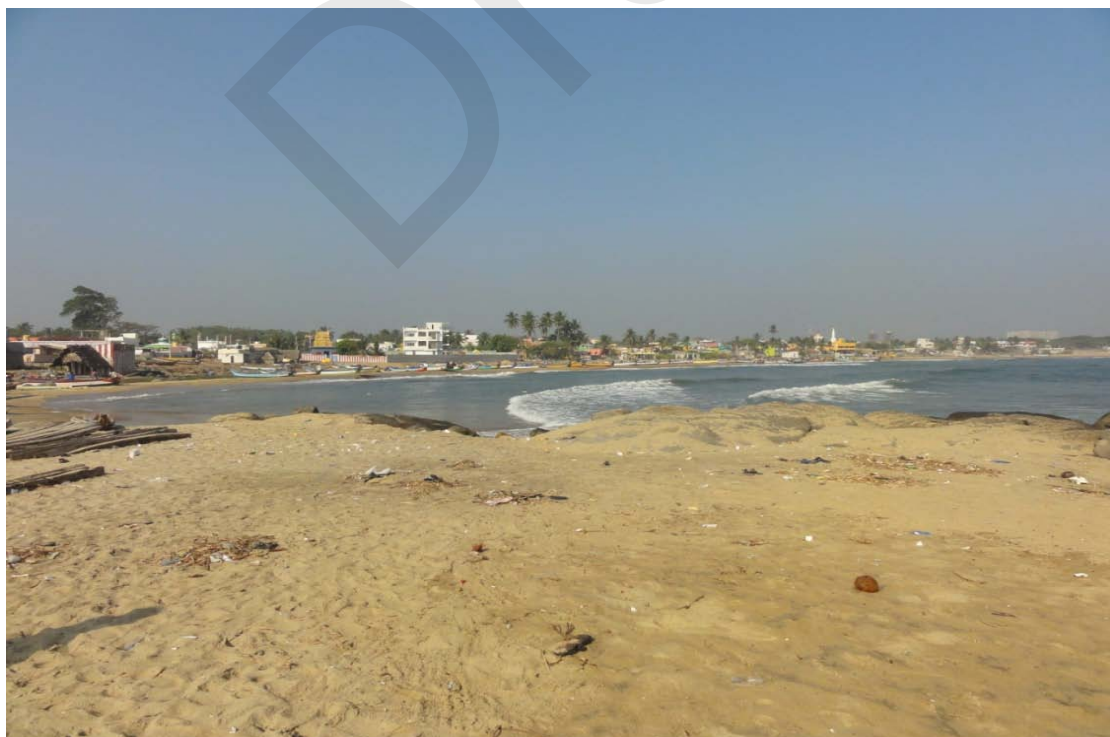
Fig.10.3a Beach profile Left (North) of yellow temple

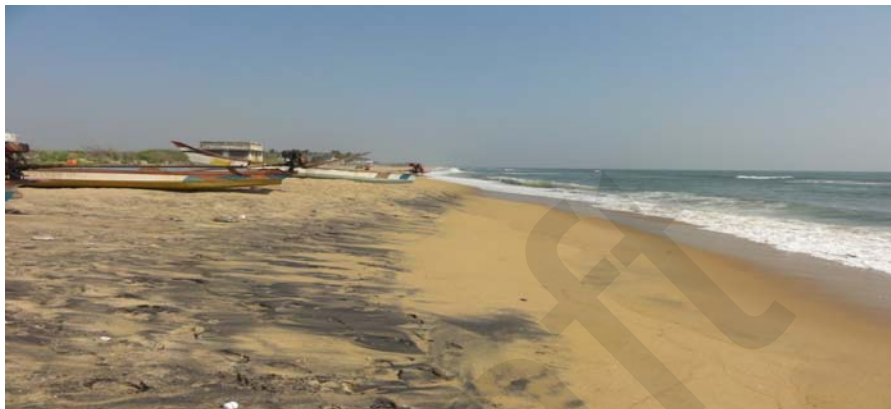
Fig.10.4a Beach profile North of Kokilamedu

This stretch of the coast on the north shown in **Fig.10.4a** although experiences erosion to the tune of 5m/yr as it is presently inhabited only by about 800 people, as many of them have moved to safer place, for instance, to Edaikkadu. The protection measure can be considered under the phase II of the highly vulnerable locations. Only in the event the local public express anxiety, should this stretch be taken up for protection. A groin field of short groins could be planned for this stretch so that the pockets in between the groins filled with sand due to littoral drift can be used for landing small fishing boats. The south of the stretch of

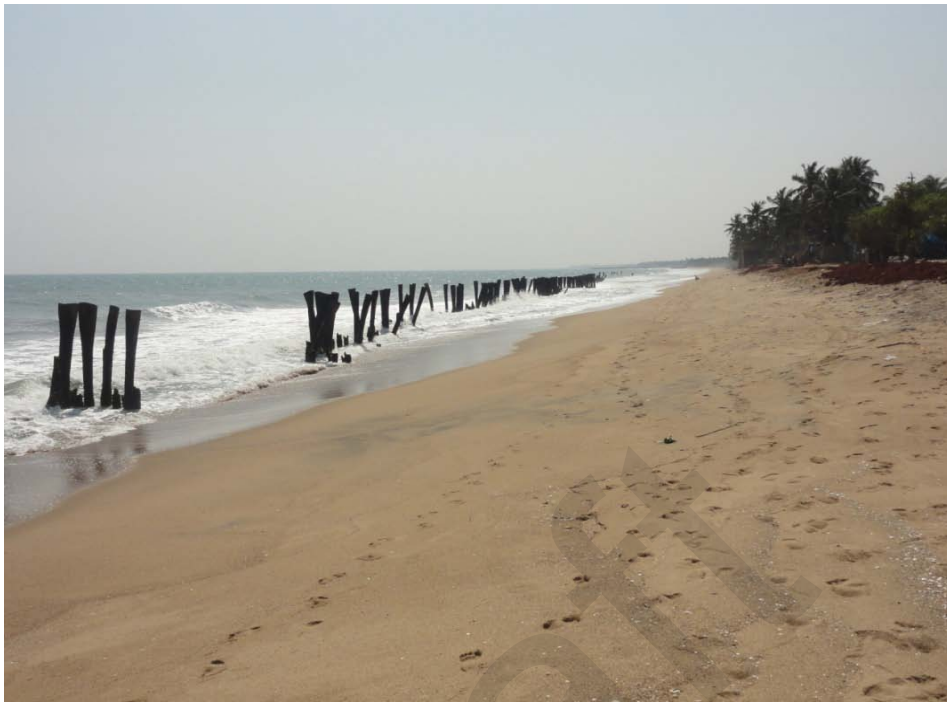
Fig.10.5a Beach profile South of Bommayapalayam

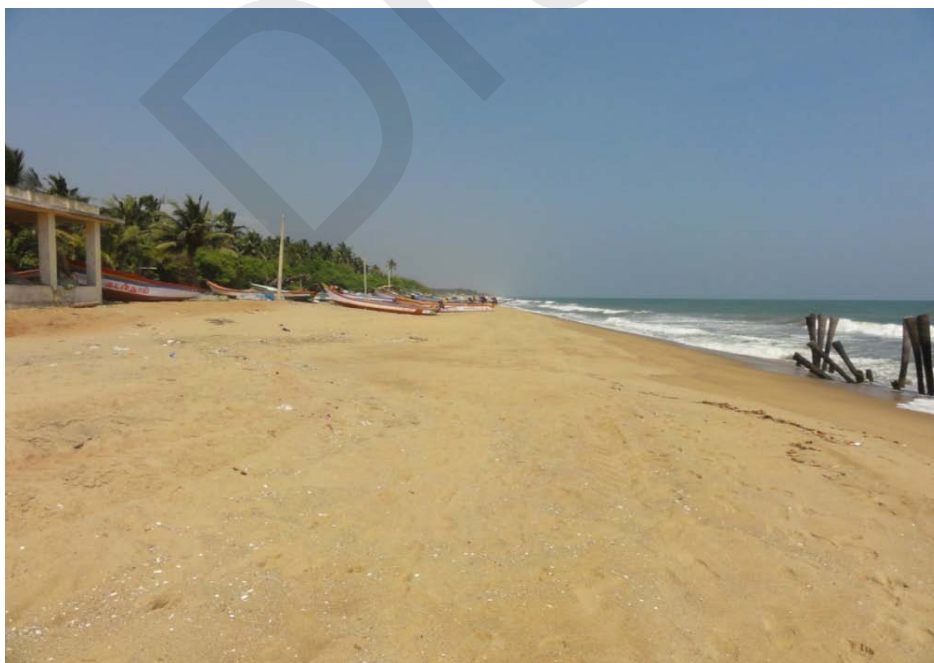
Fig.10.5b Beach profile north of Bommayapalayam

This stretch of the coast has been experiencing erosion at a rate of 5m/yr over a length of about 3.5km. As the longshore drift is dominant along this stretch, a carefully designed groin field could be a solution. The beach formed in between the groins could be used the landing of fishing boats. Slightly south of this location groin field has proved to be very effective in protecting the coast as well as resulting in beach formation. Unfortunately, without any design principles or concepts, Palmyra trees have been driven into the sea bed (**Fig.10.5a**), which in fact is bound to accelerate scour particularly during the down wash of the waves from the beach towards the Sea. The beach on the north of the measurement point exhibits a much flatter beach as can be seen in **Fig. 10.5b**. The beach profile in the south is observed to be steeper. The practice of driving logs of wood into the seabed parallel to the shoreline should be avoided and instead, the Palmyra trees could be tried normal to the shoreline and placed as close as possible in two rows as they can act as groins. An example of such a protection adopted in the Baltic Sea as a semi-permanent measure is seen in **Fig. 10.5c**. Sediment samples have been collected along the beach, the results from the sieve analysis is shown in **Fig.10.5d**, whereas, the variation of the beach slope along this stretch of the coast is shown in **Fig. 10.5e**.

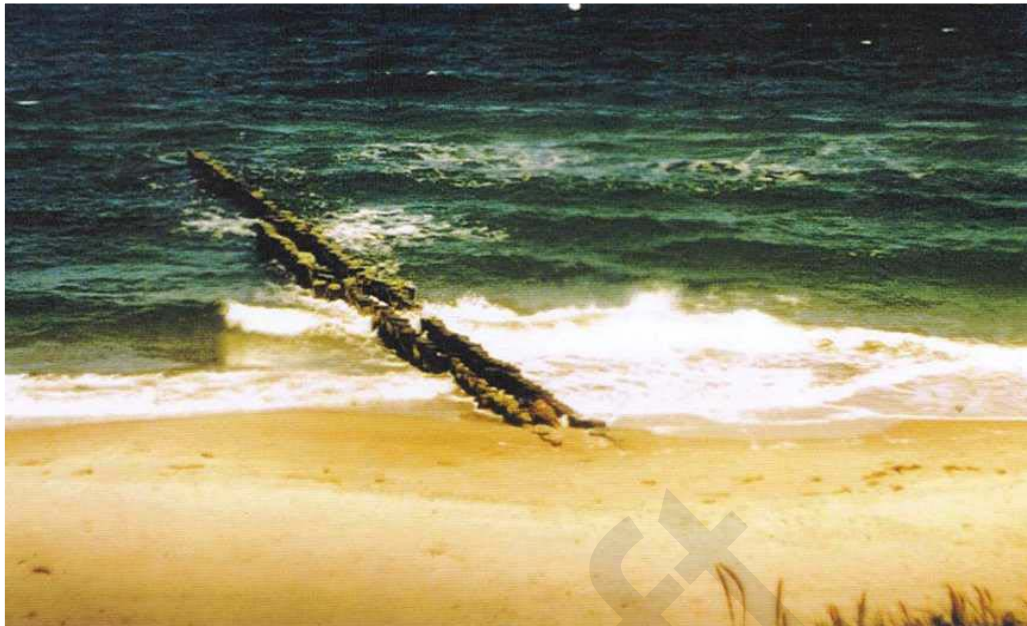
Fig.10.5c Two rows of wooden logs driven into the seabed normal to the shoreline act as groin field.

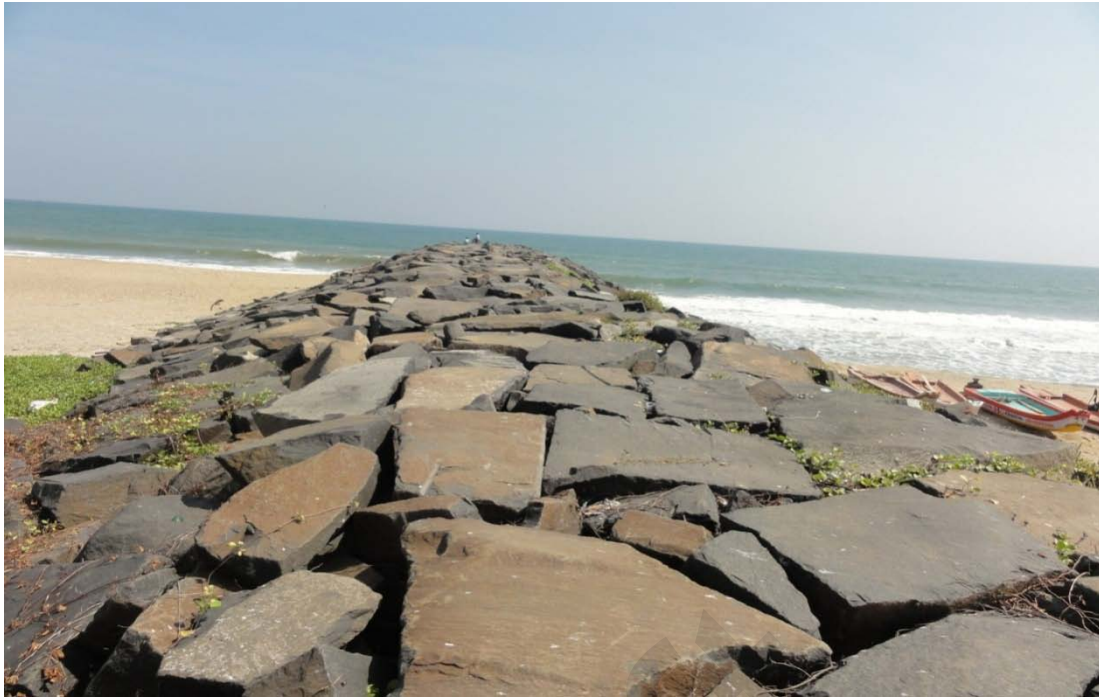
Fig.10.6Trunk of the groin

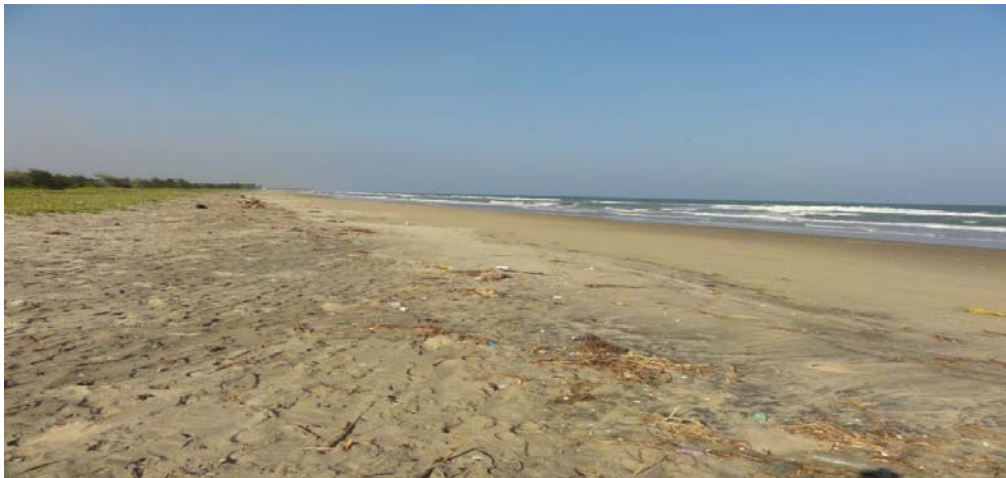
Fig.10.7a Beach profile North of Devanampattinam

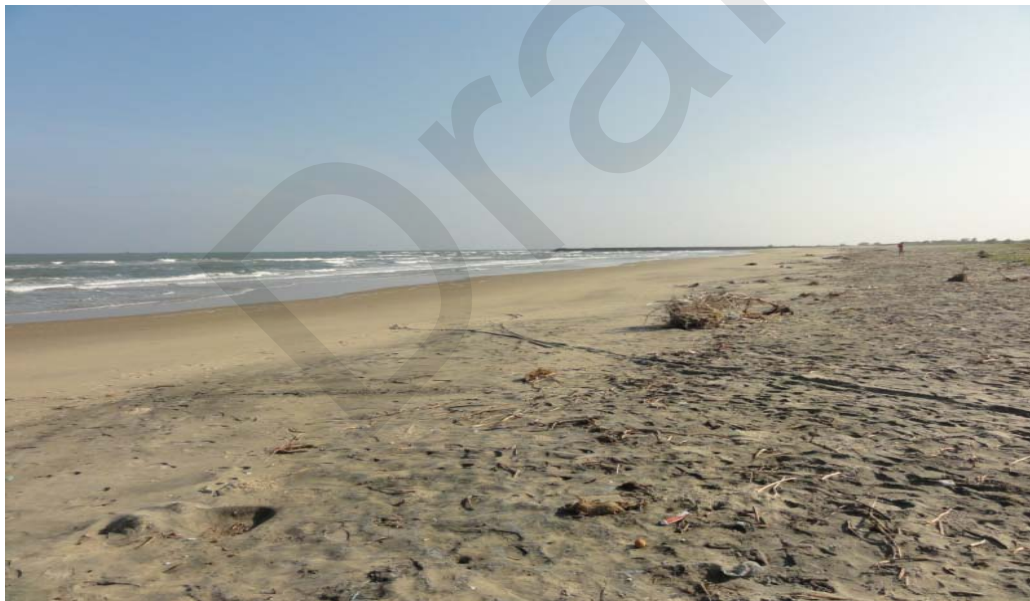
Fig.10.7b Beach profile south of Devanampattinam

The beach slope is very flat as can be in **Figs. 10.7a** and **10.7b**. This location less inhabited experiences erosion and advancement of shoreline. This is due to the northern breakwater of the cuddaloreport, which port is an open roadstead (anchorage) Port situated at the confluence of the rivers Uppanar and Paravanar. This stretch of the coast has been experiencing severe erosion as a perineal problem as well as suffered severe problem during the tsunami 2004. a few pictures of the damages suffered are shown in **Fig. 10.7c**. The shoreline keep oscillating due to the variation in the direction of littoral drift. Sediment samples have been collected along the beach, the results from the sieve analysis is shown in **Fig.10.7d**, whereas, the variation of the beach slope along this stretch of the coast is shown in **Fig. 10.7e**. This stretch of the coast experiences flooding during extreme coastal events and as such the priority for coastal protection may be low. This stretch also includes **Akkavai**.

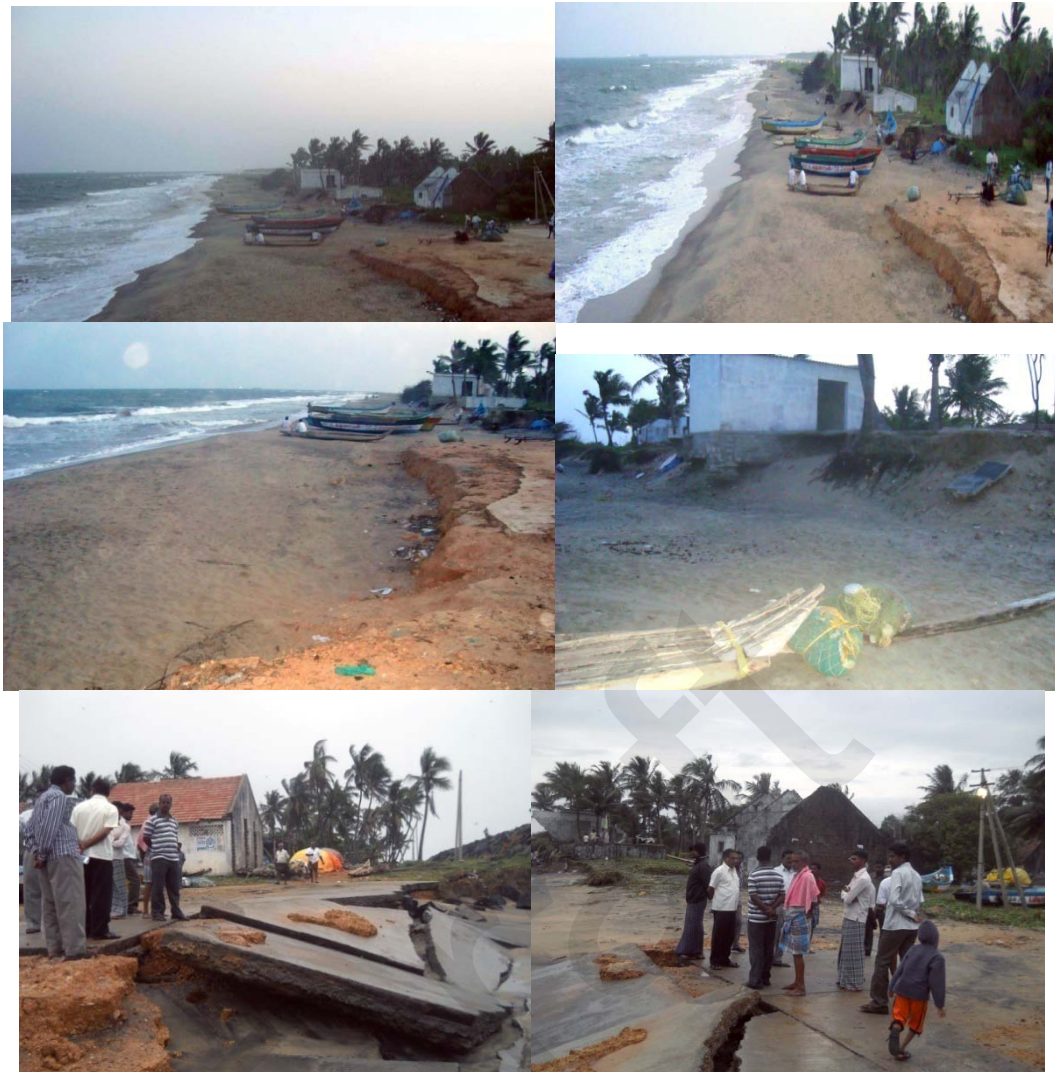
Fig.10.7cDamages along the coast of Devanampattinam

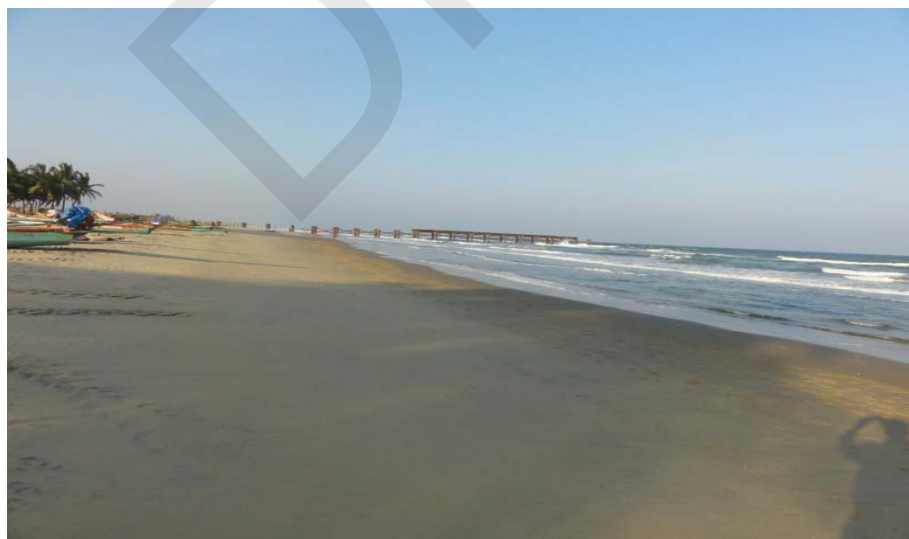
Fig.10.8a Beach profile north of Sangolikuppam

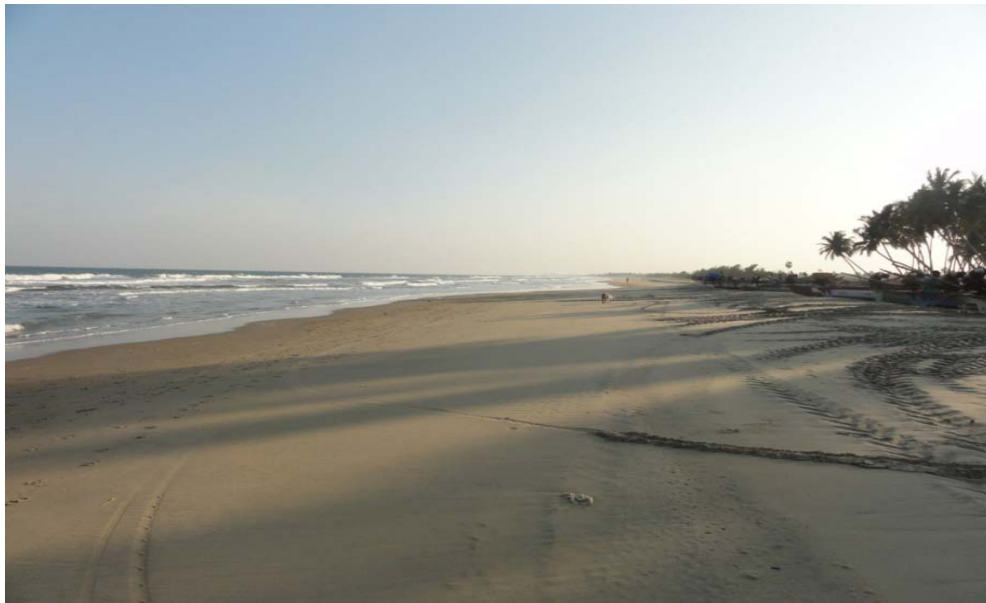
Fig.10.8b Beach profile south of Sangolikuppam

Although, beach formation is observed in Jan 2016 (non-monsoon season), this stretch of the coast has been experiencing erosion to an extent of 5m per year. An unused offshore jetty to the observation point does not act as a littoral barrier as it is supported on piles, thus, allowing free passage of sediments alongshore. Views of the beach along the north and south of the measurement location are projected in **Figs.10.8a** and **10.8b** respectively.

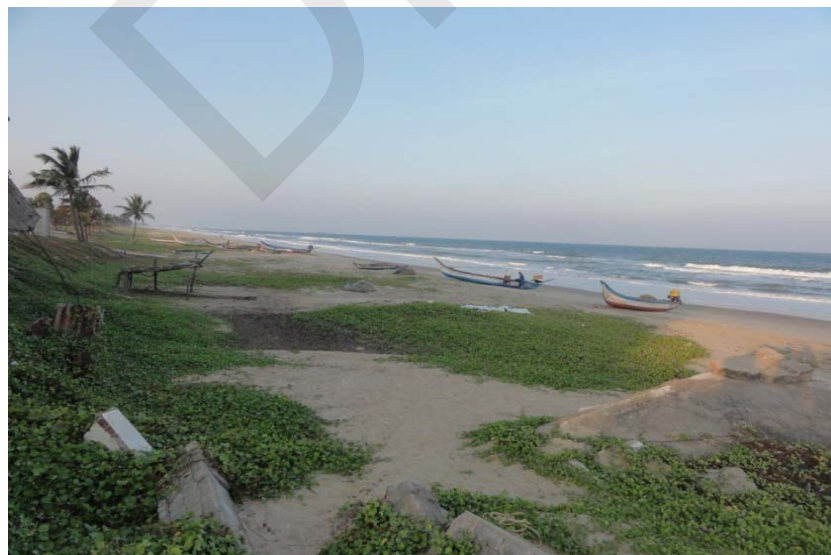
Fig.10.9a Beach profile north of Periyakuppam

This stretch of the coast with flat beach as seen in **Figs. 10.9a** and **10.9b** is very badly affected by erosion. Buildings and an existing fishing jetty have been demolished due to erosion and flood beach as can be seen in **Figs.10.9c** and **10.9d**.

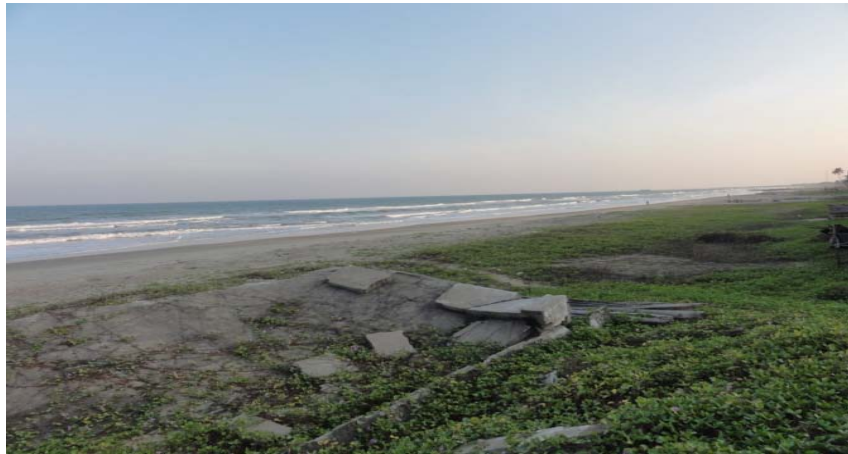
Fig.10.9b Beach profilesouth of Periyakuppam

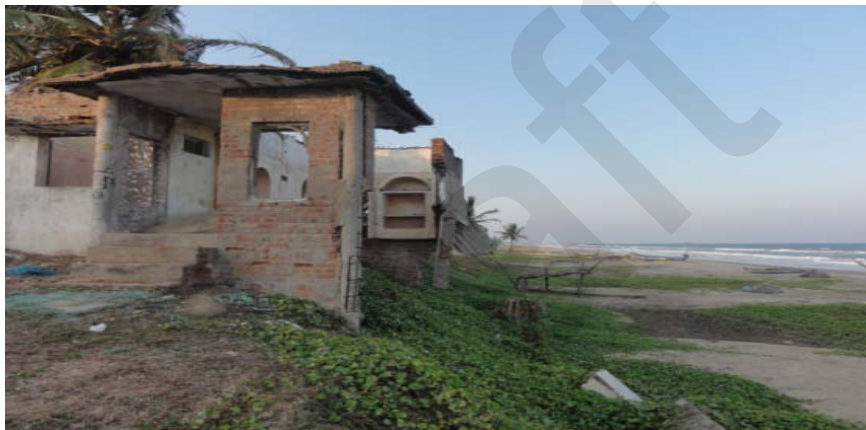
Fig.10.9c Demolished buildings

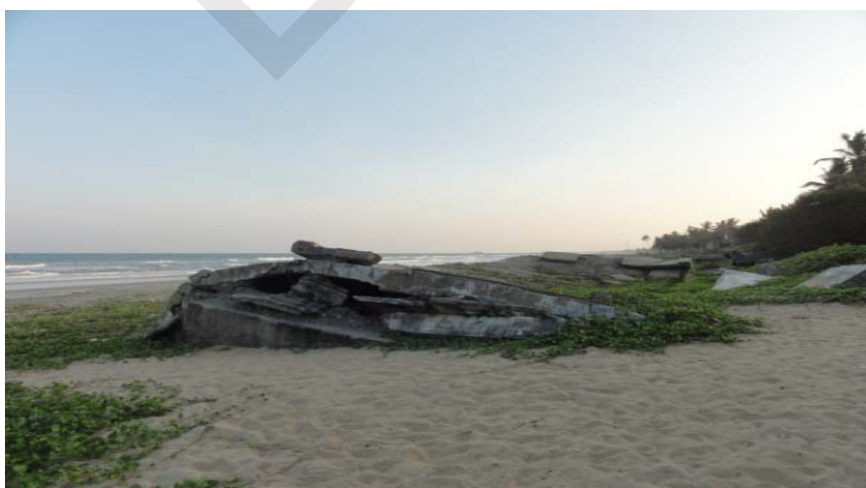
Fig.10.9d Demolished buildings

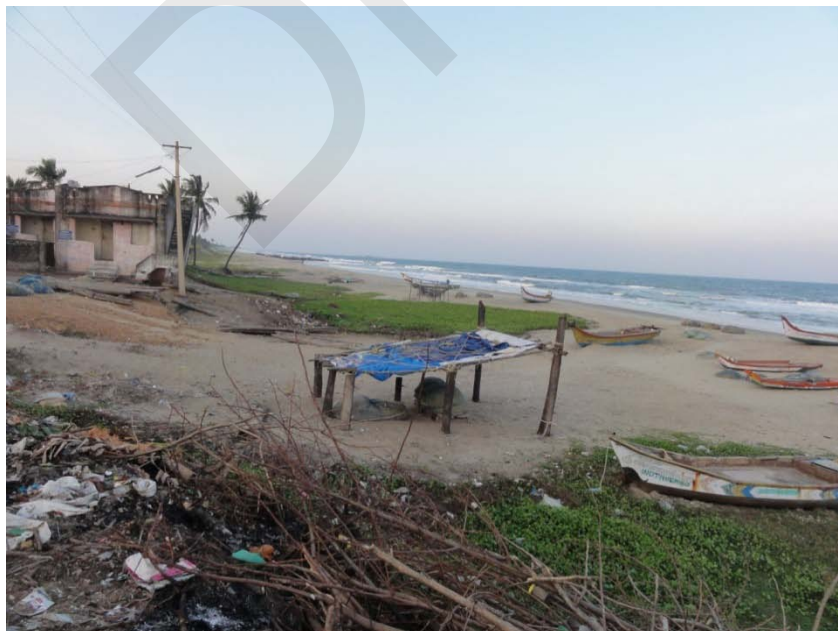
Fig.10.10a Beach profile North of Pettodai

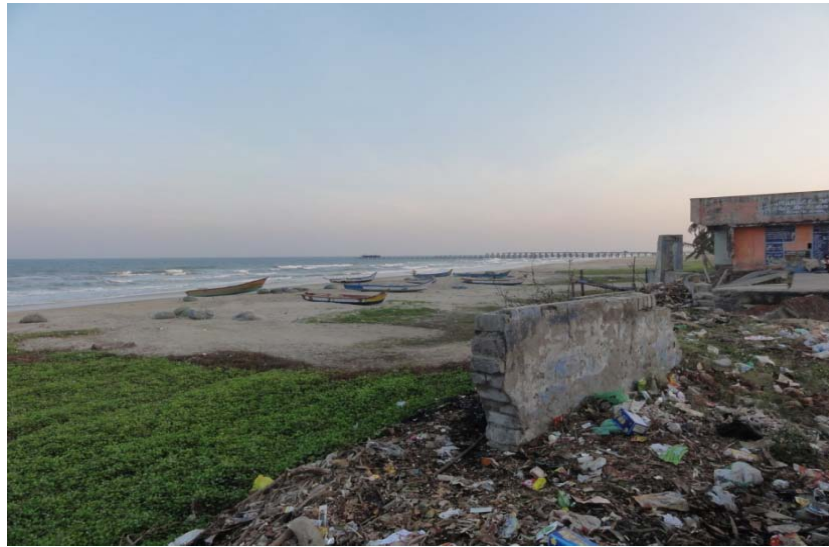
Fig.10.10b Beach profile South of Pettodai

On either side of location (North and South), significant erosion and damages to buildings as seen in **Figs. 10.10a** and **10.10b** remain a threat to the coastal community (highly inhabited) and in the event of an extreme coastal hazard, the threat can be manifold and hence protection measure to this stretch is essential.

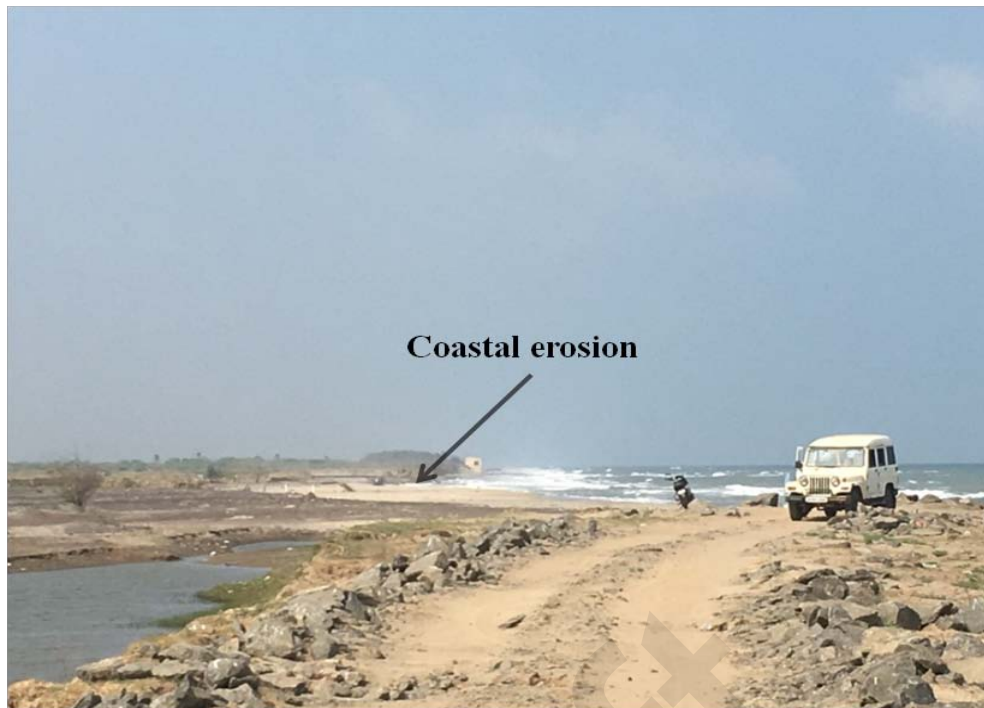
Fig.10.11a View of the eroding shoreline on the north of northern breakwater of Poompuhar fishing harbour. Photo also shows the diverted drainage channel behind the harbour.

The newly constructed northern breakwater of Poompuhar fishing harbour has resulted erosion to an extent of about more than 5m/year (**Fig.10.11a**). The erosion is found to occur over an extent of 1km. The measured beach profile along the eroding area as well as the grain size distribution are projected in **Fig.10.11b** and **10.11c** respectively. Since there is no habitation along this stretch of this coast, a seawall that could prevent further loss of land and this measure could be considered only after the completion of first two priorities suggested in this report.

During the construction of the fishing harbour, the storm water drainage channel has been diverted on the north of northern breakwater. This might be properly trained to avoid inland inundation. This should be taken as a part of the fishing harbour development.

Solution suggested: *The storm water drainage should be properly diverted into sea to avoid flooding inland.*

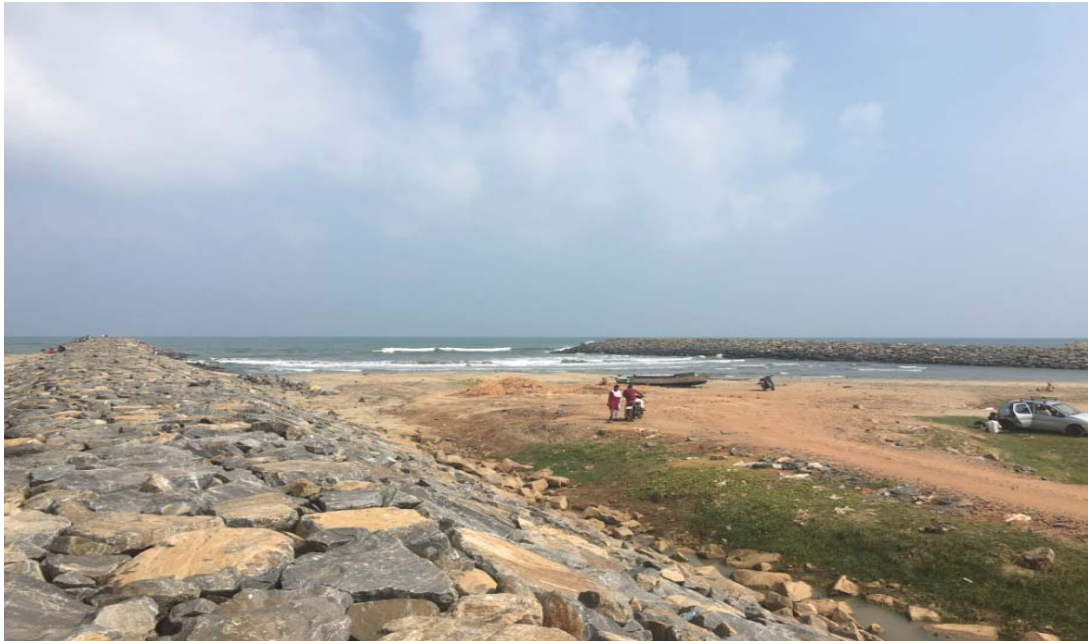
Fig.10.12aView of the pair of training walls at Cauvery confluence point

A pair of training walls has been constructed at the mouth of Cauvery in-fall (**Fig 10.12a**). There are five groins along with seawall has been constructed on the north and south of mouth without any scientific studies. A view of a groin on the south of Cauvery confluence point is shown in **Fig.10.12c**. On the north of the mouth and behind the seawall, the available space is best suitable for plantations so that Department of Environment could consider this site for the said purpose (**Fig.10.12b**).

Solution suggested: *An effect can be put in considering the concepts of dredging the river mouth using the dredged spoil to fill geo-textile tubes that may be considered to serve as training walls. A detailed scientific study is required prior to implementation.*

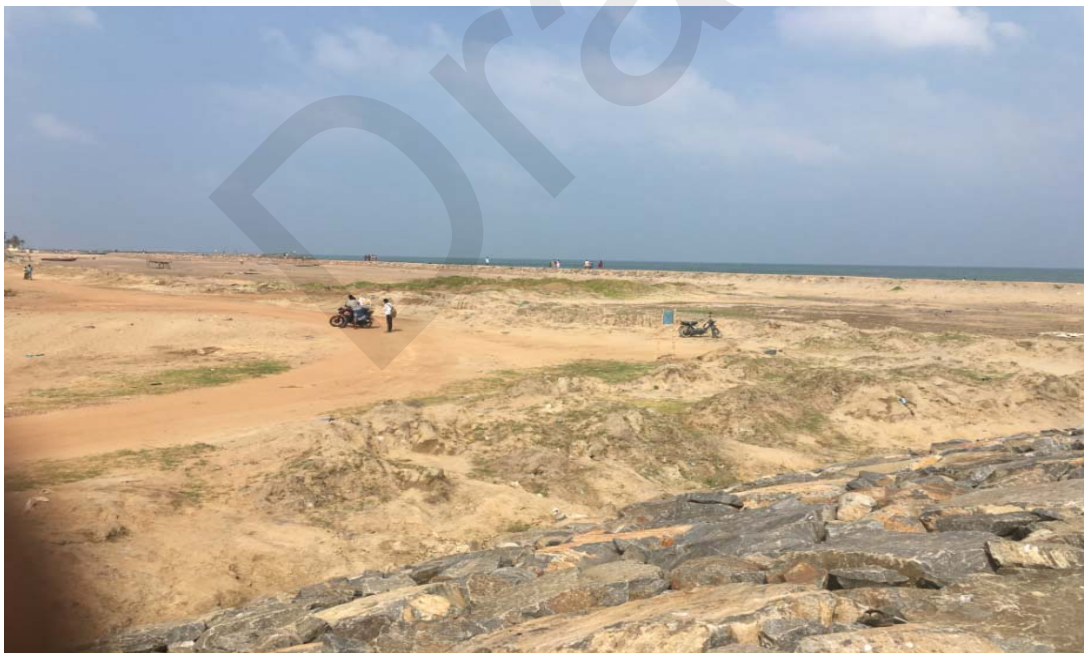
Fig.10.12bView of the location suitable for plantation which is behind the seawall

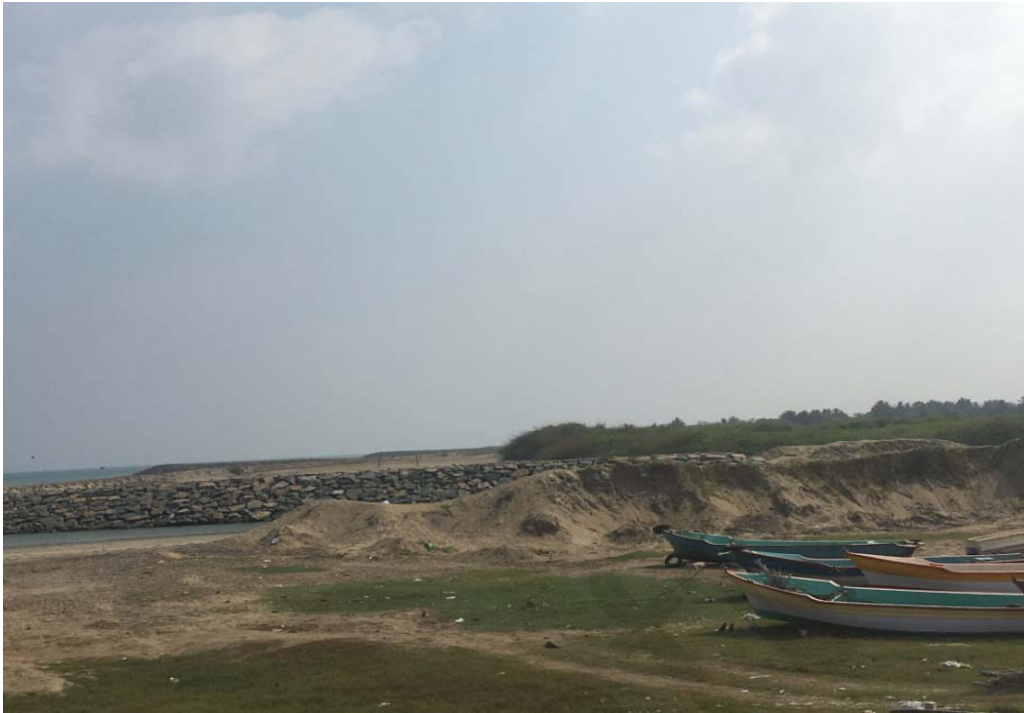
Fig.10.12cView of a groin on the south of Cauvery confluence point

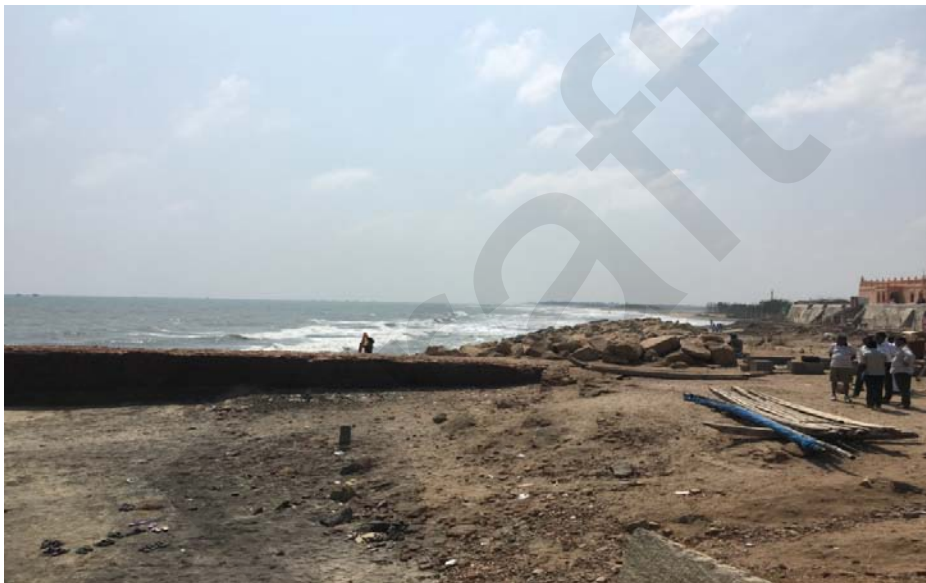
Fig.10.13a View of the remnants of existing building that act as littoral barrier in front of the Fort museum in Tharangambadi

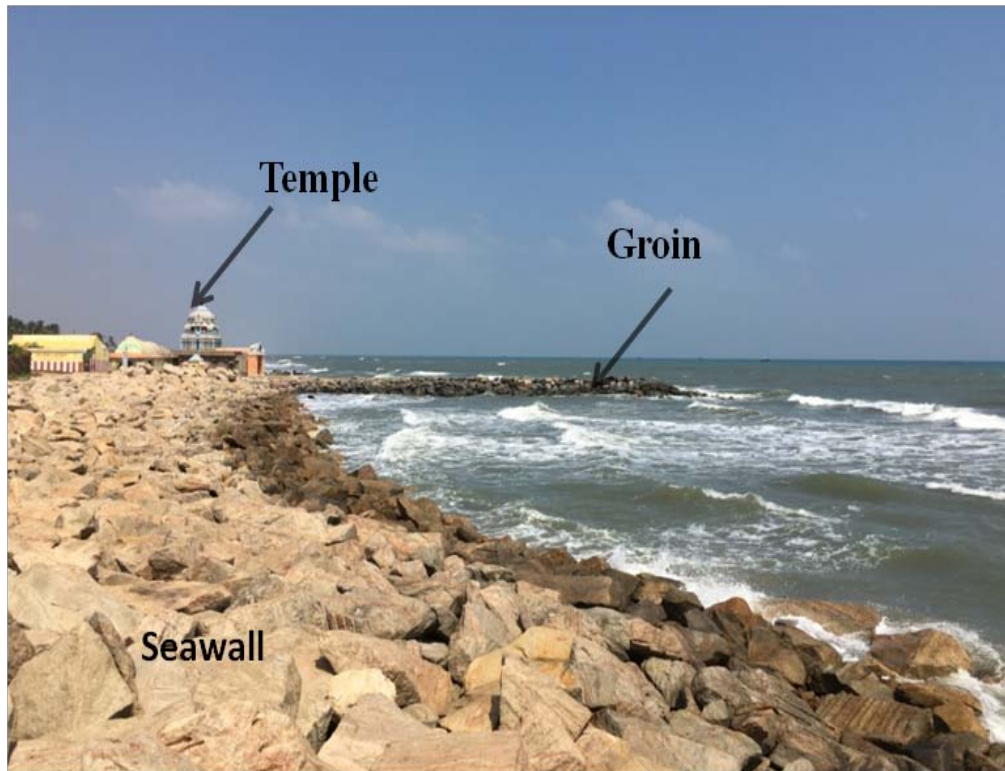
Fig.10.13b View of the existing groin in front of the Masilanathar temple in Tharangambadi

Solution suggested: *In order to save the Fort museum and also regain stability of unprotected stretch including the stretch of Uppanar river mouth, seawall and revetment are recommended. A short training wall at the Uppanar river mouth may be considered as a last priority after monitoring the shoreline.*

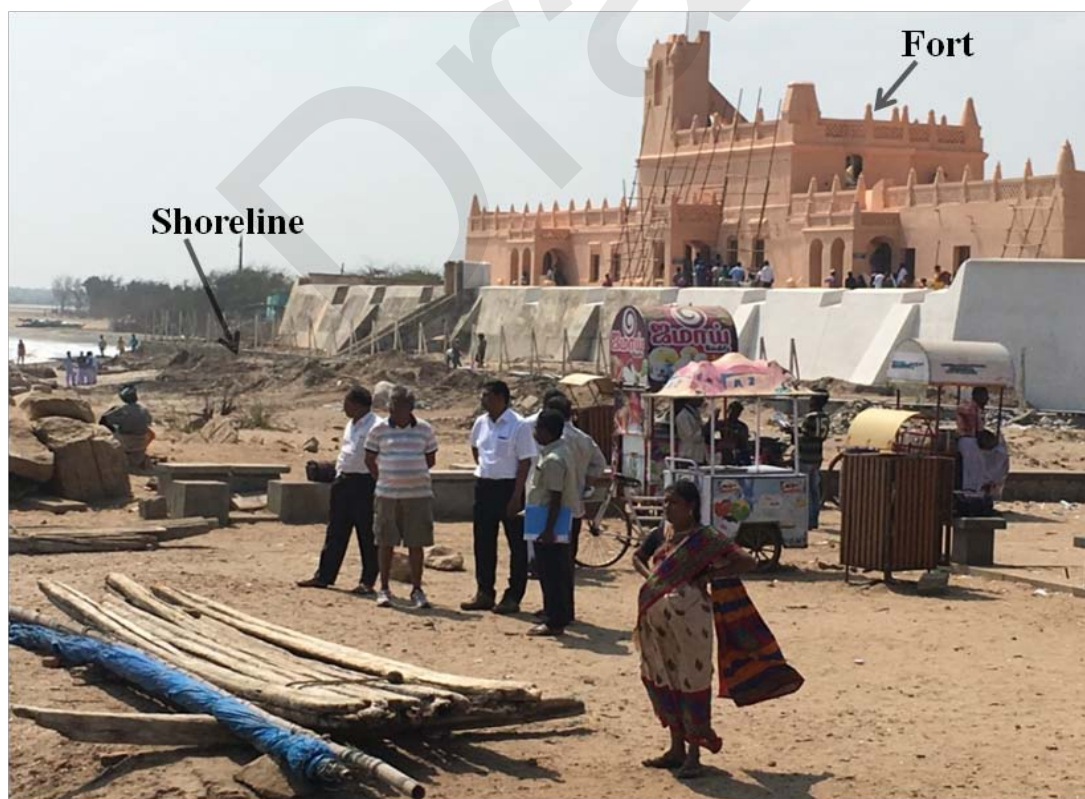
Fig.10.13c View of the Fort museum showing the shoreline erosion reaches its boundary
