Assessment on coral reef and seagrass meadows within the 10km radius from the proposed groynes site in Keelavaippar coast, Gulf of Mannar

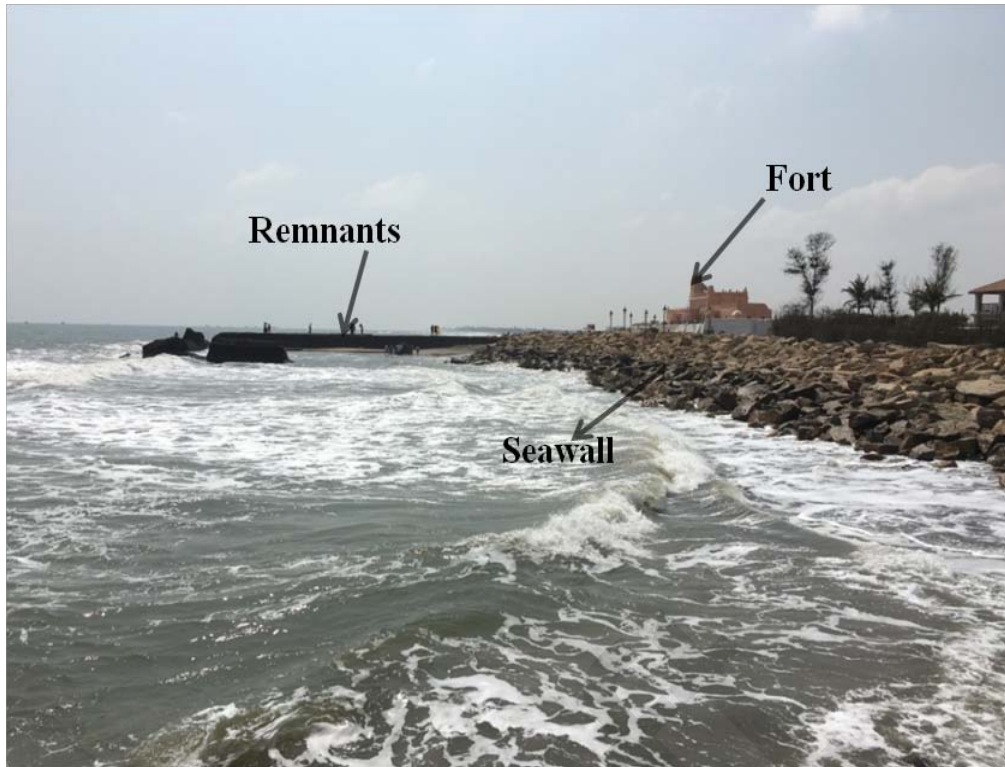
Fig.10.13d View of the existing seawall and the remnants of the building on the south of the Masilanathar temple in Tharangambadi

Solution suggested: *In order to save the Fort museum and also regain stability of unprotected stretch including the stretch of Uppanar river mouth, seawall and revetment are recommended. A short training wall at the Uppanar river mouth may be considered as a last priority after monitoring the shoreline.*

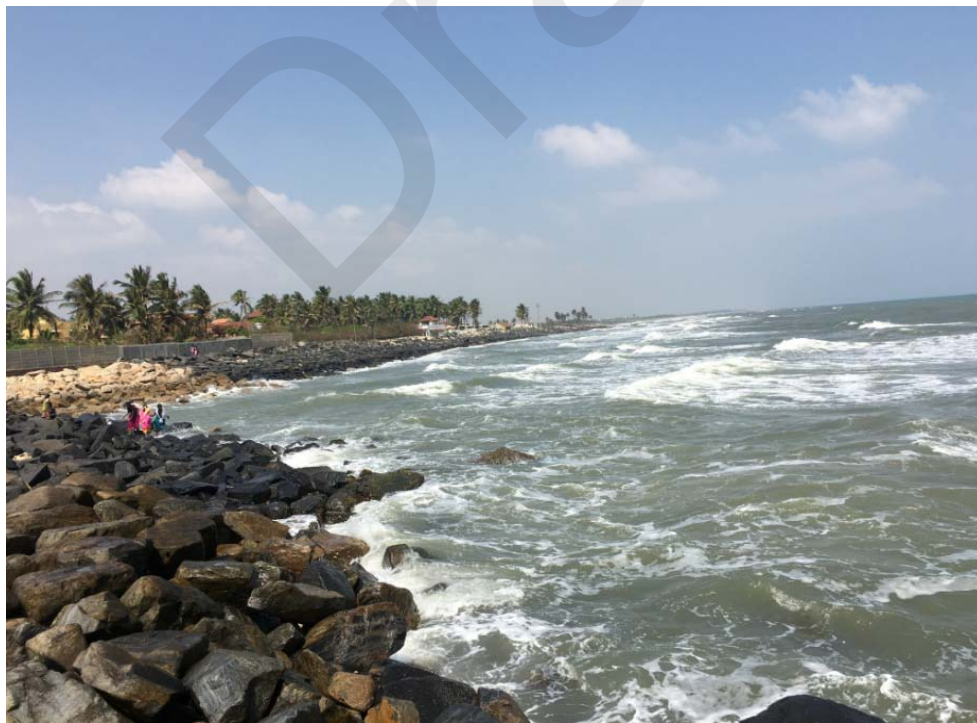
Fig.10.13e View of the existing seawall on the north of the Masilanathar temple in Tharangambadi

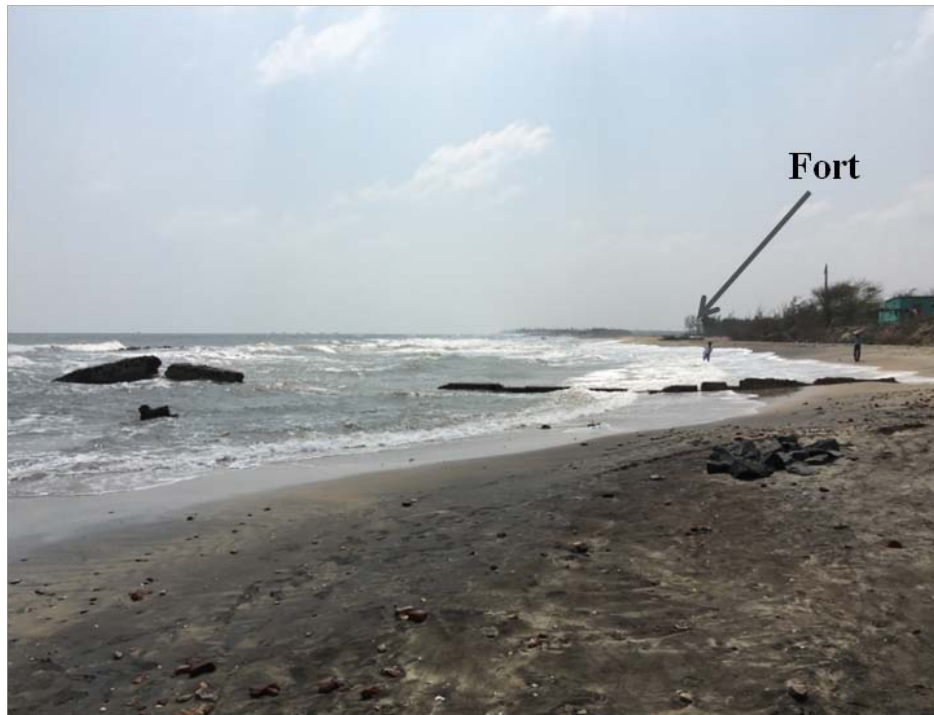
Fig.10.13f View of the shoreline intrusion on the south of Fort museum uptoUppanaar river mouth

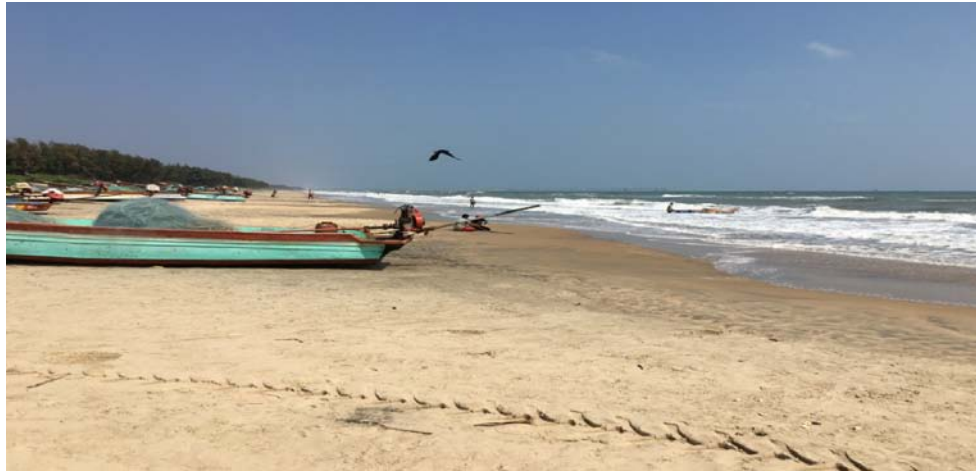
Fig.10.14aSamanthanpettai southern coastal stretch

Samanthanpettai is an another fishing village with a flat beach front. The northern and southern coastal stretch of Samanthanpettai are Fig **10.14a** and **10.14b** respectively. The measured beach profile along the north and south of this stretch of the coast is shown in Figs. **10.14c** and **10.14d** respectively. The grain size distribution for this stretch is shown in Fig. **10.14e**. There are about one hundred boats landing on the beach. There are many dwelling units located about 100m from the shoreline landwards. Due to the flat topography of 150m wide corridor on its immediate southern side, the surge makes it into the land and inundates the entire habitat from all possible directions.

Solution suggested: *A coastal bund using soft structures to prevent water ingress is an immediate mitigation measure with **the first priority**. Further, a series of T-groins for a stretch of 600m might prevent the loss of beach width over the years. The latter may be considered under **priority 3**.*

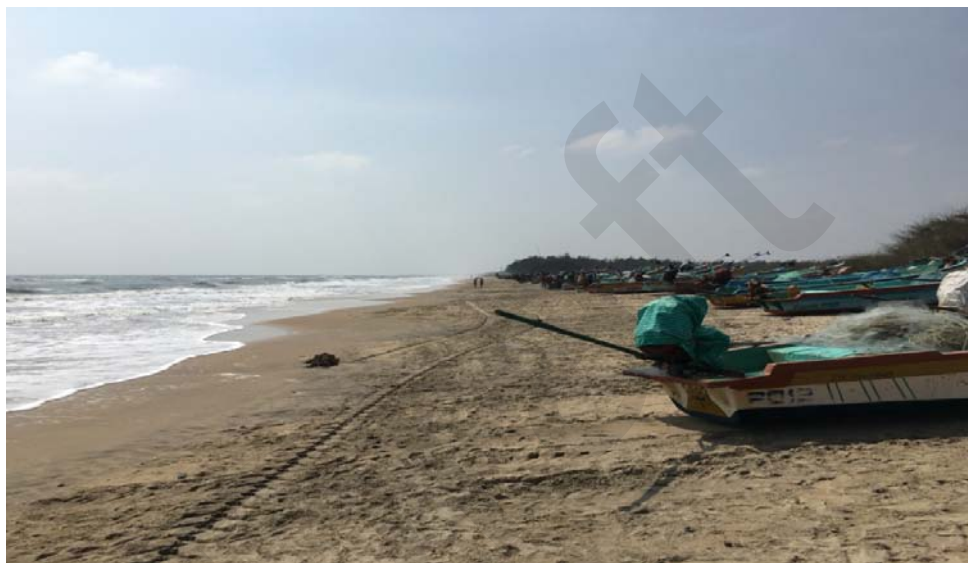
Fig. 10.14bSamanthanpettai northern coastal stretch

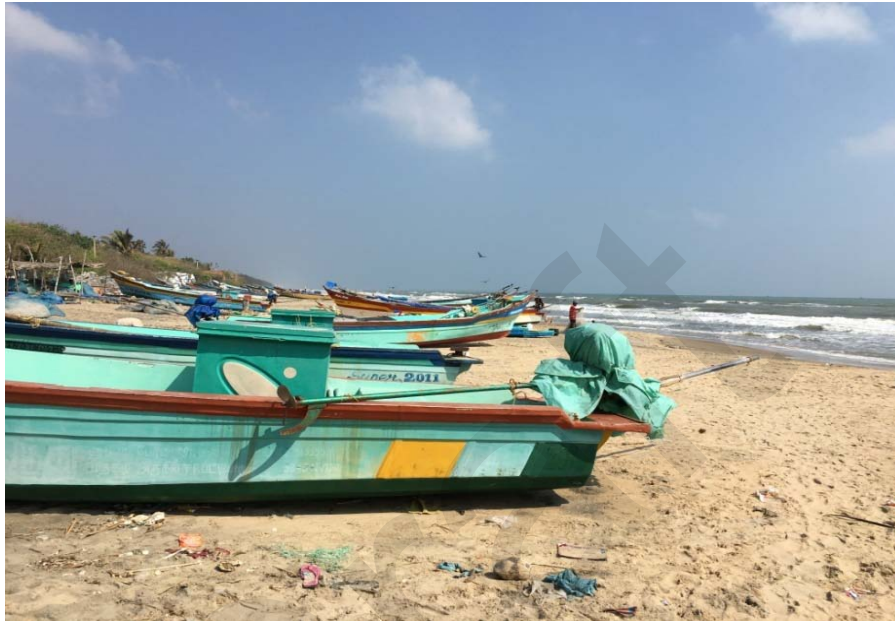
Fig.10.15aNambiyarnagar coastal stretch.

There are several boats parked along the coast is shown in Fig 10.15a. The length of stretch of coast along the Nambiyarnagar is about 800m. This stretch had suffered huge damage during the tsunami. This is a part of the stretch of 6km from Kadavayar river to Nagore that was damaged heavily during the Tsunami for which groin filed was recommended in 2005. At present, for combating the perennial erosion alone, a transition T-groin field in this densely populated coastal villages would function well and the beaches formed in between the groins could serve as a useful shelter for landing the boats on the beaches. This coastal stretch is further extended on its north with: a beach front for about 500m long; and dense vegetation for a length of 600m. For this stretch '**do nothing**' could

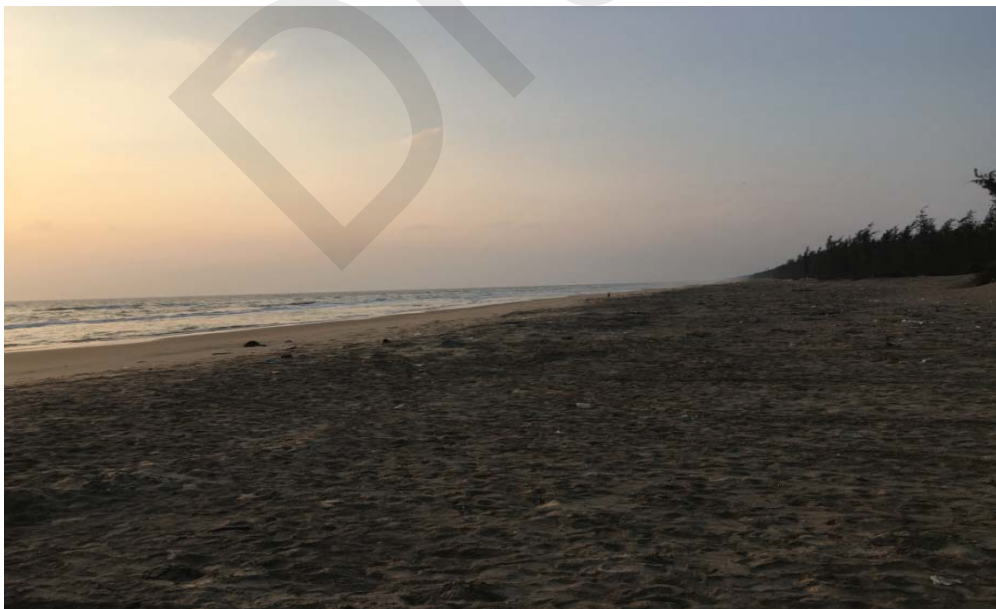
Fig. 10.17a View of coastal stretch towards south along the southern Velankanni shoreline.

The Vellaiyar river mouth requires a pair of training walls. Further, the river needs to be dredged and the dredged spoil either can be used to nourish the beach on the north or can be used to fill geo-textile tube which could probably run parallel to shoreline to serve as a protection against possible erosion, the schematic representation of which is shown in **Fig.10.17b**. **This site could be taken up as third priority**. The beach slope and grain size distribution are shown in **Fig. 10.17c** and **10.17d** respectively.

Solution suggested: *It is recommended to dredge the river mouth Vellar and nourish the beach on its northern side. This could be one time solution provided a sand dune along with plantation is implemented. In order to consider also the extreme events like cyclone and tsunami, buffer blocks on the landward side of the dune could be planned for (Fig.10.17e).*

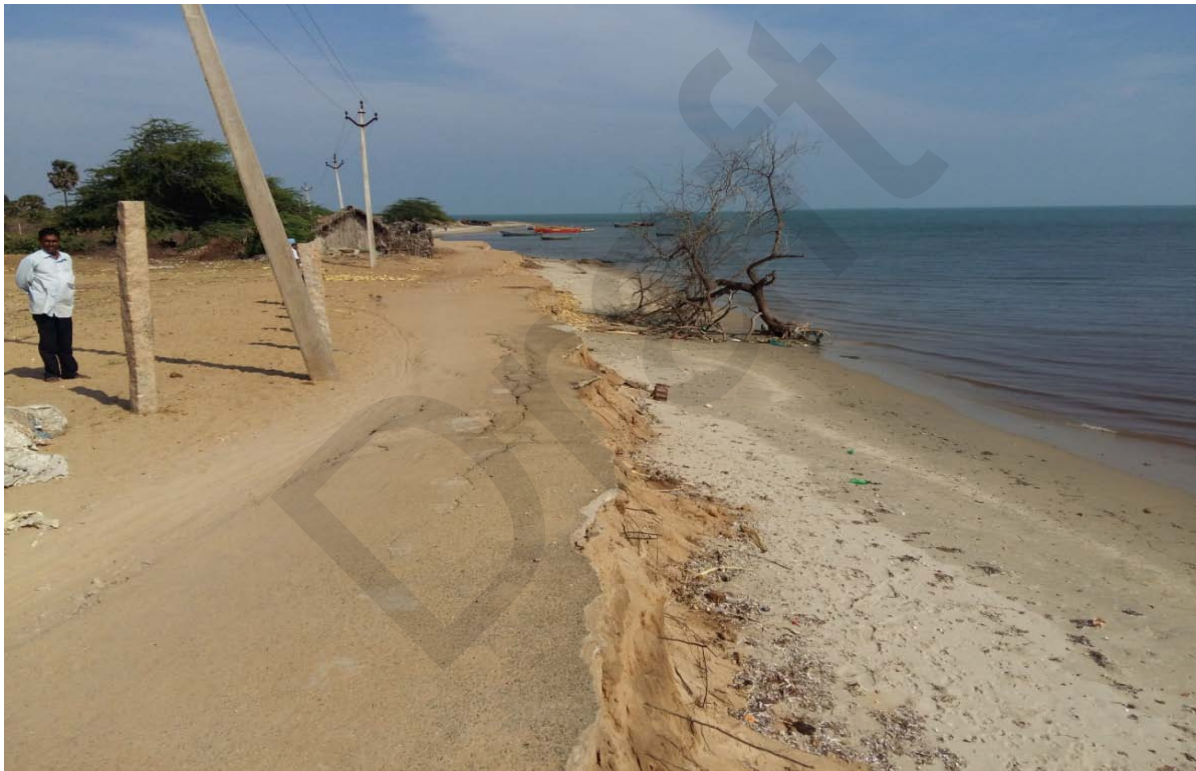
Fig.10.18a Damage of coastal road along SeeniappaDharga in Rameswaram

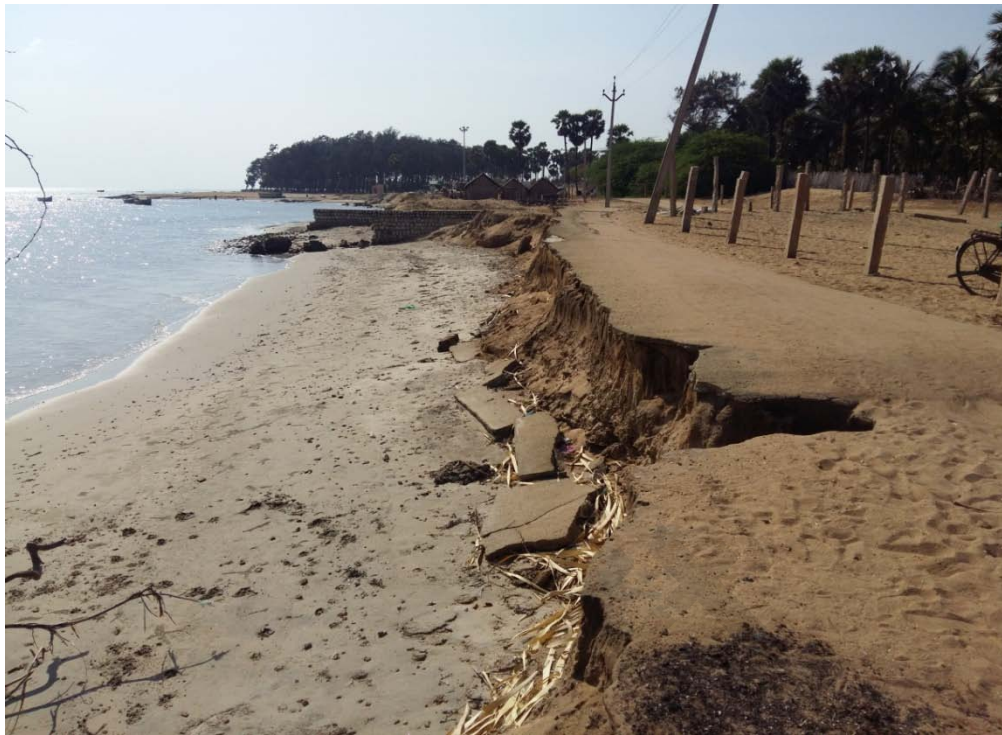
Fig.10.18b. Damage of coastal road along SeeniappaDharga in Rameswaram

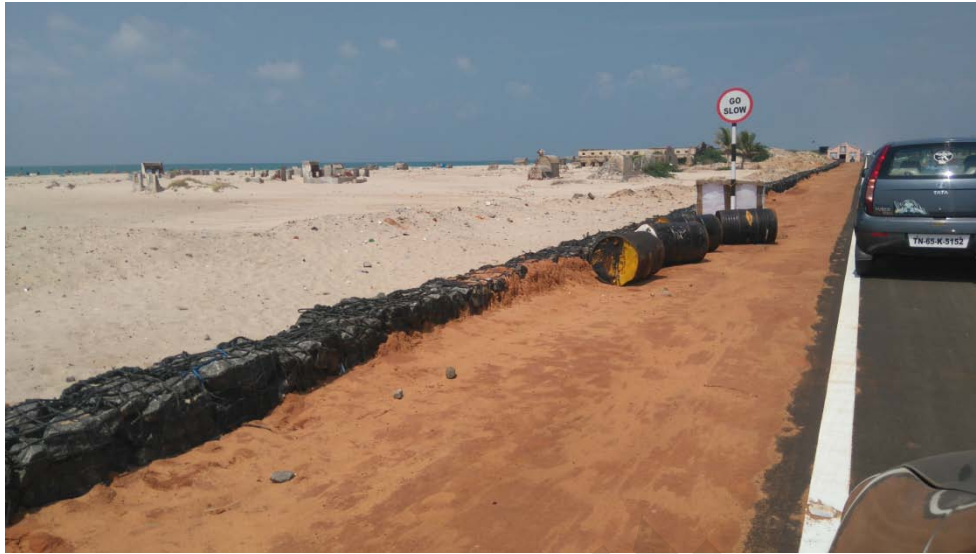
Fig.10.19a. Gabions adopted for protecting the road.

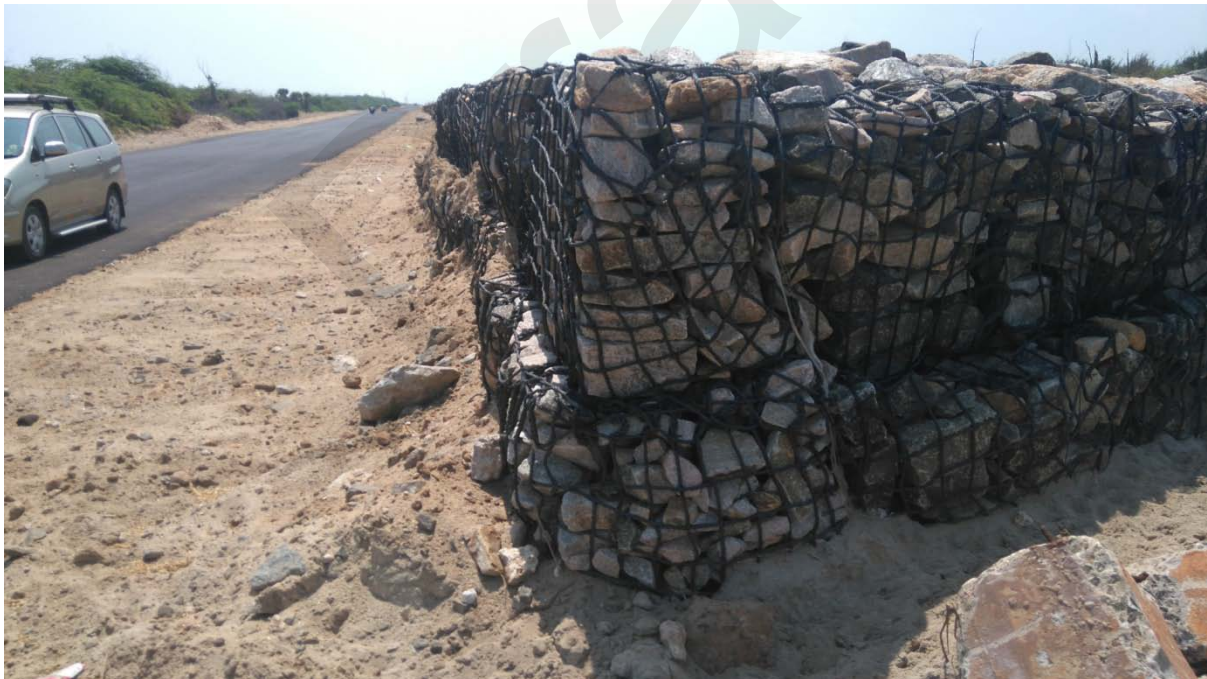
Fig.10.19b. Gabions adopted for protecting the road.

A road of length of about 5km has laid using gabion box as protection measure on this continuously vanishing stretch of the coast. The protection measure is likely to be damaged over time particularly during monsoon seasons. The gabions of 0.5m height adopted as shown in **Fig.10.19a** will not be sufficient enough to resist during extreme events. Further, the percolation of storm water in between the road and gabions is likely result in scour, thereby leading to its failure. Similarly, along the coast, the gap between the gabion seawall and the road (**Fig.10.19b**) also not protected with filter layer is bound to result in failure. In order to protect a proper filter layer need to be designed and implemented. This needs to be carried prior to the onset of next monsoon. .

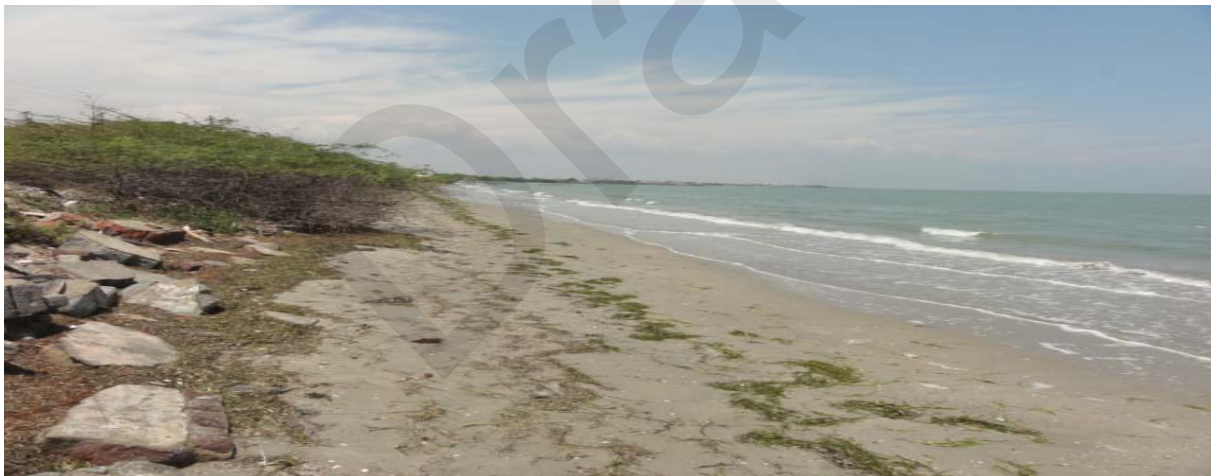
Fig.10.20a Coastal stretch at Inigo Nagar

The damaged coastal stretch at Inigo Nagar is shown in **Fig.10.20a** and **Fig.10.20b** respectively. The northern coastal stretch of Tuticorin port has been experiencing very severe erosion of the order more than 5m/year in the last one decade. A Hindu temple is under threat of being sacrificed into the sea. And, at present, there is only a narrow stretch of land of width about 10m to 15m separating the backwaters from the sea. If further erosion continues, the sea would extend upto the land for about 1km inland. This would result in the change in the biodiversity in this region. To avoid such a threat, a soft structure solution can be considered for a stretch of about 1km.

Solution suggested: *A soft structure solution may be designed following detailed scientific study. This can also be taken up as a site for scientific testing of new methods of implementation of soft measures.*

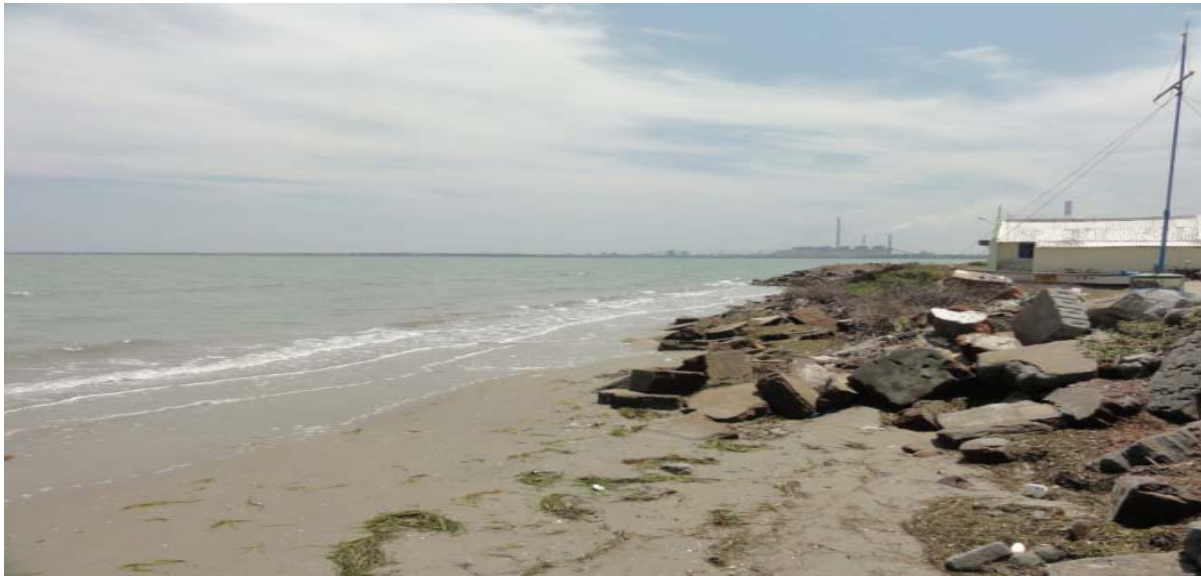
Fig.10.20bInigonagar damaged coastal stretch

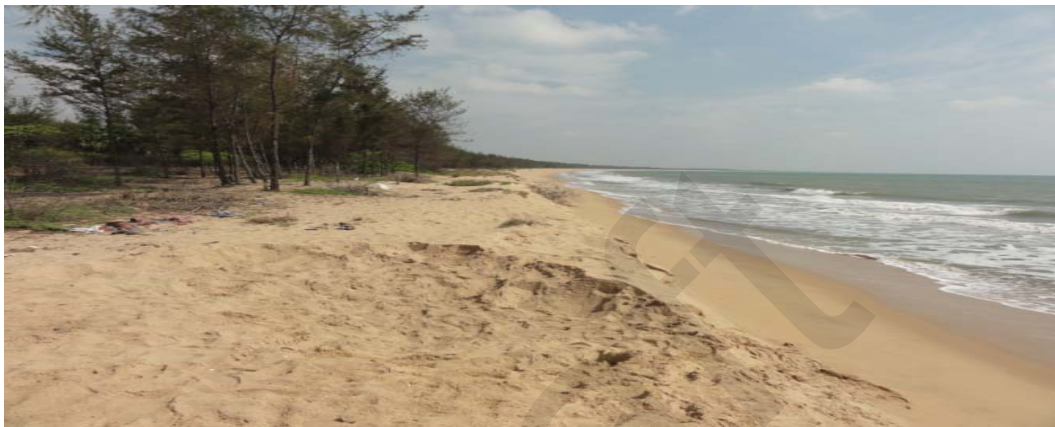
The View of Northern and Southern coastal stretch along Kulasekarapatnam village is shown in **Fig.10.21a** and **Fig.10.21b** respectively. This stretch of the coast of about 600m is experiencing perennial erosion due to its coastal morphology, being located on the north of the Manapad coastal stretch dominated by rocky strata. The average rate of erosion is of the order of 4m/year for the last one decade. However, this stretch has no habitation in its vicinity. However, in order to avoid further loss, this stretch of the coast is ideal for

Fig.10.21a View of Northern coastal stretch along Kulasekarapatnam

Solution suggested: *This site is ideal for plantation. A pilot stage implementation of plantation is highly recommended.*

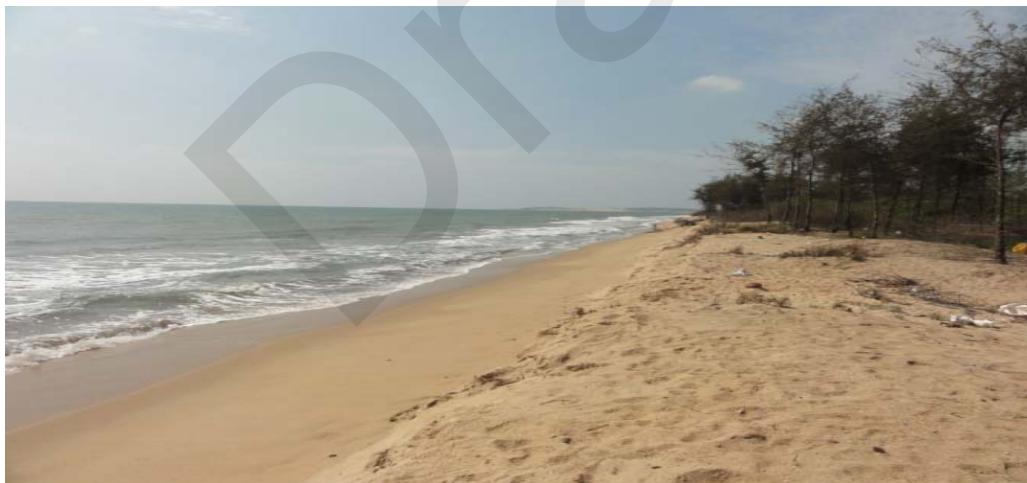
Fig.10.21b View of Southern coastal stretch along Kulasekarapatnam village

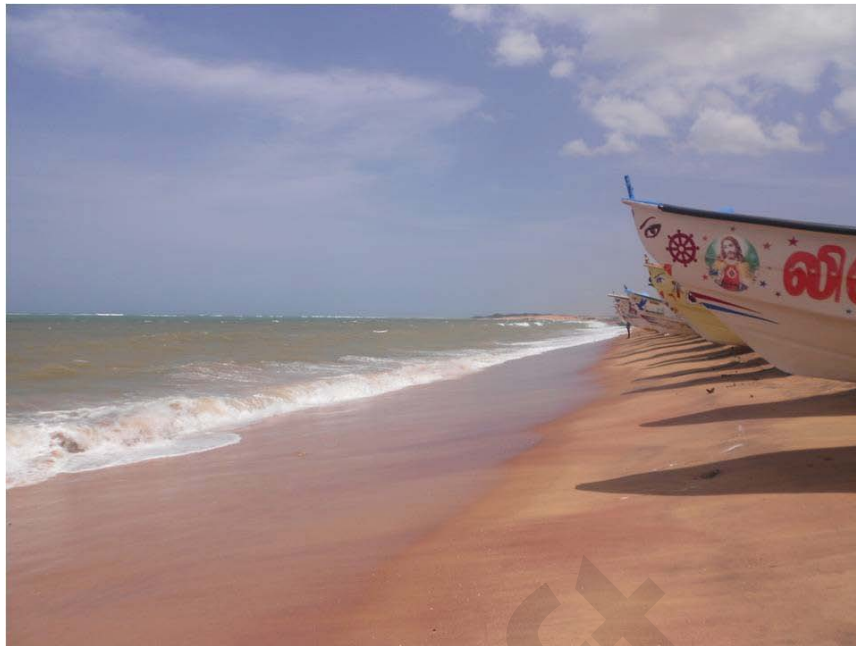
This stretch of the coast has been experiencing continuous erosion and threatening the villages along the coast. There are several fishing vessels that adopt beach landing facility as shown in **Fig.10.22**. Hence , it is worth considering a groin field.

Fig.10.22. Fishing vessels adopting beach landing facility

Solution suggested: *The straight forward solution would be a series of groins as pockets in between them could serve as shelters for the fishing boats in addition to serving as beach protection.*

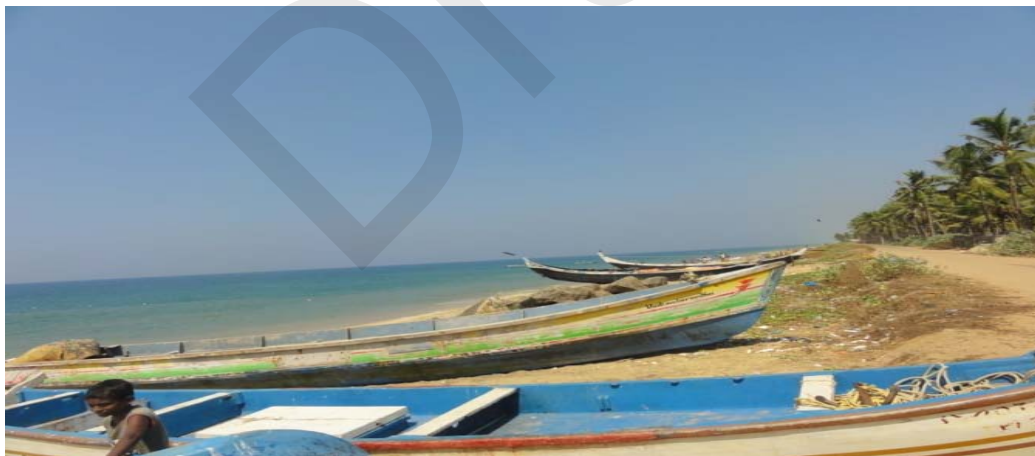
Fig.10.24a Erosion up to the berm

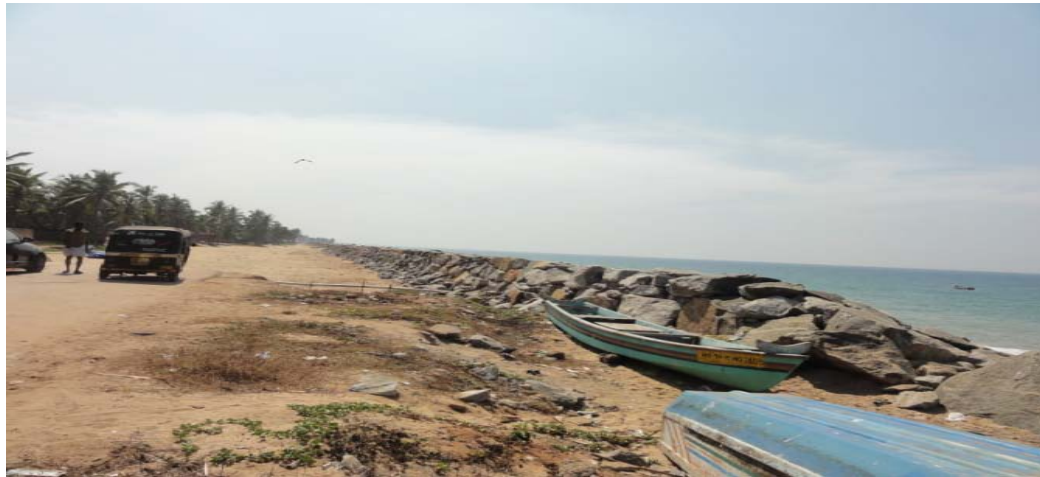
Fig.10.24b Damages to the coastal road

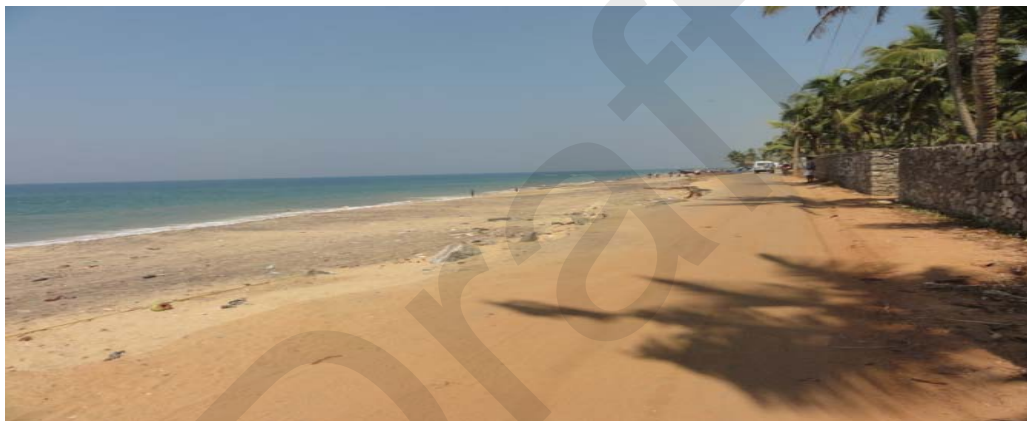
Fig.10.24c View of the partial loss of road width

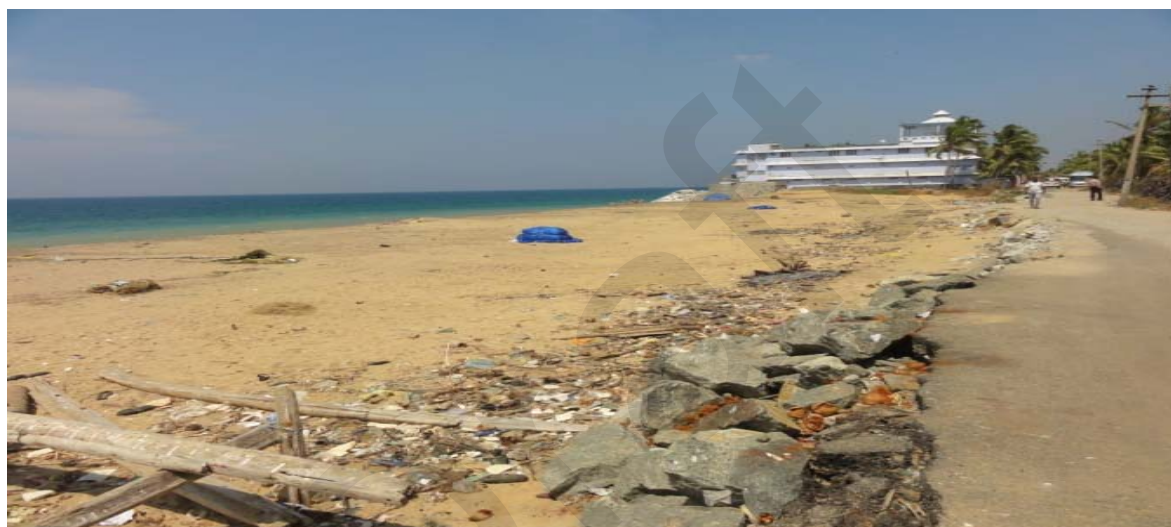
Fig.10.25aEdappadu coastal stretch showing the damages to the coastal road

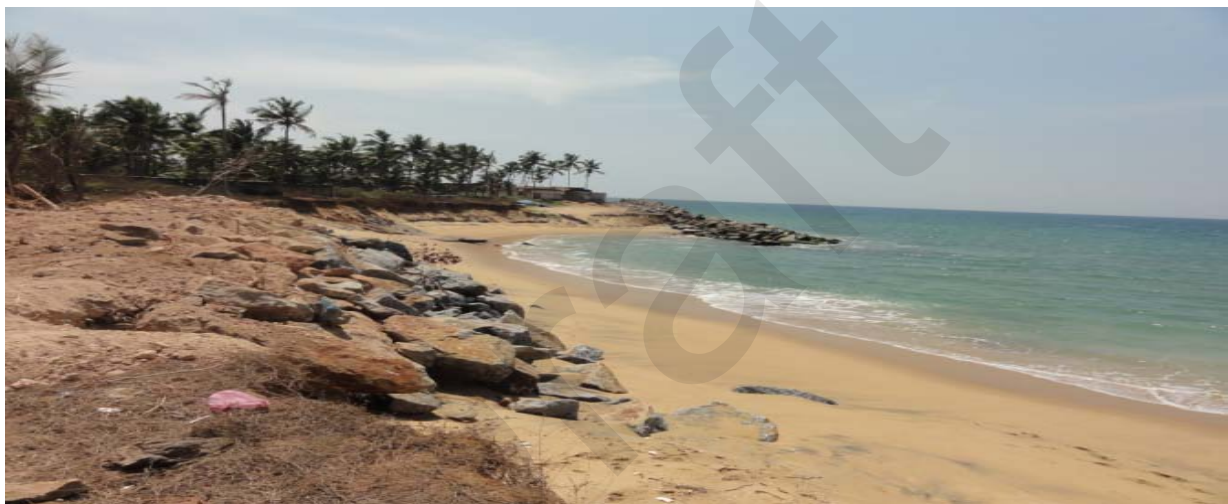
Fig.10.26 Severe erosion at Eraviputhamthurai coastal stretch

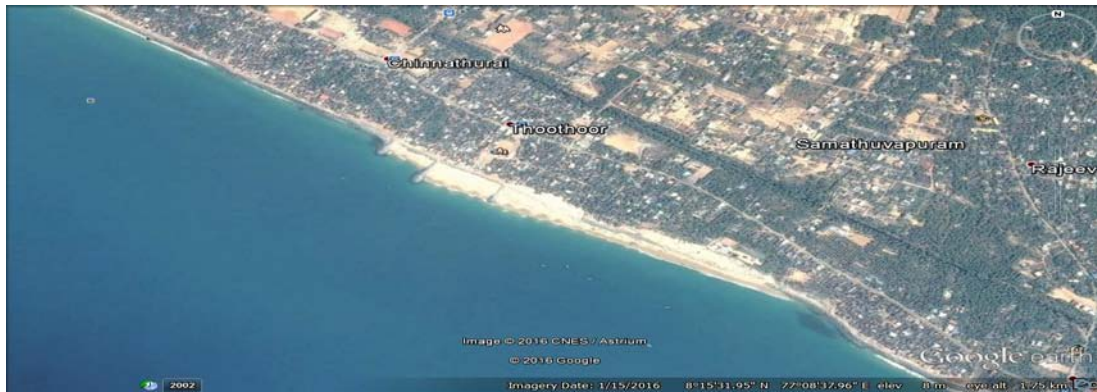
Fig.10.27a Google image showing the effectiveness of the groins at Thoothoor

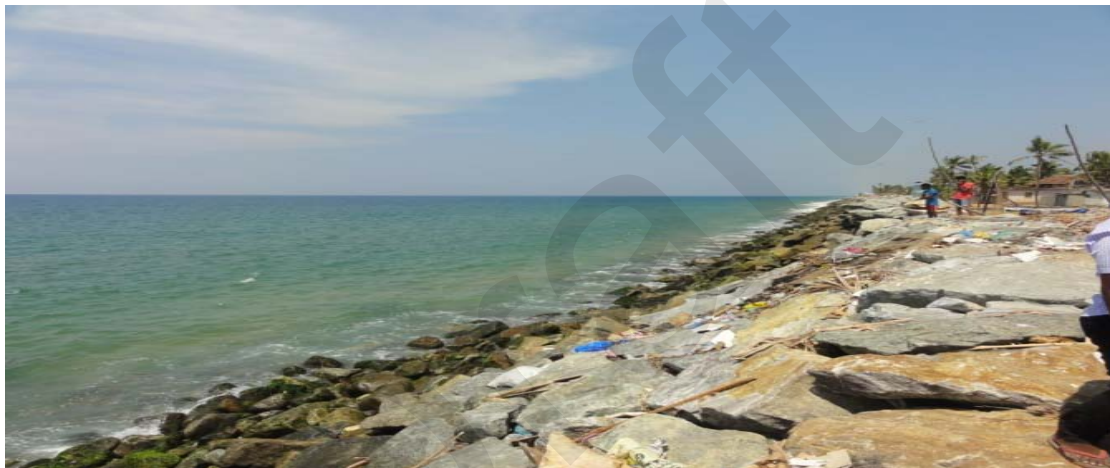
Fig.10.27b Damaged seawall

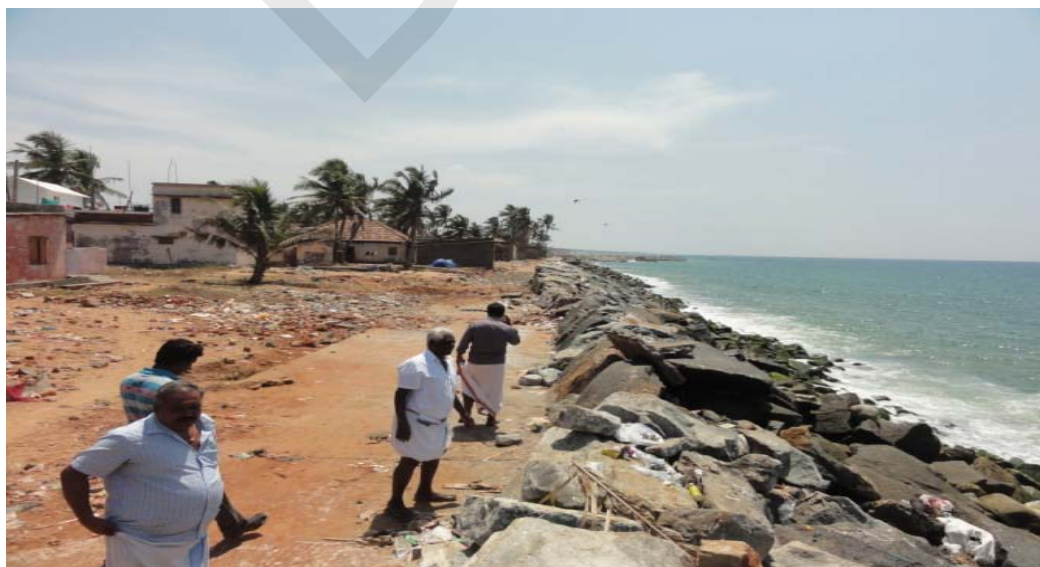
Fig.10.27c Partially functional coastal road abutting the seawall

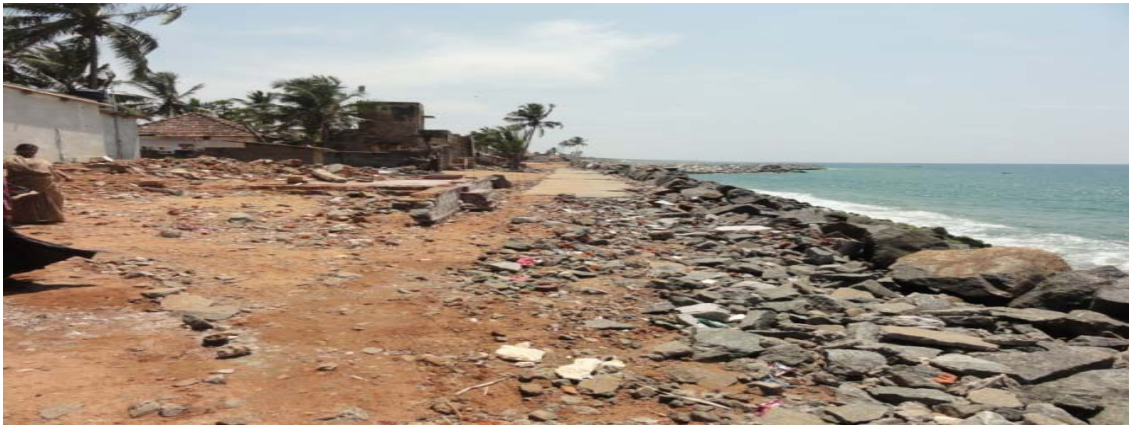
Damages of the many houses have shown the severity of the shoreline erosion. Few houses were fully sacrificed to the sea in the recent past. The existing seawall is not effective during rough monsoon season leading to significant overtopping during monsoon. Three short groins proposed by IIT Madras for the purposes of fish landing centre at Thoothoor has proved to be successful (**Fig.10.27a**) in protecting the beach in between them and on its upstream. This only proves again that this area is the zone of active sediment transport along the shore. Hence, groin field can be considered as effective coastal protection measure along this stretch. The damaged seawall along coast of Chinnathurai is shown in **Fig.10.27b**. The partially functional coastal road abutting seawall and view of Thoothoor groin on the east is shown in **Fig.10.27c** and **Fig.10.27d** respectively.

Fig.10.27d View of Thoothoor groin on the east

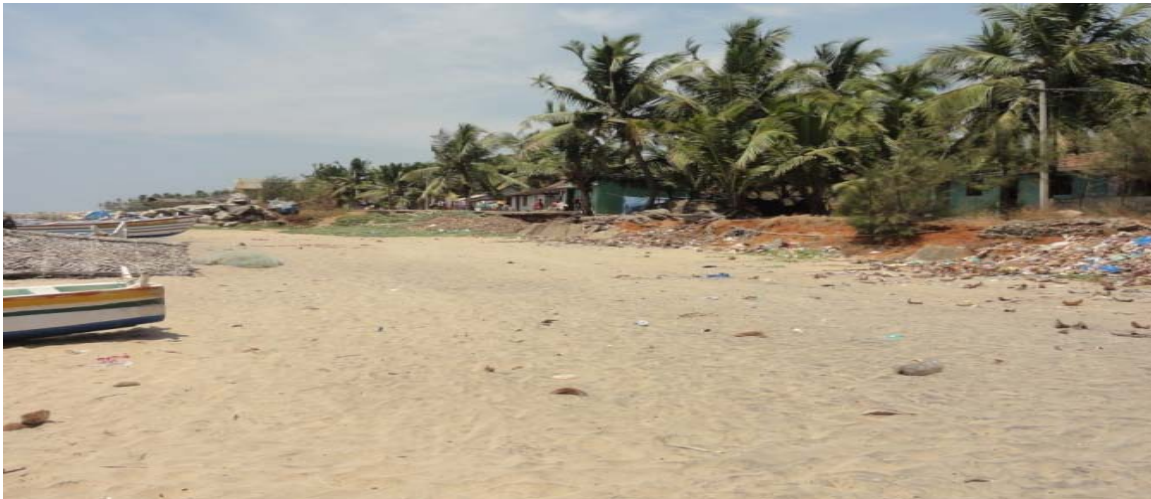
Fig.10.28aView of damaged coastal road

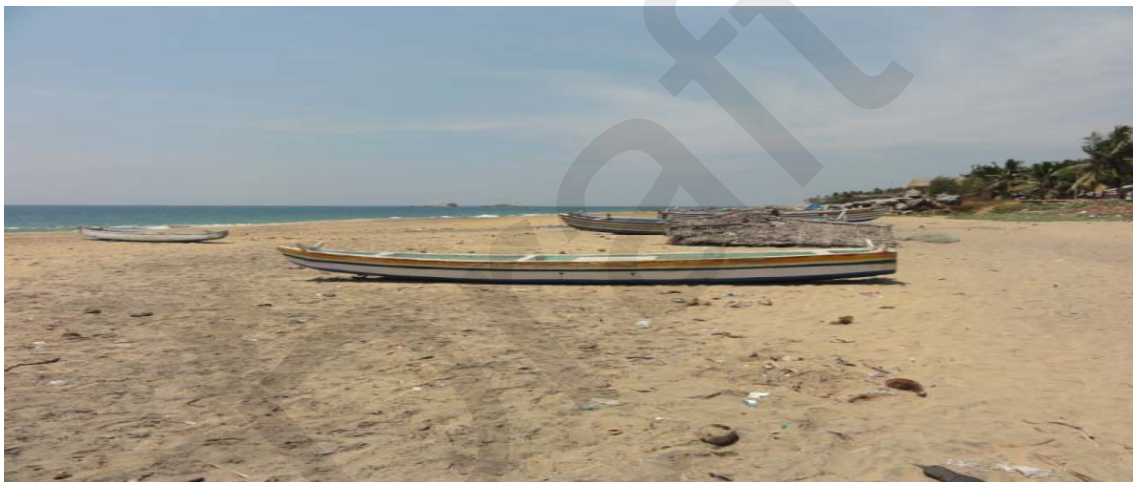
Nearly 400m stretch of the coast has been suffering the damages. Few houses are in danger and the village coastal road has damaged in full. The local people have been demanding for the implementation of the groin field between Inayam and Muttom, which was suggested in 2005 by IIT Madras after Tsunami. The western side of this stretch has been protected by seawalls and has been serving its purpose. This stretch of the coast can either be protected by groin field as suggested by IIT Madras in 2005 report or a flat seawall as being adopted by PWD. The damaged coastal road is shown in **Fig.10.28a**. During the fair weather season, the beach width is shown in **Fig.10.28b**, whereas the wave scouring the building foundation is shown in **Fig.10.28c**.

Fig.10.28bView of beach width during fair weather season

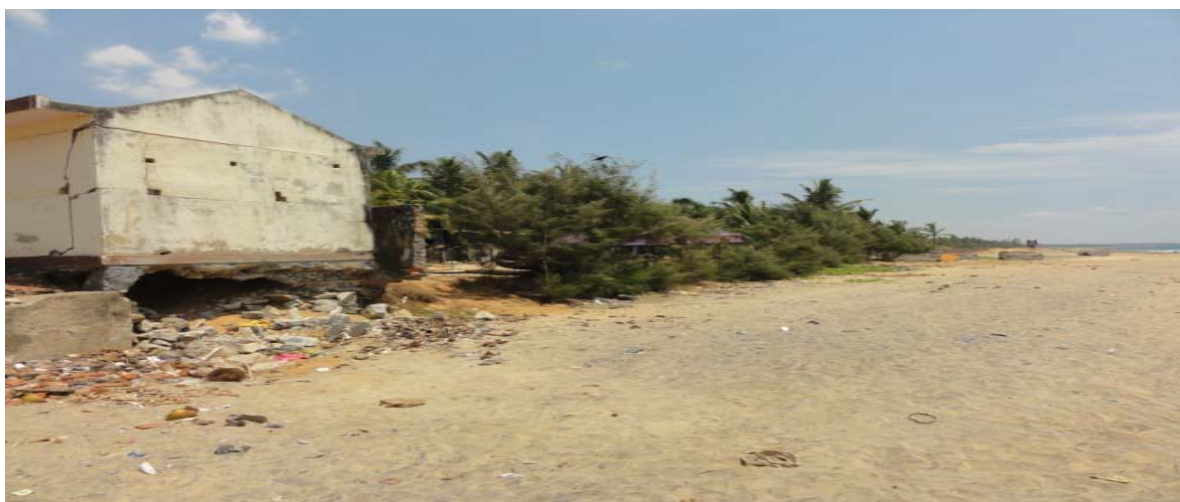
Fig.10.28c Wave scouring the building foundation

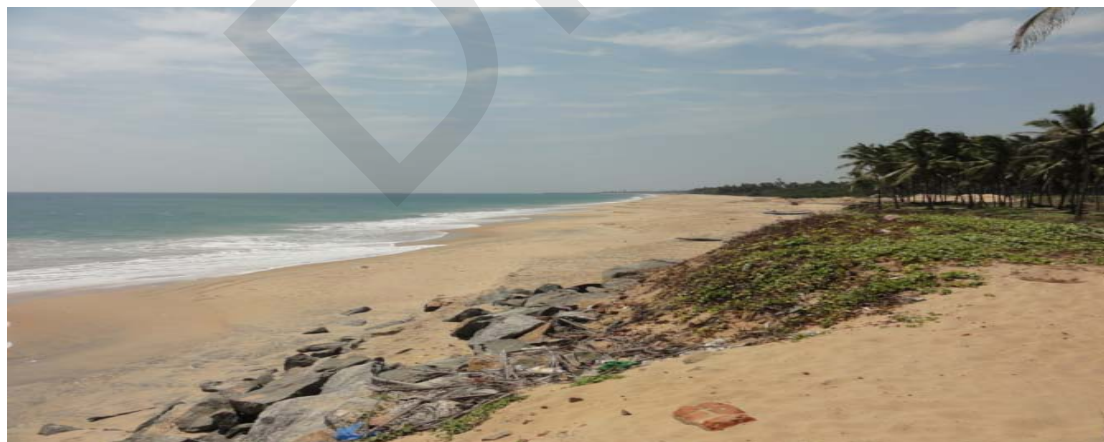
A famous temple and a church along the coastal stretch of MandaikaduPudur are importance pilgrimage centres and have been densely populated along this 850m long coastal stretch. It is beneficial to the public, in particular a large number of pilgrimages, to protect the coast by retaining the sand being lost to sea. During severe weather season, the wave ingress into the land and hence, the habitation which is at the level of +5m above mean sea level are under threat of being collapsed. The stretch of the coast of Mandaikadu is shown in **Fig.10.29a** and **Fig.10.29b**. During fair weather season, about 20m beach width is normally available. T-groins would be effective in this stretch and one smaller stretch within this groin field may be created for boat-beach landing facility. The variation of the beach slope along this stretch of the coast is shown in **Fig.10.29c**, whereas the Sediment collected along the beach, the results of which from the sieve analysis is shown in **Fig.10.29d**.

Fig.10.29a Erosion along the western end coast of Mandaikadu

Solution suggested: *T-groins would be effective in this stretch and one smaller stretch within this groin field may be created for boat-beach landing facility. The higher elevated land topography is need to be protected using geo-textile tubes.*

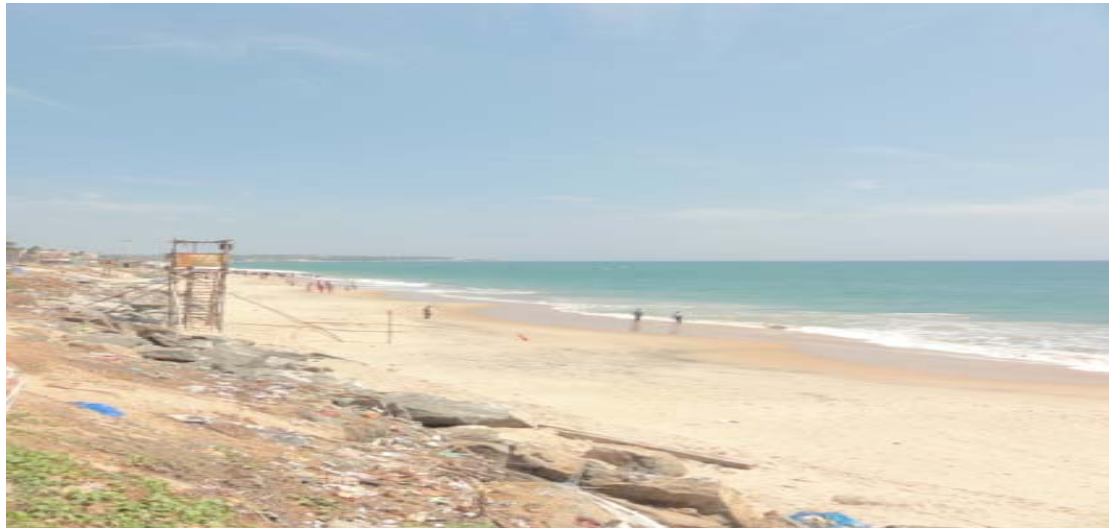
Fig.10.29b Mandaikadu Pudur coastal stretch showing the severity of the coastal berm erosion

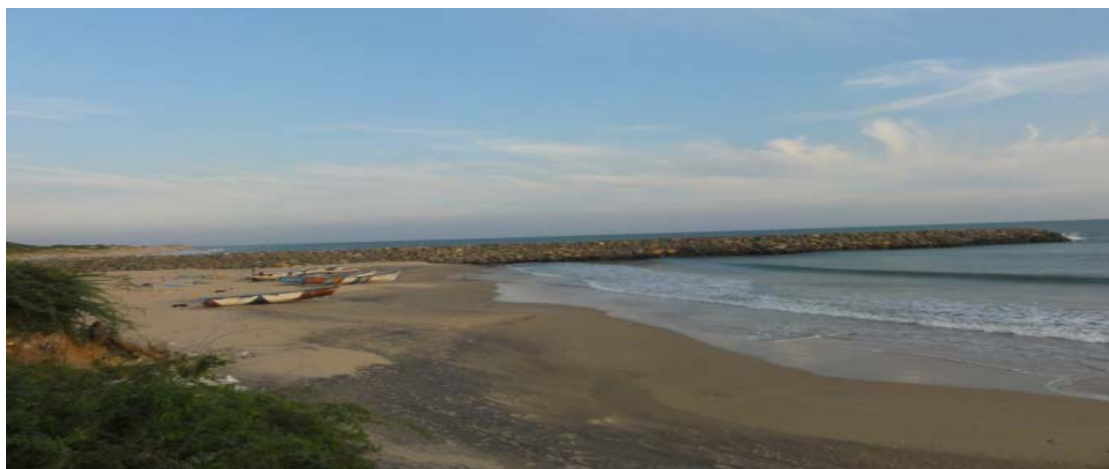
The view of the North and South groin at Perumanal is shown in **Fig.10.30a** and **Fig.10.30b** respectively. The fisheries department has constructed two groins in 2015 with an idea of gap between groins as a boat landing facility. The net littoral movement along this stretch is in general balanced. And, thus it is not expected any severe adverse impact. If the fish landing requirements demand, one of the groin may be bend to form as a fully protected basin. The beach profile along the coast of Perumanal is shown in **Fig.10.30c**. And the grain size distribution for Perumanal is shown in **Fig.10.30d**.

Fig.10.30a View of the North groin at Perumanal

Solution suggested: *A pair of groins has been constructed recently and one of which may be extended to form a fish landing facility.*

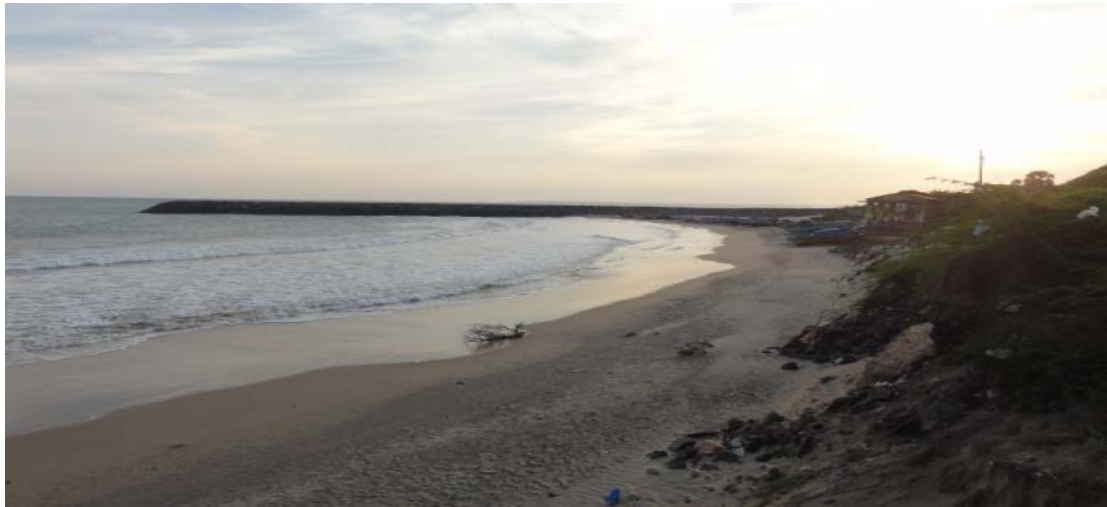
Fig.10.30b View of the South groin at Perumanal

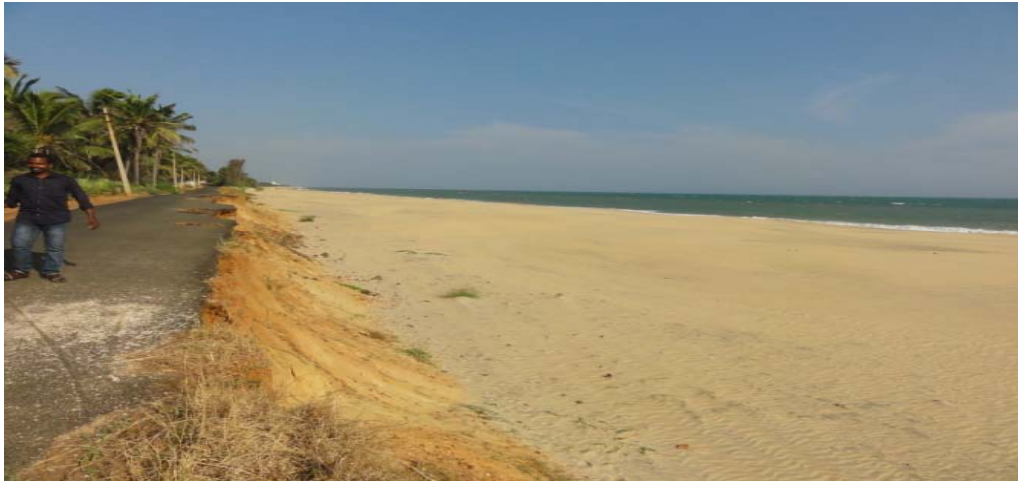
Fig.10.31a Erosion of road in Chothuvalai Beach
