Assessment on coral reef and seagrass meadows within the 10km radius from the proposed groynes site in Keelavaippar coast, Gulf of Mannar

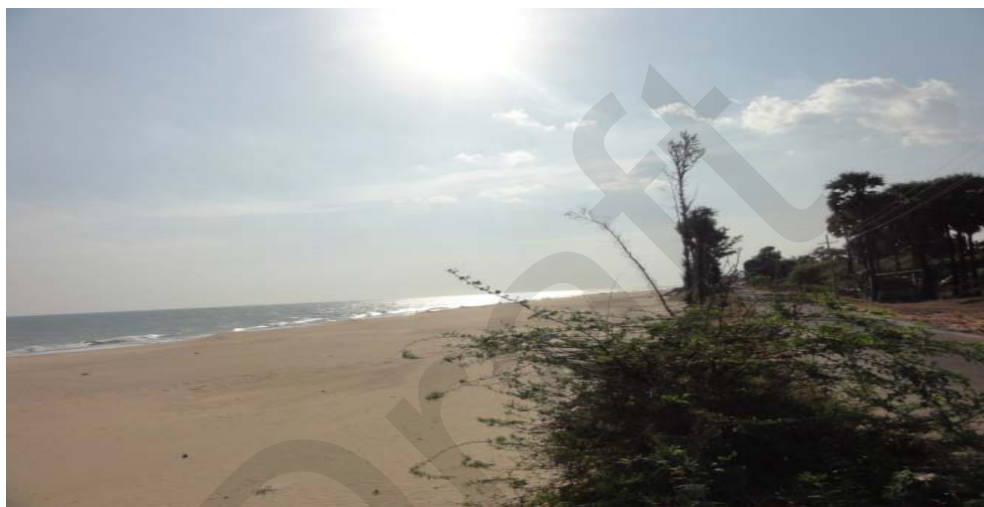
The existing coastal road at certain locations damaged severely to an extent of loss of 50% of beach width. Public transport has been stopped for the last 3 years along this road. This stretch of 1km needs immediate protection with geotextile tube running parallel to the coast to serve as a seawall over which plantation can serve as additional protection. This not only save beach and also beautify the tourist beach. It is believed that this stretch was fronted by casuarinas plantations which have been sacrificed to sea over the years. The erosion of road in Chothuvalai Beach is shown in **Fig.10.31a** and **Fig.10.31b** respectively. The beach profile along this coast is shown in **Fig.10.31c**, whereasthe results of grain size distribution from the sieve analysis is shown in **Fig.10.31d**.

Fig.10.31b Chothuvalai tourism beach showing the coastal road is being eroded

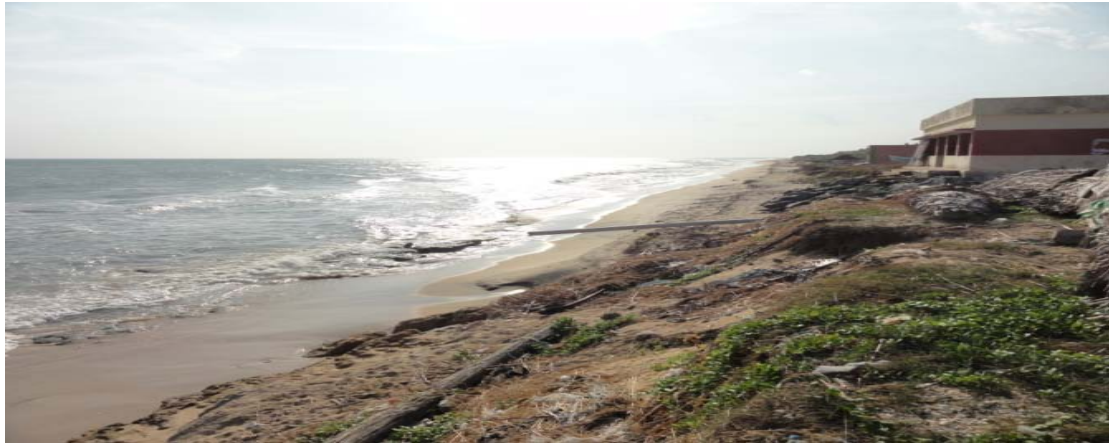
Fig.10.32a Erosion of soil near Melamanakudi

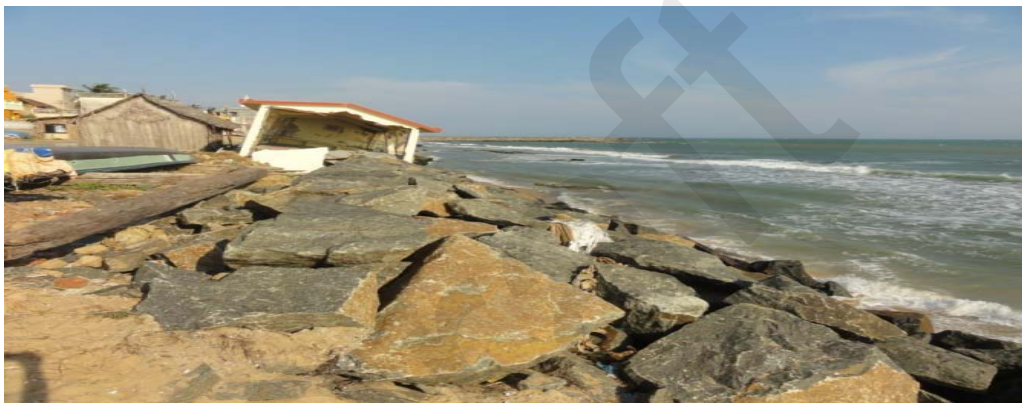
The river mouth joining to sea to Manakudilake has been protected from mouth closure by a pair of training walls. Due to dominant westerly littoral movement along this stretch, the sediment bypasses the eastern training wall and blocks the mouth of the river during most of the year. This has to be rectified by dredging the river mouth in between the training walls. By doing so, necessary tidal prism would prevail to keep the mouth open throughout the year by maintaining sufficient current flow. Alternatively, the eastern training wall may be considered to increase its length in addition to the dredging. The erosion of soil near Melamanakudi is shown in **Fig.10.32a**. The damages seawall and building is shown in **Fig.10.32b**.

Due to this pair of training walls, the downstream coastal stretch of 1.2km long along Melamanakudi village has been suffering severe erosion resulting many shore buildings sacrificed to the sea. The seawall that was constructed in the past decades had been completely washed away at many locations. A series of groin is the best solution in this littoral dominant location. The view of the Melamanakudi river mouth closure during March 2016 is shown in **Fig.10.32c**. The beach profile and the grain size distribution along the coast of Melamanakudi is shown in **Fig.10.32d** and **Fig.10.32e** respectively.

Fig.10.32b Melamanakudi coast showing the damaged seawall and the collapse of building

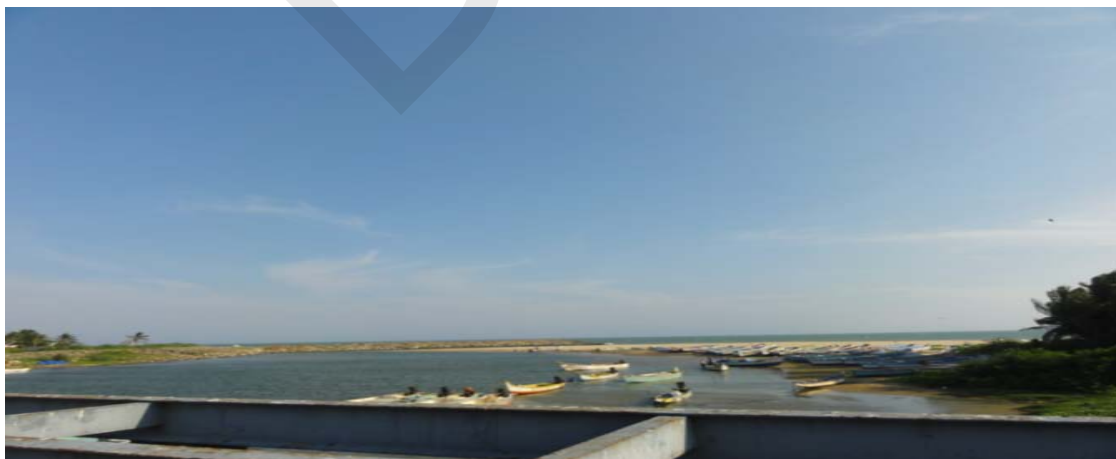
Fig.10.32c View of the Melamanakudi river mouth closure during March 2016.

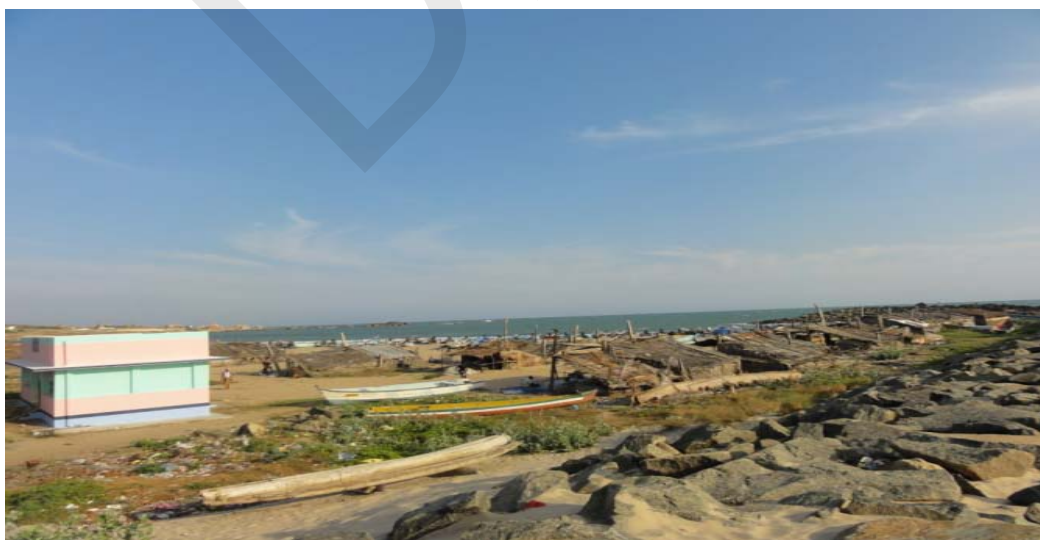
A long groin along the coastal stretch of Kovalam village, just west of the Kanyakumari, has been constructed in 2003 to create a safe fish landing facility on its east. However, the downstream of this groin has shown severe erosion over the years due to scarcity of sediment movement. The erosion at downstream coastal stretch of Kovalam is shown in **Fig.10.33a**. The entire stretch of coastal road connecting upto Kanyakumari has been lost to the sea. In addition, several houses had been sacrificed to the sea. This 500m long coastal stretch, downstream of Kovalam groin should be protected using a transition groin field such that the downstream of the last groin should not be affected. The view of upstream accretion and subsequent beach landing is shown in **Fig.10.33b**.

Fig.10.33bView of upstream accretion and subsequent beach landing
